Profile/Photo Observation Report

Date:	04/22/2018	Weather:		Coding:	PACP 6.0
Pipe Length (ft):	287.3	Owner:	NA	Pre Clean:	Not Known
P.O.#:		Surveyor:	Mark Ruby	PSR:	P-805-011-010
Customer:		Clean Date:	01/01/1900	Shape:	C

Street:	Capitol	Flow Control:	Not Controlled
City:	Hobart, IN	Year Renewed:	
Location:	Alley	Tape/Media #:	
Purpose:	Maintenance Related	Dia/Height:	12"
Use:	Sanitary	Material:	PVC
Drain Area:	NA	Lining:	Cured in Place
Category:	NA		
Comment:	flow incorrect.

Location Details:		Direction of Survey:	Downstream
US MH:	M-805-010	DS MH:	M-805-011
		Total Length Surveyed (ft):	266.9

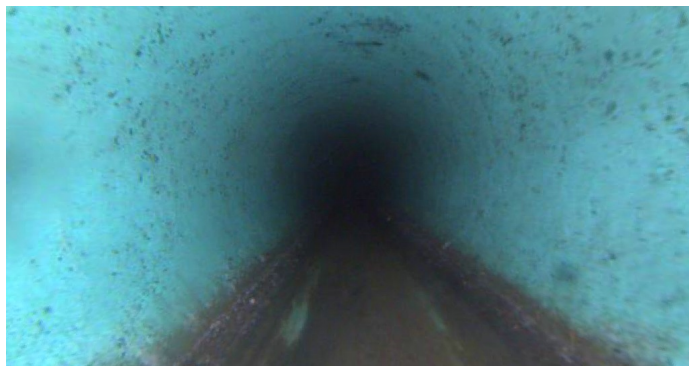
Code: **AMH**
 Description: **Manhole**

Distance (ft): **.0**
 Structural Grade: **0**
 O&M Grade: **0**
 Clock Start/From:
 Clock To:
 1st Value:
 2nd Value:
 Value Percent:
 Continuous Index:
 Within 8" of Joint: **NO**
 Remarks: **M-805-010**

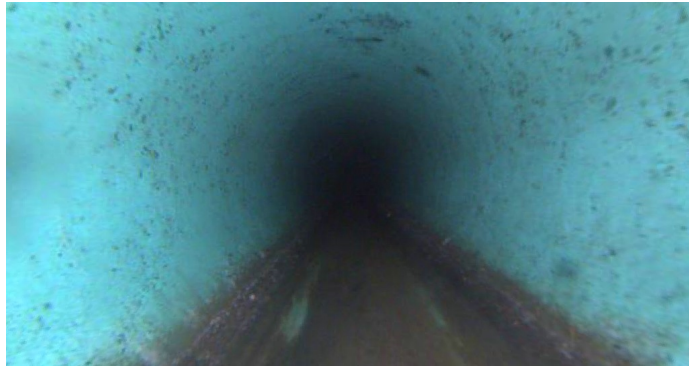
Code: **MWL**
Description: **Water Level**

Distance (ft): **.0**
Structural Grade: **0**
O&M Grade: **0**
Clock Start/From:
Clock To:
1st Value:
2nd Value:
Value Percent: **10.000**
Continuous Index:
Within 8" of Joint: **NO**
Remarks:

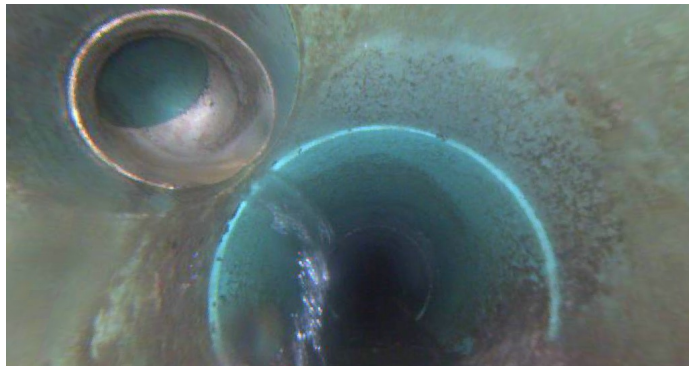
Code: **TFA**
Description: **Tap Factory Active**

Distance (ft): **24.0**
Structural Grade: **0**
O&M Grade: **0**
Clock Start/From: **10**
Clock To:
1st Value: **4.000**
2nd Value:
Value Percent:
Continuous Index:
Within 8" of Joint:
Remarks:

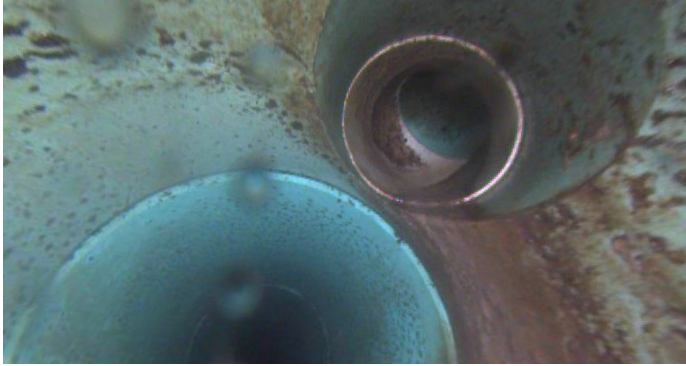
Code: **TF**
Description: **Tap Factory**

Distance (ft): **54.9**
Structural Grade: **0**
O&M Grade: **0**
Clock Start/From: **2**
Clock To:
1st Value: **4.000**
2nd Value:
Value Percent:
Continuous Index:
Within 8" of Joint:
Remarks:

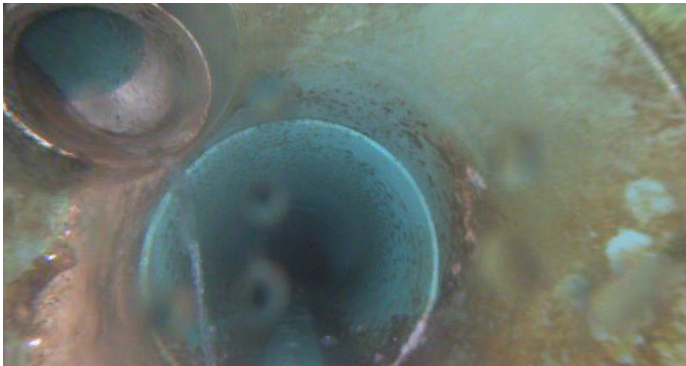
Code: **TFA**
Description: **Tap Factory Active**

Distance (ft): **104.4**
Structural Grade: **0**
O&M Grade: **0**
Clock Start/From: **10**
Clock To:
1st Value: **4.000**
2nd Value:
Value Percent:
Continuous Index:
Within 8" of Joint:
Remarks:

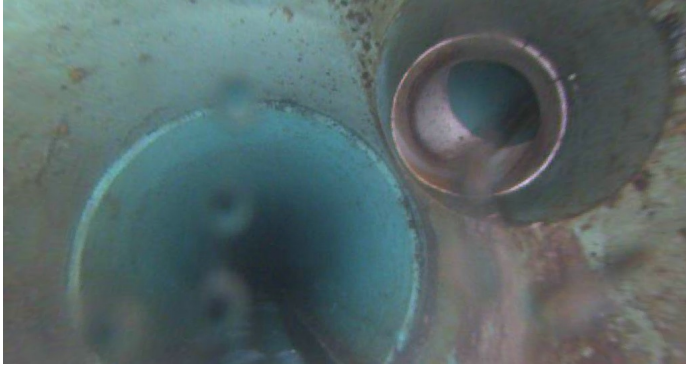
Code: **TF**
Description: **Tap Factory**

Distance (ft): **112.5**
Structural Grade: **0**
O&M Grade: **0**
Clock Start/From: **2**
Clock To:
1st Value: **4.000**
2nd Value:
Value Percent:
Continuous Index:
Within 8" of Joint:
Remarks:

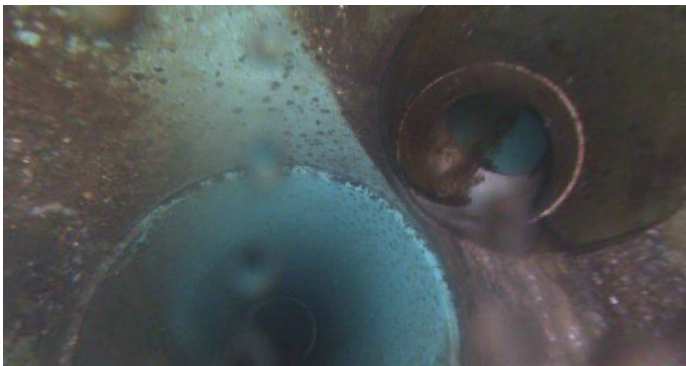
Code: **TF**
Description: **Tap Factory**

Distance (ft): **153.5**
Structural Grade: **0**
O&M Grade: **0**
Clock Start/From: **2**
Clock To:
1st Value: **4.000**
2nd Value:
Value Percent:
Continuous Index:
Within 8" of Joint:
Remarks:

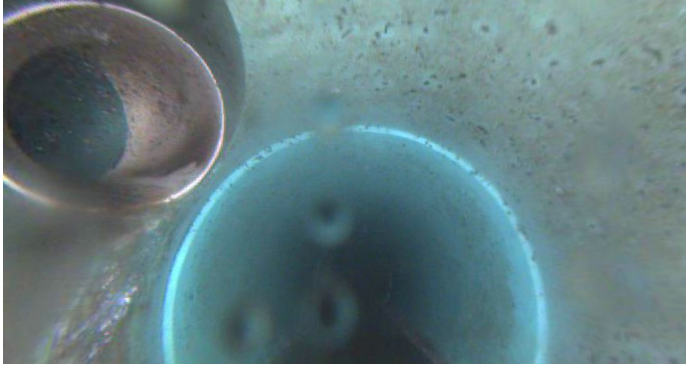
Code: **TFA**
Description: **Tap Factory Active**

Distance (ft): **157.8**
Structural Grade: **0**
O&M Grade: **0**
Clock Start/From: **10**
Clock To:
1st Value: **4.000**
2nd Value:
Value Percent:
Continuous Index:
Within 8" of Joint:
Remarks:

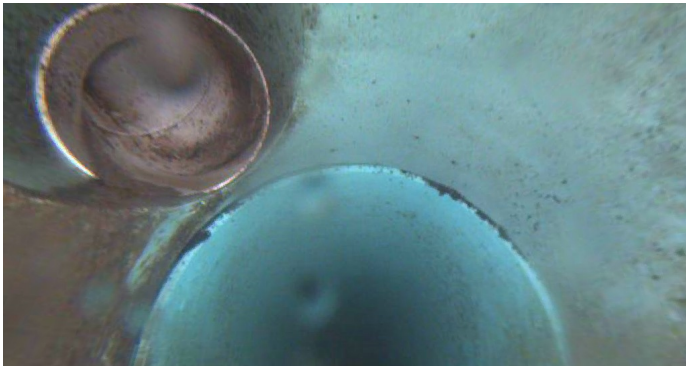
Code: **TF**
Description: **Tap Factory**

Distance (ft): **227.1**
Structural Grade: **0**
O&M Grade: **0**
Clock Start/From: **10**
Clock To:
1st Value: **4.000**
2nd Value:
Value Percent:
Continuous Index:
Within 8" of Joint:
Remarks:

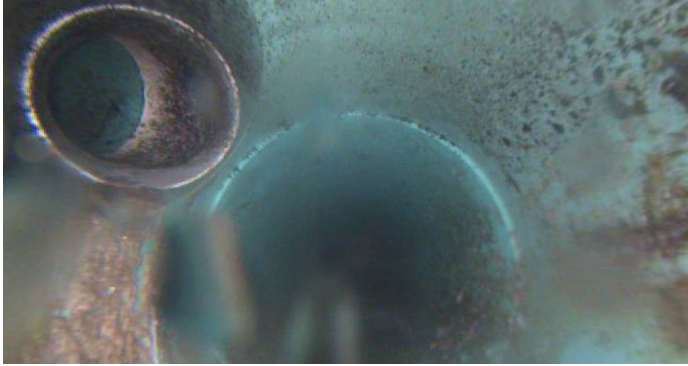
Code: **TF**
Description: **Tap Factory**

Distance (ft): **259.7**
Structural Grade: **0**
O&M Grade: **0**
Clock Start/From: **10**
Clock To:
1st Value: **4.000**
2nd Value:
Value Percent:
Continuous Index:
Within 8" of Joint:
Remarks:

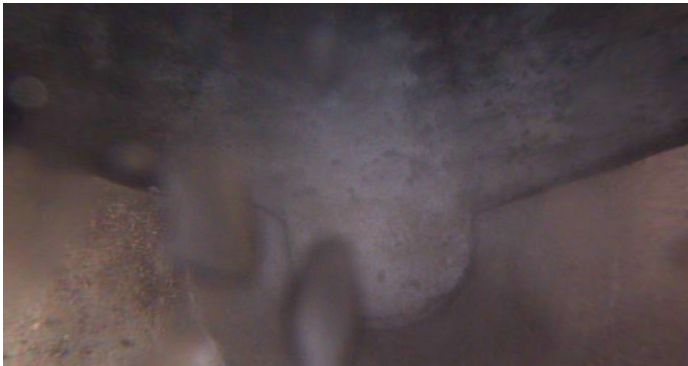
Code: **AMH**
Description: **Manhole**

Distance (ft): **266.9**
Structural Grade: **0**
O&M Grade: **0**
Clock Start/From:
Clock To:
1st Value:
2nd Value:
Value Percent:
Continuous Index:
Within 8" of Joint: **NO**
Remarks: **M-805-011**
