## Profile/Photo Observation Report

Date:	<b>05/05/2018</b>	Weather:		Coding:	<b>PACP 6.0</b>
Pipe Length (ft):		Owner:	<b>City of Hobart</b>	Pre Clean:	<b>No Pre-Cleaning</b>
P.O.#:	<b>193</b>	Surveyor:	<b>M. Pielacha</b>	PSR:	<b>P-805-009-013</b>
Customer:	<b>City of Hobart</b>	Clean Date:		Shape:	<b>C</b>

Street:	<b>5th Street</b>	Flow Control:	<b>Not Controlled</b>
City:	<b>Hobart, IN</b>	Year Renewed:	
Location:	<b>Light Highway</b>	Tape/Media #:	<b>DEP 193</b>
Purpose:	<b>Routine Assessment</b>	Dia/Height:	<b>20"</b>
Use:	<b>Sanitary</b>	Material:	<b>VCP</b>
Drain Area:		Lining:	
Category:	<b>NA</b>		
Comment:	<b>5-21-2018</b>		
Location Details:		Direction of Survey:	<b>Upstream</b>
US MH:	<b>M-805-013</b>	DS MH:	<b>M-805-009</b>
		Total Length Surveyed (ft):	<b>325.1</b>

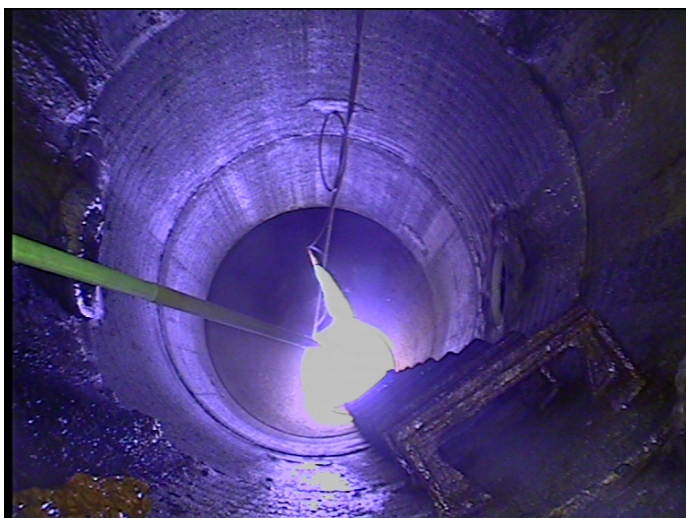
Code: **AMH**  
 Description: **Manhole**

Distance (ft): **.0**  
 Structural Grade: **0**  
 O&M Grade: **0**  
 Clock Start/From:  
 Clock To:  
 1st Value:  
 2nd Value:  
 Value Percent:  
 Continuous Index:  
 Within 8" of Joint: **NO**  
 Remarks: **M-805-013**

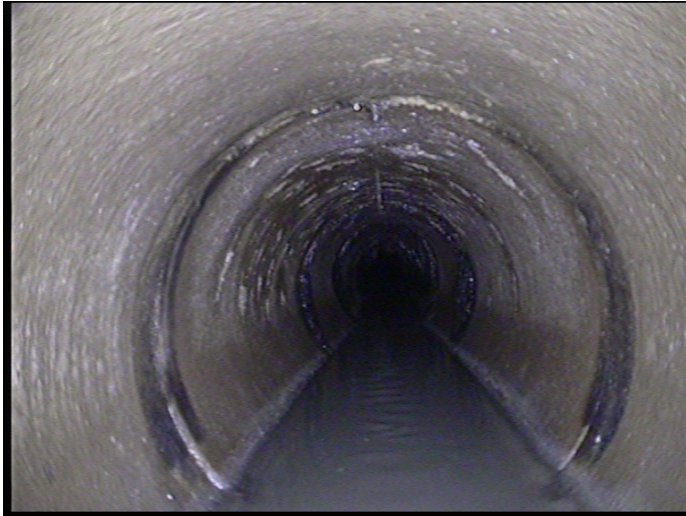
Code:	<b>MWL</b>
Description:	<b>Water Level</b>
Distance (ft):	<b>.0</b>
Structural Grade:	<b>0</b>
O&M Grade:	<b>0</b>
Clock Start/From:	
Clock To:	
1st Value:	
2nd Value:	
Value Percent:	<b>5.000</b>
Continuous Index:	
Within 8" of Joint:	<b>NO</b>
Remarks:

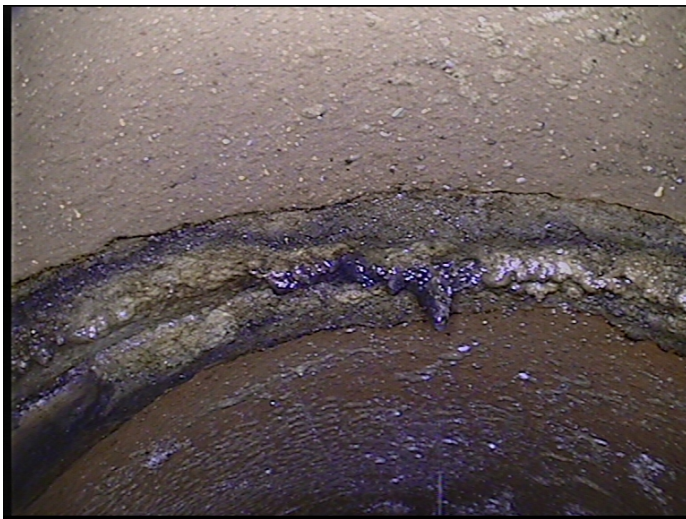
Code:	<b>ID</b>
Description:	<b>Infil Dripper</b>
Distance (ft):	<b>1.0</b>
Structural Grade:	<b>0</b>
O&M Grade:	<b>3</b>
Clock Start/From:	<b>12</b>
Clock To:	
1st Value:	
2nd Value:	
Value Percent:	
Continuous Index:	
Within 8" of Joint:	<b>YES</b>
Remarks:

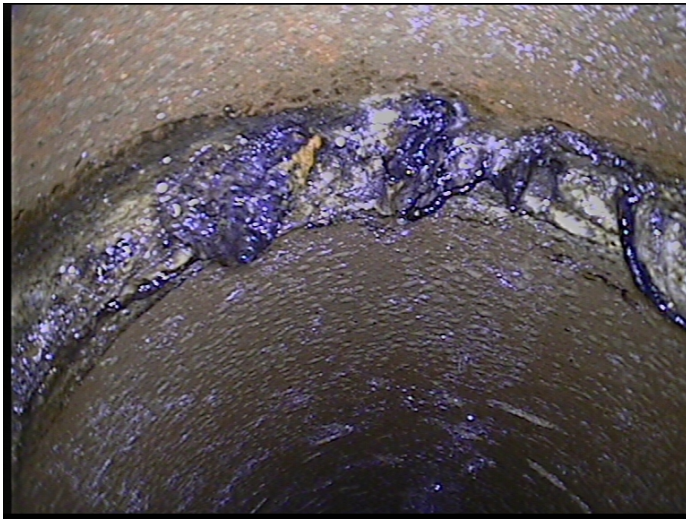
Code:	<b>DAE</b>
Description:	<b>Deposits Attached Encrustation</b>
Distance (ft):	<b>15.1</b>
Structural Grade:	<b>0</b>
O&M Grade:	<b>2</b>
Clock Start/From:	<b>7</b>
Clock To:	<b>5</b>
1st Value:	
2nd Value:	
Value Percent:	<b>5.000</b>
Continuous Index:	<b>S01</b>
Within 8" of Joint:	<b>YES</b>
Remarks:

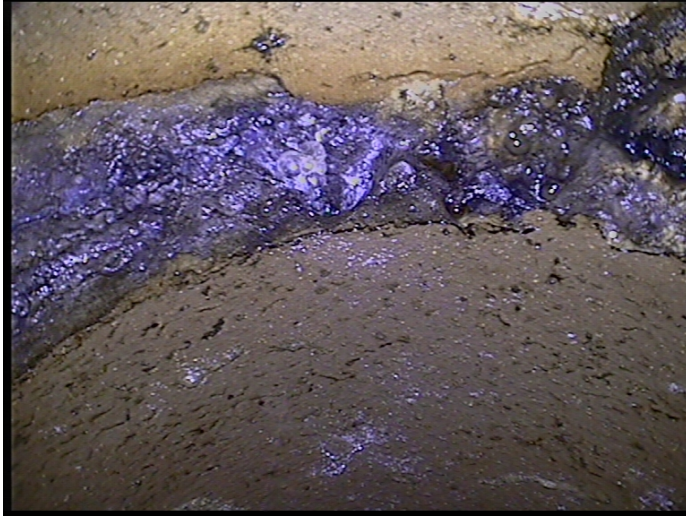
Code: ID  
Description: Infil Dripper

Distance (ft): 92.0  
Structural Grade: 0  
O&M Grade: 3  
Clock Start/From: 11  
Clock To:  
1st Value:  
2nd Value:  
Value Percent:  
Continuous Index:  
Within 8" of Joint: YES  
Remarks:

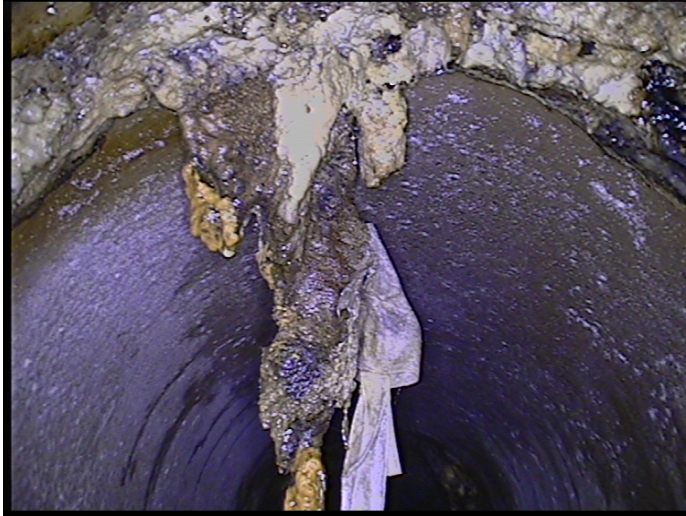
Code: **ID**  
Description: **Infil Dripper**

Distance (ft): **111.2**  
Structural Grade: **0**  
O&M Grade: **3**  
Clock Start/From: **12**  
Clock To:  
1st Value:  
2nd Value:  
Value Percent:  
Continuous Index:  
Within 8" of Joint: **YES**  
Remarks:

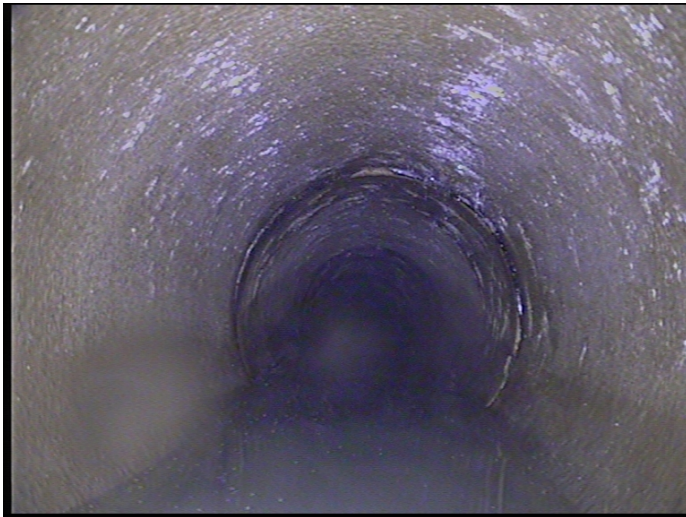
Code: **DAE**  
Description: **Deposits Attached Encrustation**

Distance (ft): **146.9**  
Structural Grade: **0**  
O&M Grade: **2**  
Clock Start/From: **7**  
Clock To: **5**  
1st Value:  
2nd Value:  
Value Percent: **5.000**  
Continuous Index: **F01**  
Within 8" of Joint: **NO**  
Remarks:

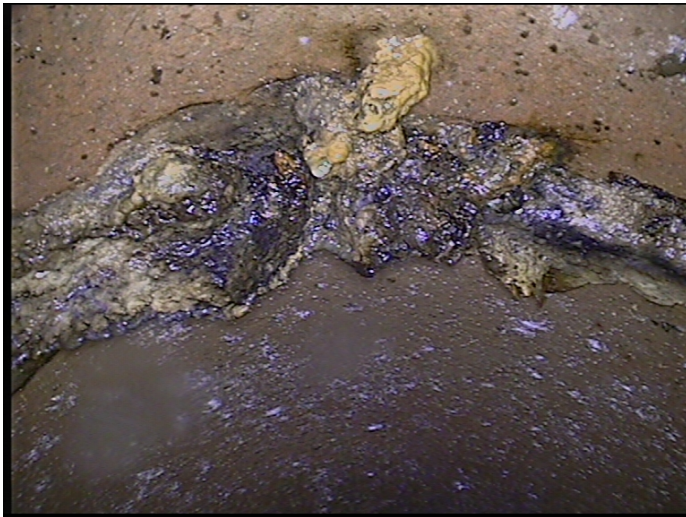
Code: **ID**  
Description: **Infil Dripper**

Distance (ft): **224.1**  
Structural Grade: **0**  
O&M Grade: **3**  
Clock Start/From: **10**  
Clock To:  
1st Value:  
2nd Value:  
Value Percent:  
Continuous Index:  
Within 8" of Joint: **YES**  
Remarks:
