Profile/Photo Observation Report

Date:	03/01/2024	Weather:		Coding:	PACP 7.0
Pipe Length (ft):	331.0	Owner:	City of Hobart	Pre Clean:	Heavy Cleaning
P.O.#:		Surveyor:	S. Bucklin	PSR:	P-805-013-018
Customer:	City of Hobart	Clean Date:	09/01/2022	Shape:	C

Street:	E 5TH ST	Flow Control:	Not Controlled
City:	Hobart, IN	Year Renewed:	
Location:	Local rural streets with light traffic, t	Tape/Media #:	
Purpose:	Sewer System Evaluation Survey (SS	Dia/Height:	21"
Use:	Sanitary Sewage Pipe	Material:	PVC
Drain Area:		Lining:	None
Category:	NA		
Comment:			
Location Details:		Direction of Survey:	Upstream
US MH:	M-805-018	DS MH:	M-805-013
		Total Length Surveyed (ft):	3.2

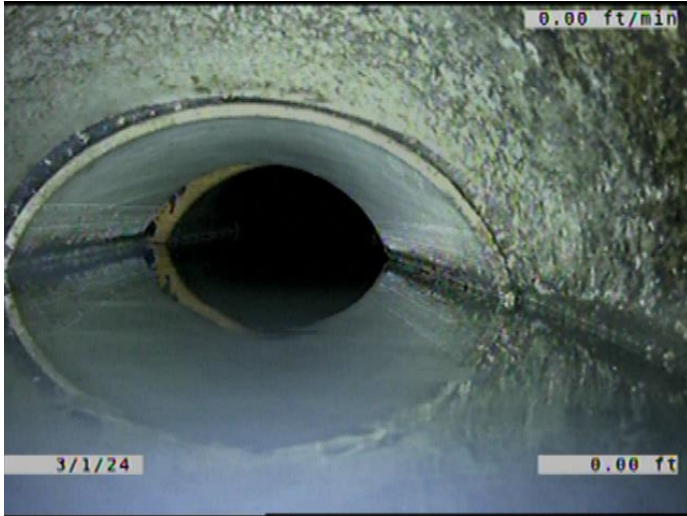
Code: **MWL**
Description: **Miscellaneous Water Level**

Distance (ft): **.0**
Structural Grade: **0**
O&M Grade: **0**
Clock Start/From:
Clock To:
1st Value:
2nd Value:
Value Percent: **45.000**
Continuous Index:
Within 8" of Joint: **NO**
Remarks:
