## Profile/Photo Observation Report

Date:	<b>04/22/2018</b>	Weather:		Coding:	<b>PACP 6.0</b>
Pipe Length (ft):	<b>223.0</b>	Owner:	<b>NA</b>	Pre Clean:	<b>Not Known</b>
P.O.#:		Surveyor:	<b>Mark Ruby</b>	PSR:	<b>P-805-017-018</b>
Customer:		Clean Date:	<b>01/01/1900</b>	Shape:	<b>C</b>

Street:	<b>E 5TH ST</b>	Flow Control:	<b>Not Controlled</b>
City:	<b>Hobart, IN</b>	Year Renewed:	
Location:	<b>Alley</b>	Tape/Media #:	
Purpose:	<b>Maintenance Related</b>	Dia/Height:	<b>10"</b>
Use:	<b>Sanitary</b>	Material:	<b>VCP</b>
Drain Area:	<b>NA</b>	Lining:	<b>Cured in Place</b>
Category:	<b>NA</b>		
Comment:	<b>heavy debris at 114'.-flow incorrect.</b>		
Location Details:		Direction of Survey:	<b>Upstream</b>
US MH:	<b>M-805-018</b>	DS MH:	<b>M-805-017</b>
		Total Length Surveyed (ft):	<b>115.2</b>

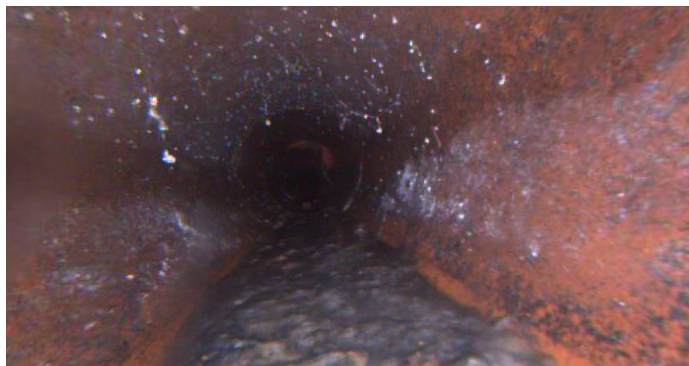
Code: **AMH**  
Description: **Manhole**

Distance (ft): **.0**  
Structural Grade: **0**  
O&M Grade: **0**  
Clock Start/From:  
Clock To:  
1st Value:  
2nd Value:  
Value Percent:  
Continuous Index:  
Within 8" of Joint: **NO**  
Remarks: **M-805-017**

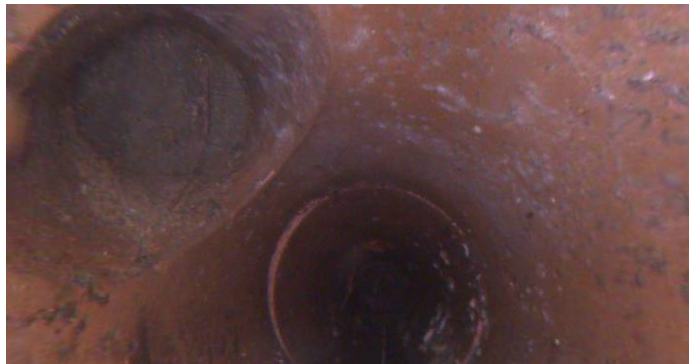
Code: **TFC**  
Description: **Tap Factory Capped**

Distance (ft): **7.9**  
Structural Grade: **0**  
O&M Grade: **0**  
Clock Start/From: **2**  
Clock To:  
1st Value: **4.000**  
2nd Value:  
Value Percent:  
Continuous Index:  
Within 8" of Joint:  
Remarks:

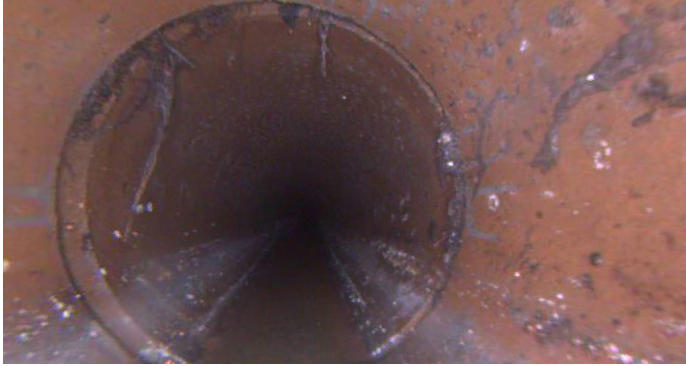
Code: **RFJ**  
Description: **Roots Fine Joint**

Distance (ft): **7.9**  
Structural Grade: **0**  
O&M Grade: **1**  
Clock Start/From: **10**  
Clock To: **5**  
1st Value:  
2nd Value:  
Value Percent:  
Continuous Index:  
Within 8" of Joint: **YES**  
Remarks:

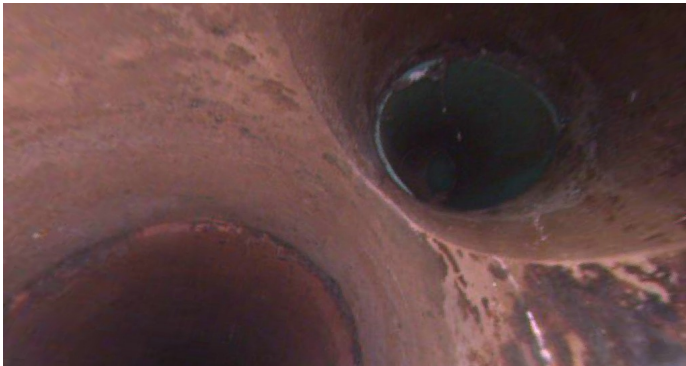
Code: **TF**  
Description: **Tap Factory**

Distance (ft): **17.6**  
Structural Grade: **0**  
O&M Grade: **0**  
Clock Start/From: **10**  
Clock To:  
1st Value: **4.000**  
2nd Value:  
Value Percent:  
Continuous Index:  
Within 8" of Joint:  
Remarks:

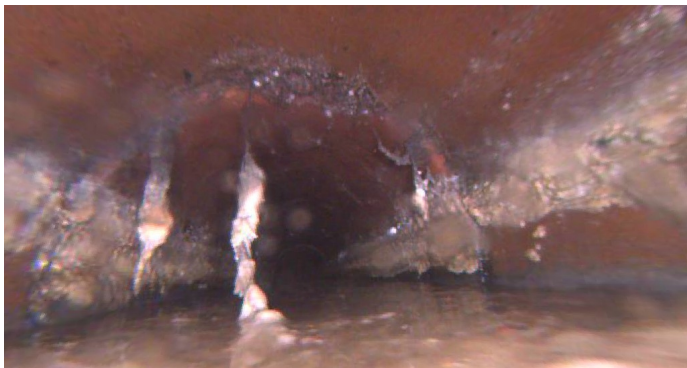
Code:	<b>RFJ</b>
Description:	<b>Roots Fine Joint</b>
Distance (ft):	<b>101.0</b>
Structural Grade:	<b>0</b>
O&M Grade:	<b>1</b>
Clock Start/From:	<b>2</b>
Clock To:	<b>8</b>
1st Value:	
2nd Value:	
Value Percent:	
Continuous Index:	
Within 8" of Joint:	<b>YES</b>
Remarks:

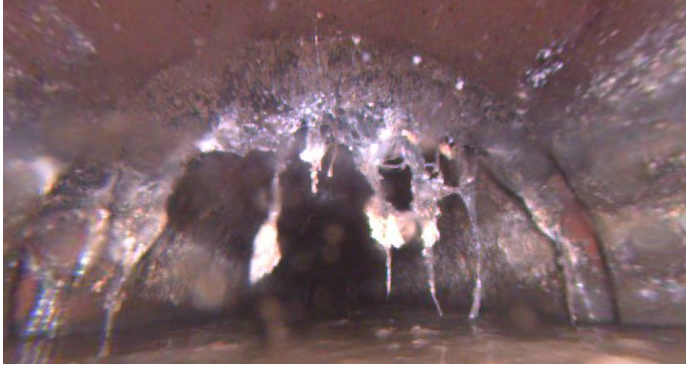
Code: **RMJ**  
Description: **Roots Medium Joint**

Distance (ft): **104.9**  
Structural Grade: **0**  
O&M Grade: **3**  
Clock Start/From: **4**  
Clock To: **8**  
1st Value:  
2nd Value:  
Value Percent: **10.000**  
Continuous Index:  
Within 8" of Joint: **YES**  
Remarks:

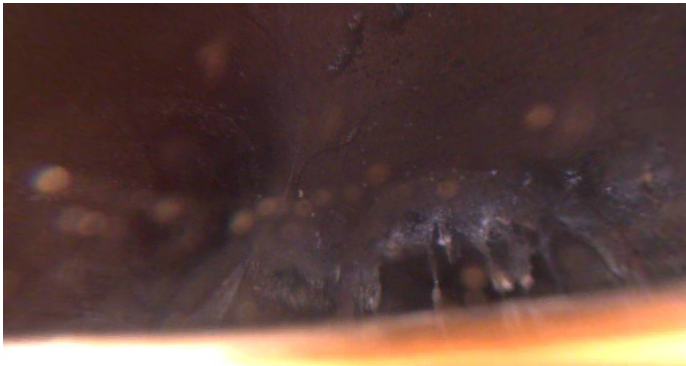
Code: **TF**  
Description: **Tap Factory**

Distance (ft): **105.5**  
Structural Grade: **0**  
O&M Grade: **0**  
Clock Start/From: **3**  
Clock To:  
1st Value: **4.000**  
2nd Value:  
Value Percent:  
Continuous Index:  
Within 8" of Joint:  
Remarks:

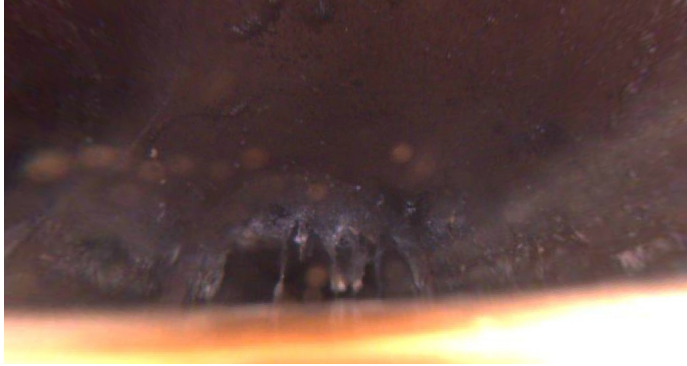
Code: **DAGS**  
Description: **Deposits Attached Grease**

Distance (ft): **105.5**  
Structural Grade: **0**  
O&M Grade: **2**  
Clock Start/From: **4**  
Clock To: **8**  
1st Value:  
2nd Value:  
Value Percent: **5.000**  
Continuous Index: **F01**  
Within 8" of Joint: **NO**  
Remarks:

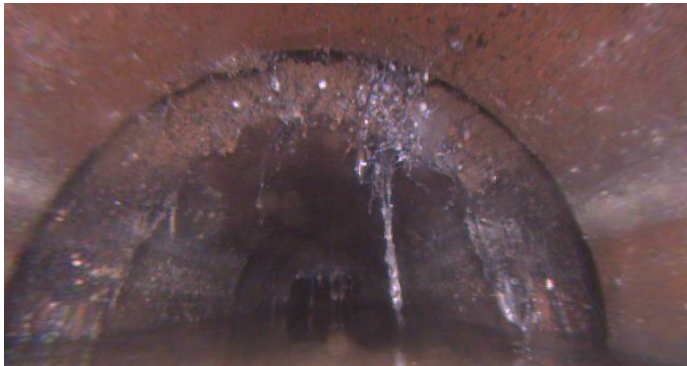
Code: **RFJ**  
Description: **Roots Fine Joint**

Distance (ft): **107.1**  
Structural Grade: **0**  
O&M Grade: **1**  
Clock Start/From: **4**  
Clock To: **8**  
1st Value:  
2nd Value:  
Value Percent:  
Continuous Index:  
Within 8" of Joint: **YES**  
Remarks:

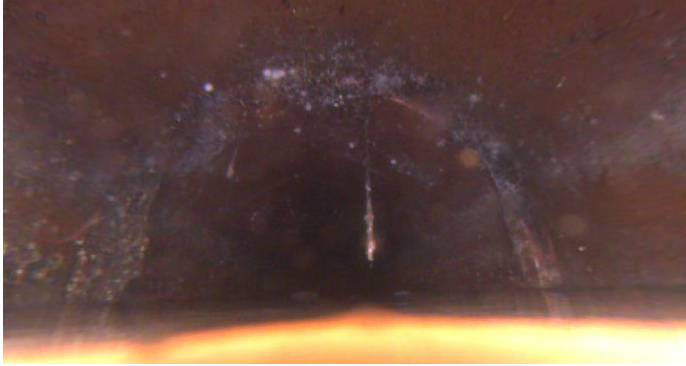
Code: **RFJ**  
Description: **Roots Fine Joint**

Distance (ft): **111.3**  
Structural Grade: **0**  
O&M Grade: **1**  
Clock Start/From: **4**  
Clock To: **8**  
1st Value:  
2nd Value:  
Value Percent:  
Continuous Index:  
Within 8" of Joint: **YES**  
Remarks:
