Profile/Photo Observation Report

Date:	04/22/2018	Weather:		Coding:	PACP 6.0
Pipe Length (ft):	146.4	Owner:	NA	Pre Clean:	Not Known
P.O.#:		Surveyor:	Mark Ruby	PSR:	P-805-020-019
Customer:		Clean Date:	01/01/1900	Shape:	C

Street:	S LIBERTY PL & S JOLIET ST	Flow Control:	Not Controlled
City:	Hobart, IN	Year Renewed:	
Location:	Alley	Tape/Media #:	
Purpose:	Maintenance Related	Dia/Height:	10"
Use:	Sanitary	Material:	VCP
Drain Area:	NA	Lining:	Cured in Place
Category:	NA		
Comment:	flow reversed

Location Details:		Direction of Survey:	Downstream
US MH:	M-805-019	DS MH:	M-805-020
		Total Length Surveyed (ft):	167.2

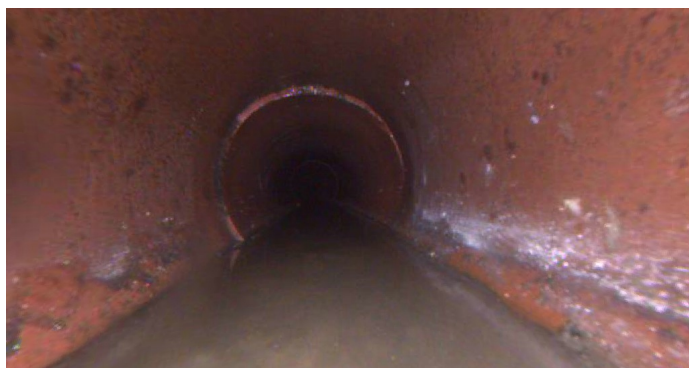
Code: **AMH**
 Description: **Manhole**

Distance (ft): **.0**
 Structural Grade: **0**
 O&M Grade: **0**
 Clock Start/From:
 Clock To:
 1st Value:
 2nd Value:
 Value Percent:
 Continuous Index:
 Within 8" of Joint: **NO**
 Remarks: **M-805-019**

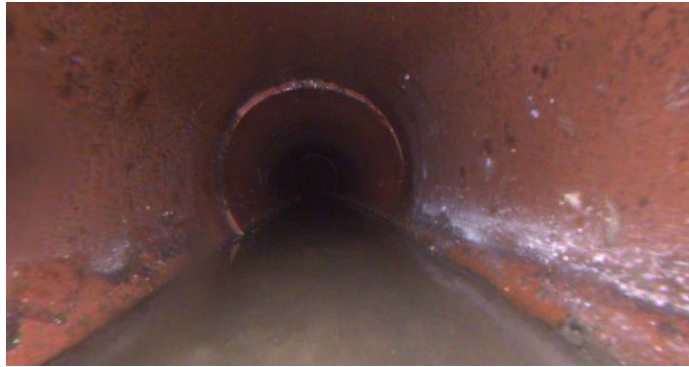
Code: **MWL**
Description: **Water Level**

Distance (ft): **.0**
Structural Grade: **0**
O&M Grade: **0**
Clock Start/From:
Clock To:
1st Value:
2nd Value:
Value Percent: **10.000**
Continuous Index:
Within 8" of Joint: **NO**
Remarks:

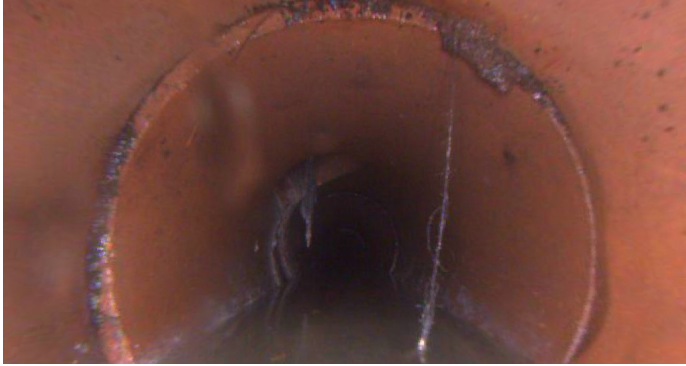
Code: **RFJ**
Description: **Roots Fine Joint**

Distance (ft): **26.2**
Structural Grade: **0**
O&M Grade: **1**
Clock Start/From: **2**
Clock To:
1st Value:
2nd Value:
Value Percent:
Continuous Index:
Within 8" of Joint: **YES**
Remarks:

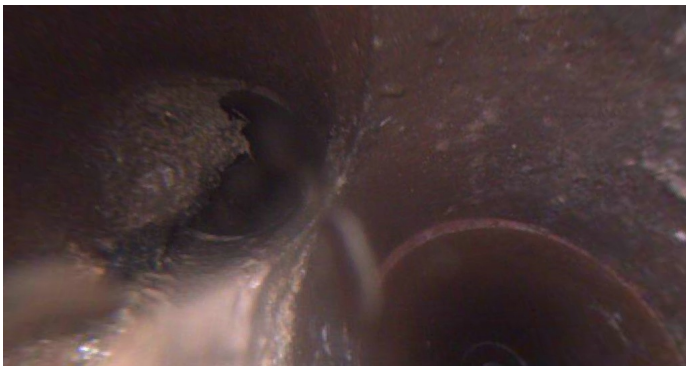
Code: **TFD**
Description: **Tap Factory Defective**

Distance (ft): **97.3**
Structural Grade: **0**
O&M Grade: **2**
Clock Start/From: **10**
Clock To:
1st Value: **4.000**
2nd Value:
Value Percent:
Continuous Index:
Within 8" of Joint:
Remarks: **RFL**

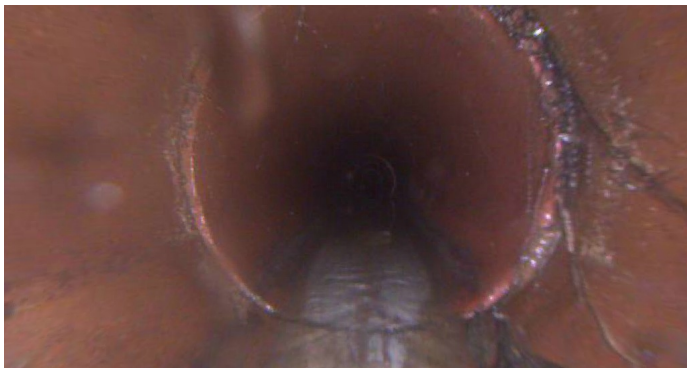
Code:	RFJ
Description:	Roots Fine Joint
Distance (ft):	110.0
Structural Grade:	0
O&M Grade:	1
Clock Start/From:	7
Clock To:	5
1st Value:	
2nd Value:	
Value Percent:	
Continuous Index:	
Within 8" of Joint:	YES
Remarks:

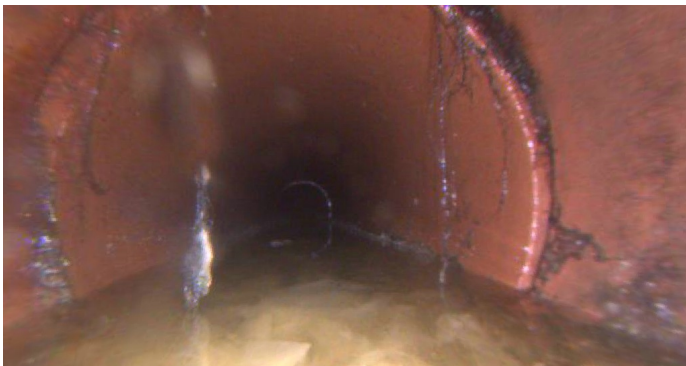
Code: **RFJ**
Description: **Roots Fine Joint**

Distance (ft): **116.2**
Structural Grade: **0**
O&M Grade: **1**
Clock Start/From: **7**
Clock To: **5**
1st Value:
2nd Value:
Value Percent:
Continuous Index:
Within 8" of Joint: **YES**
Remarks:

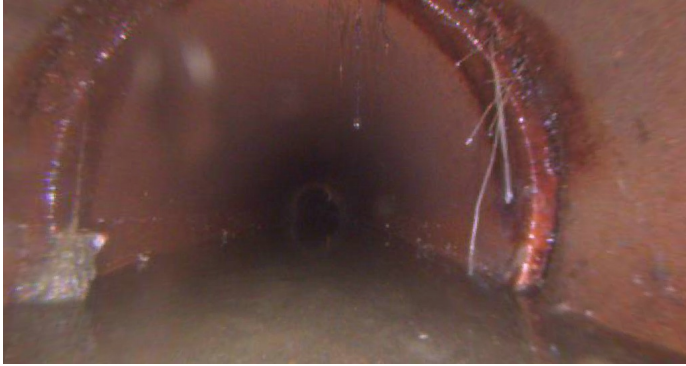
Code: **RFJ**
Description: **Roots Fine Joint**

Distance (ft): **132.4**
Structural Grade: **0**
O&M Grade: **1**
Clock Start/From: **7**
Clock To: **5**
1st Value:
2nd Value:
Value Percent:
Continuous Index:
Within 8" of Joint: **YES**
Remarks:

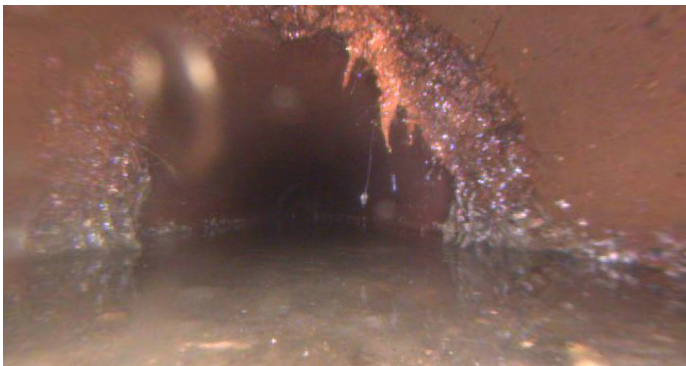
Code: **RFJ**
Description: **Roots Fine Joint**

Distance (ft): **136.4**
Structural Grade: **0**
O&M Grade: **1**
Clock Start/From: **7**
Clock To: **5**
1st Value:
2nd Value:
Value Percent:
Continuous Index:
Within 8" of Joint: **YES**
Remarks:

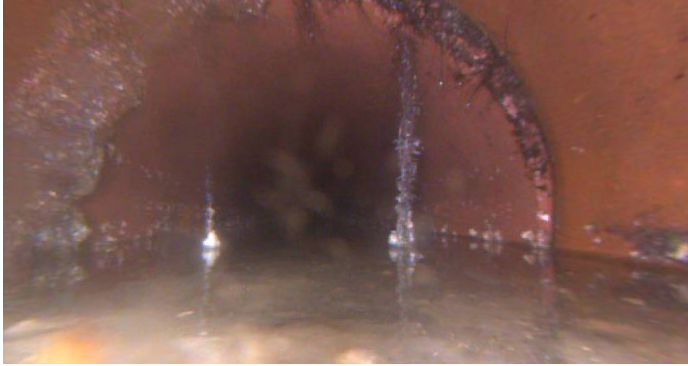
Code: **RFJ**
Description: **Roots Fine Joint**

Distance (ft): **140.6**
Structural Grade: **0**
O&M Grade: **1**
Clock Start/From: **8**
Clock To: **2**
1st Value:
2nd Value:
Value Percent:
Continuous Index:
Within 8" of Joint: **YES**
Remarks:

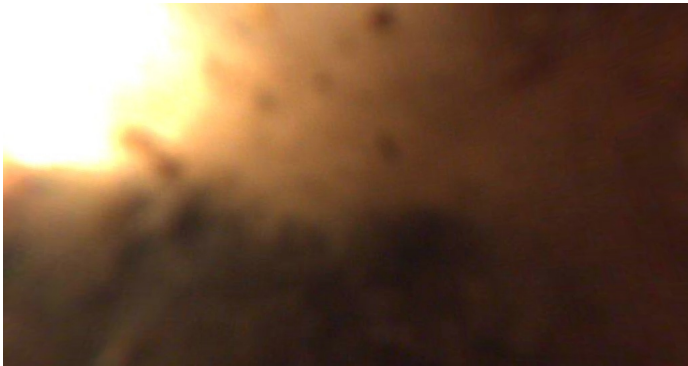
Code: **MCU**
Description: **Camera Underwater**

Distance (ft): **145.9**
Structural Grade: **0**
O&M Grade: **4**
Clock Start/From:
Clock To:
1st Value:
2nd Value:
Value Percent:
Continuous Index:
Within 8" of Joint: **NO**
Remarks:
