## Profile/Photo Observation Report

Street:	<b>Capitol</b>	Flow Control:	<b>Not Controlled</b>
City:	<b>Hobart, IN</b>	Year Renewed:	
Location:	<b>Alley</b>	Tape/Media #:	
Purpose:	<b>Maintenance Related</b>	Dia/Height:	<b>10"</b>
Use:	<b>Sanitary</b>	Material:	<b>VCP</b>
Drain Area:	<b>NA</b>	Lining:	<b>Cured in Place</b>
Category:	<b>NA</b>		
Comment:	<b>flow reversed</b>

Location Details:		Direction of Survey:	<b>Downstream</b>
US MH:	<b>M-805-019</b>	DS MH:	<b>M-805-020</b>
		Total Length Surveyed (ft):	<b>167.2</b>

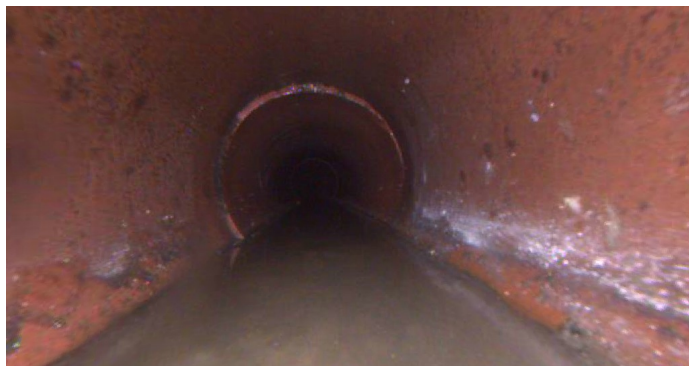
Code: **AMH**  
 Description: **Manhole**

Distance (ft): **.0**  
 Structural Grade: **0**  
 O&M Grade: **0**  
 Clock Start/From:  
 Clock To:  
 1st Value:  
 2nd Value:  
 Value Percent:  
 Continuous Index:  
 Within 8" of Joint: **NO**  
 Remarks: **M-805-019**

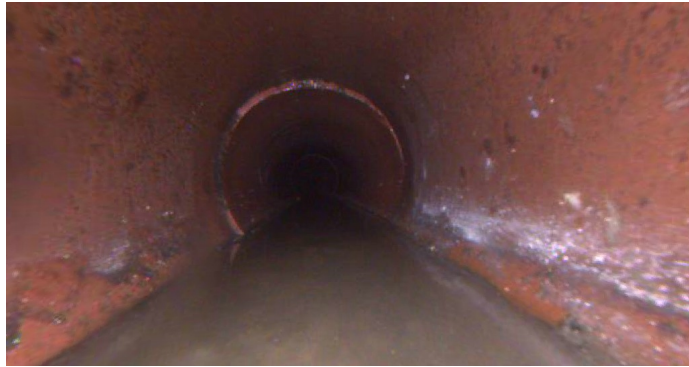
Code: **MWL**  
Description: **Water Level**

Distance (ft): **.0**  
Structural Grade: **0**  
O&M Grade: **0**  
Clock Start/From:  
Clock To:  
1st Value:  
2nd Value:  
Value Percent: **10.000**  
Continuous Index:  
Within 8" of Joint: **NO**  
Remarks:

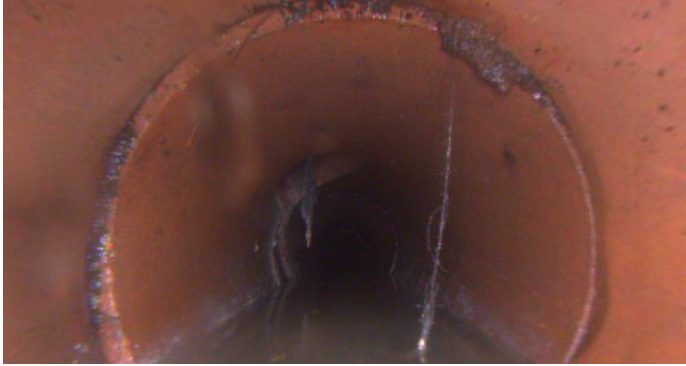
Code: **RFJ**  
Description: **Roots Fine Joint**

Distance (ft): **26.2**  
Structural Grade: **0**  
O&M Grade: **1**  
Clock Start/From: **2**  
Clock To:  
1st Value:  
2nd Value:  
Value Percent:  
Continuous Index:  
Within 8" of Joint: **YES**  
Remarks:

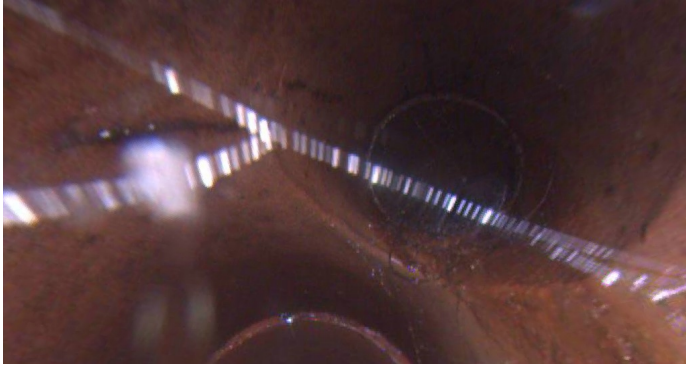
Code: **TF**  
Description: **Tap Factory**

Distance (ft): **33.8**  
Structural Grade: **0**  
O&M Grade: **0**  
Clock Start/From: **2**  
Clock To:  
1st Value: **4.000**  
2nd Value:  
Value Percent:  
Continuous Index:  
Within 8" of Joint:  
Remarks:

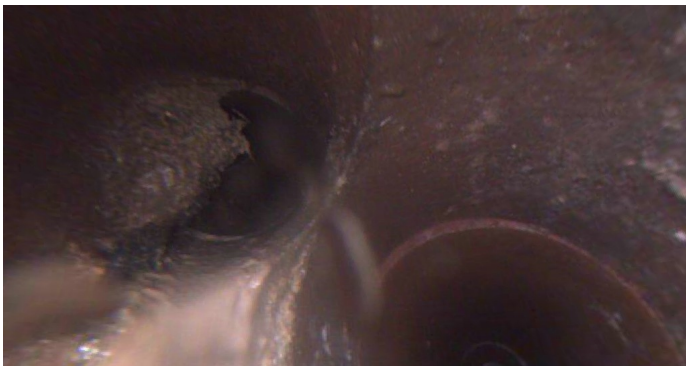
Code: **TFD**  
Description: **Tap Factory Defective**

Distance (ft): **97.3**  
Structural Grade: **0**  
O&M Grade: **2**  
Clock Start/From: **10**  
Clock To:  
1st Value: **4.000**  
2nd Value:  
Value Percent:  
Continuous Index:  
Within 8" of Joint:  
Remarks: **RFL**

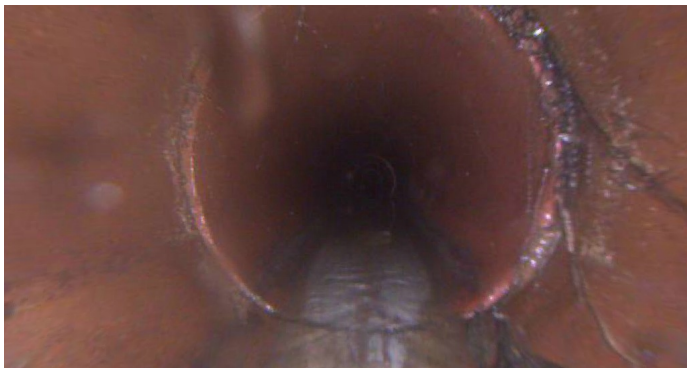
Code:	<b>RFJ</b>
Description:	<b>Roots Fine Joint</b>
Distance (ft):	<b>110.0</b>
Structural Grade:	<b>0</b>
O&M Grade:	<b>1</b>
Clock Start/From:	<b>7</b>
Clock To:	<b>5</b>
1st Value:	
2nd Value:	
Value Percent:	
Continuous Index:	
Within 8" of Joint:	<b>YES</b>
Remarks:

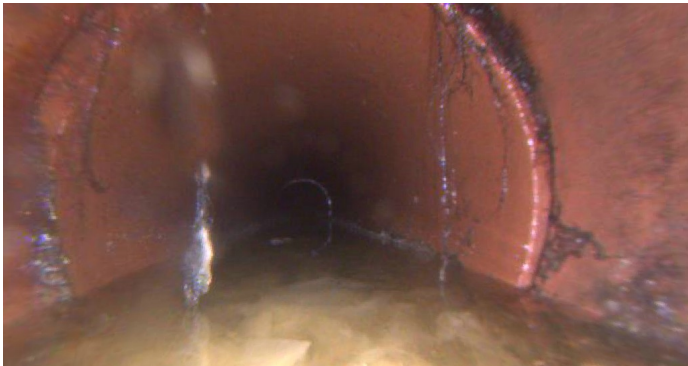
Code: **RFJ**  
Description: **Roots Fine Joint**

Distance (ft): **116.2**  
Structural Grade: **0**  
O&M Grade: **1**  
Clock Start/From: **7**  
Clock To: **5**  
1st Value:  
2nd Value:  
Value Percent:  
Continuous Index:  
Within 8" of Joint: **YES**  
Remarks:

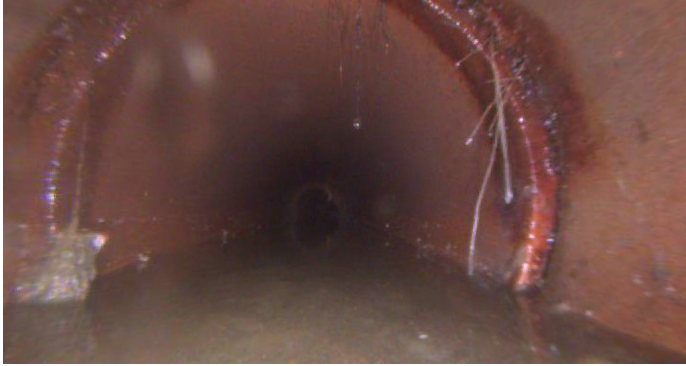
Code: **RFJ**  
Description: **Roots Fine Joint**

Distance (ft): **132.4**  
Structural Grade: **0**  
O&M Grade: **1**  
Clock Start/From: **7**  
Clock To: **5**  
1st Value:  
2nd Value:  
Value Percent:  
Continuous Index:  
Within 8" of Joint: **YES**  
Remarks:

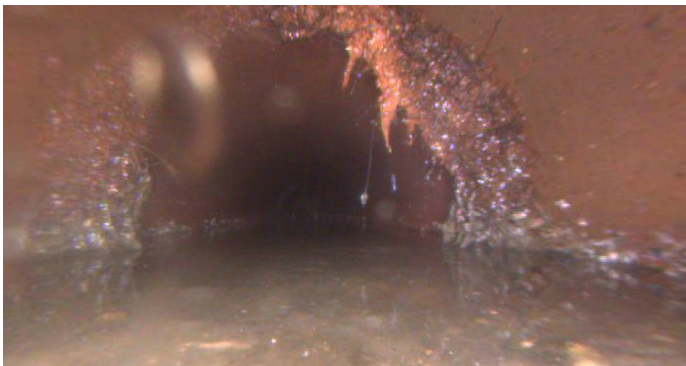
Code: **RFJ**  
Description: **Roots Fine Joint**

Distance (ft): **136.4**  
Structural Grade: **0**  
O&M Grade: **1**  
Clock Start/From: **7**  
Clock To: **5**  
1st Value:  
2nd Value:  
Value Percent:  
Continuous Index:  
Within 8" of Joint: **YES**  
Remarks:

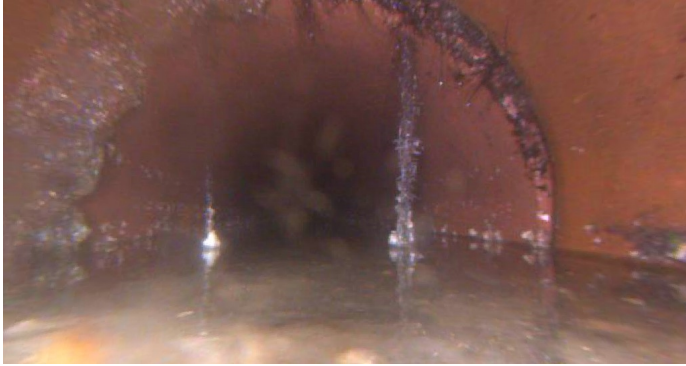
Code: **RFJ**  
Description: **Roots Fine Joint**

Distance (ft): **140.6**  
Structural Grade: **0**  
O&M Grade: **1**  
Clock Start/From: **8**  
Clock To: **2**  
1st Value:  
2nd Value:  
Value Percent:  
Continuous Index:  
Within 8" of Joint: **YES**  
Remarks:

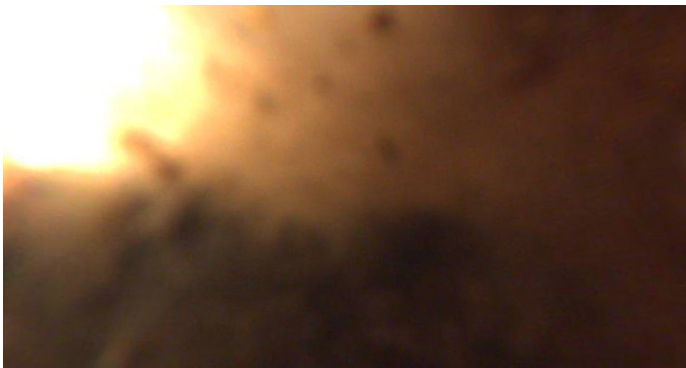
Code: **MCU**  
Description: **Camera Underwater**

Distance (ft): **145.9**  
Structural Grade: **0**  
O&M Grade: **4**  
Clock Start/From:  
Clock To:  
1st Value:  
2nd Value:  
Value Percent:  
Continuous Index:  
Within 8" of Joint: **NO**  
Remarks:

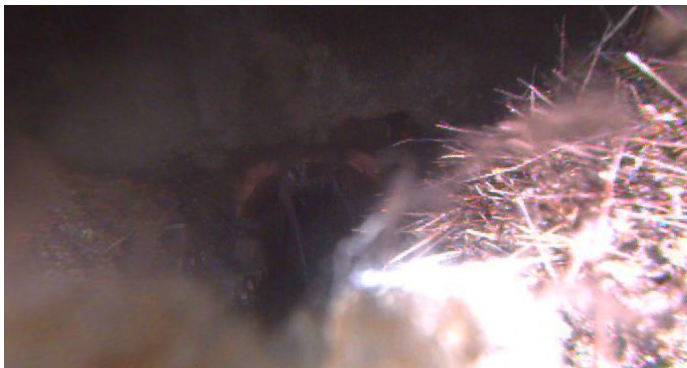
Code:	<b>AMH</b>
Description:	<b>Manhole</b>
Distance (ft):	<b>167.2</b>
Structural Grade:	<b>0</b>
O&M Grade:	<b>0</b>
Clock Start/From:	
Clock To:	
1st Value:	
2nd Value:	
Value Percent:	
Continuous Index:	
Within 8" of Joint:	<b>NO</b>
Remarks:	<b>M-805-020</b>
