## Profile/Photo Observation Report

Date:	<b>05/05/2018</b>	Weather:		Coding:	<b>PACP 6.0</b>
Pipe Length (ft):		Owner:	<b>City of Hobart</b>	Pre Clean:	<b>No Pre-Cleaning</b>
P.O.#:	<b>190</b>	Surveyor:	<b>M. Pielacha</b>	PSR:	<b>P-805-018-023</b>
Customer:	<b>City of Hobart</b>	Clean Date:		Shape:	<b>C</b>

Street:	<b>5th Street</b>	Flow Control:	<b>Not Controlled</b>
City:	<b>Hobart, IN</b>	Year Renewed:	
Location:	<b>Light Highway</b>	Tape/Media #:	<b>DEP 190</b>
Purpose:	<b>Routine Assessment</b>	Dia/Height:	<b>20"</b>
Use:	<b>Sanitary</b>	Material:	<b>VCP</b>
Drain Area:		Lining:	
Category:	<b>NA</b>		
Comment:	<b>5-21-2018</b>

Location Details:		Direction of Survey:	<b>Downstream</b>
US MH:	<b>M-805-018</b>	DS MH:	<b>M-805-023</b>
		Total Length Surveyed (ft):	<b>267.5</b>

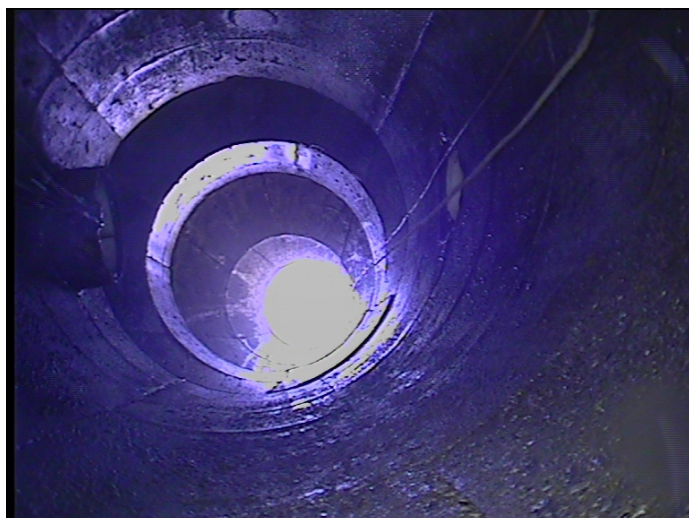
Code: **AMH**  
Description: **Manhole**

Distance (ft): **.0**  
Structural Grade: **0**  
O&M Grade: **0**  
Clock Start/From:  
Clock To:  
1st Value:  
2nd Value:  
Value Percent:  
Continuous Index:  
Within 8" of Joint: **NO**  
Remarks: **M-805-018**

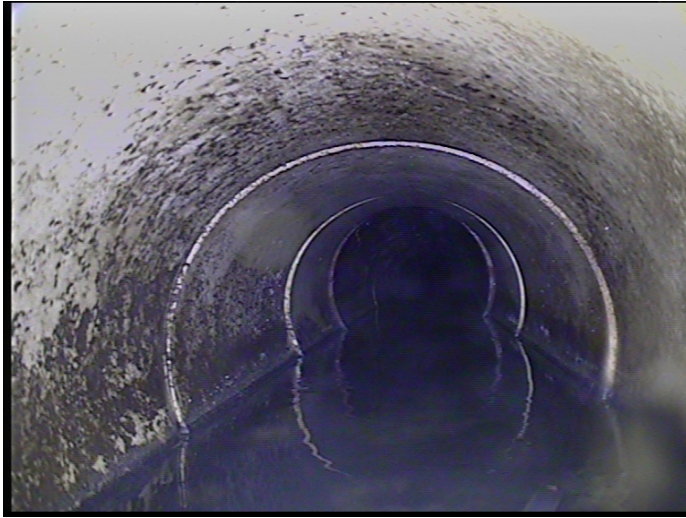
Code:	<b>MWL</b>
Description:	<b>Water Level</b>
Distance (ft):	<b>.0</b>
Structural Grade:	<b>0</b>
O&M Grade:	<b>0</b>
Clock Start/From:	
Clock To:	
1st Value:	
2nd Value:	
Value Percent:	<b>20.000</b>
Continuous Index:	
Within 8" of Joint:	<b>NO</b>
Remarks:

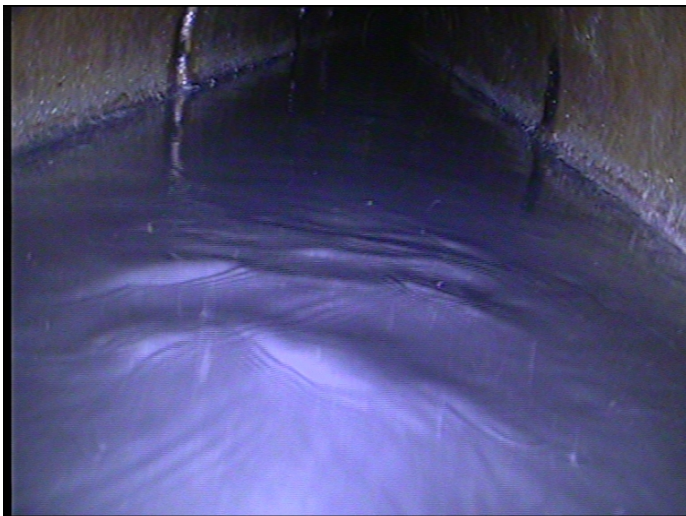
Code: **DSF**  
Description: **Deposits Settled Fine**

Distance (ft): **205.2**  
Structural Grade: **0**  
O&M Grade: **3**  
Clock Start/From: **4**  
Clock To: **8**  
1st Value:  
2nd Value:  
Value Percent: **20.000**  
Continuous Index: **S01**  
Within 8" of Joint: **YES**  
Remarks:

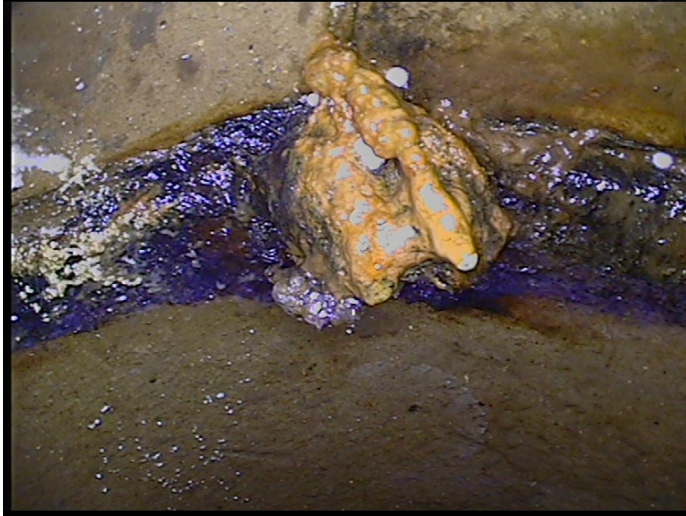
Code: ID  
Description: Infil Dripper

Distance (ft): 240.6  
Structural Grade: 0  
O&M Grade: 3  
Clock Start/From: 1  
Clock To:  
1st Value:  
2nd Value:  
Value Percent:  
Continuous Index:  
Within 8" of Joint: YES  
Remarks:

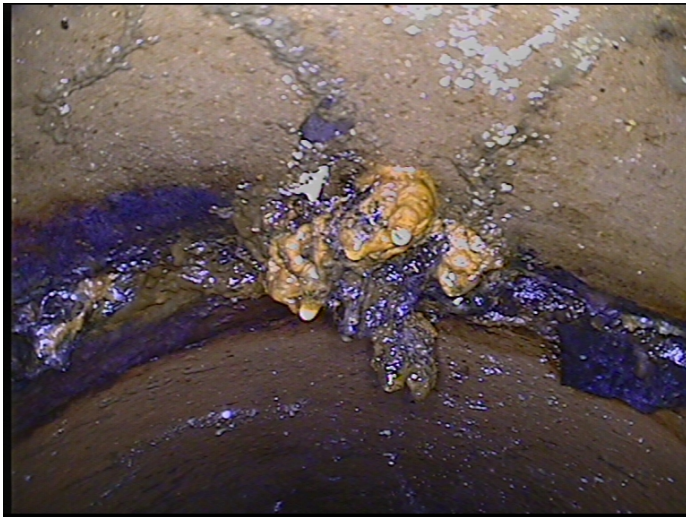
Code: ID  
Description: Infil Dripper

Distance (ft): 245.3  
Structural Grade: 0  
O&M Grade: 3  
Clock Start/From: 11  
Clock To:  
1st Value:  
2nd Value:  
Value Percent:  
Continuous Index:  
Within 8" of Joint: YES  
Remarks:

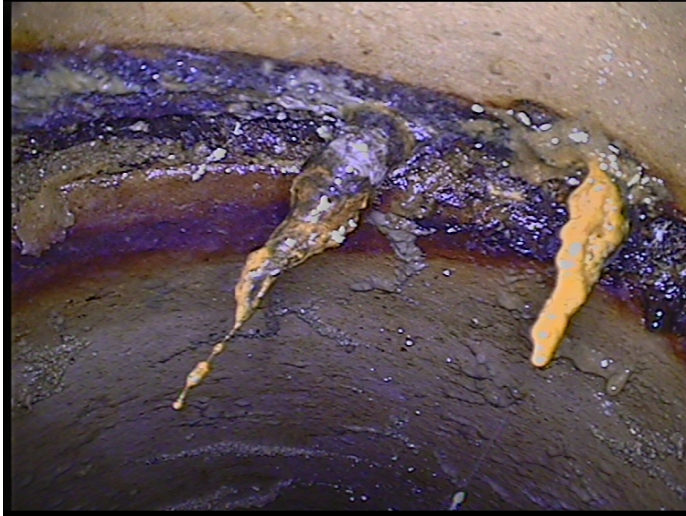
Code: **ID**  
Description: **Infil Dripper**

Distance (ft): **250.6**  
Structural Grade: **0**  
O&M Grade: **3**  
Clock Start/From: **11**  
Clock To:  
1st Value:  
2nd Value:  
Value Percent:  
Continuous Index:  
Within 8" of Joint: **YES**  
Remarks:

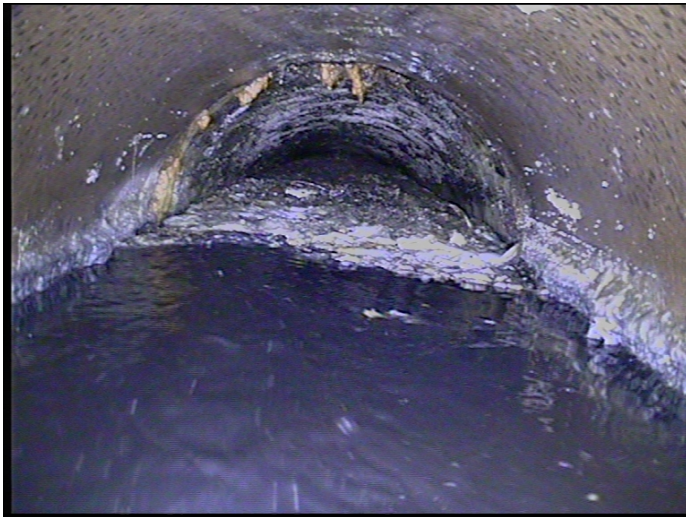
Code: **DSF**  
Description: **Deposits Settled Fine**

Distance (ft): **267.4**  
Structural Grade: **0**  
O&M Grade: **4**  
Clock Start/From: **4**  
Clock To: **8**  
1st Value:  
2nd Value:  
Value Percent: **25.000**  
Continuous Index: **F01**  
Within 8" of Joint: **NO**  
Remarks:

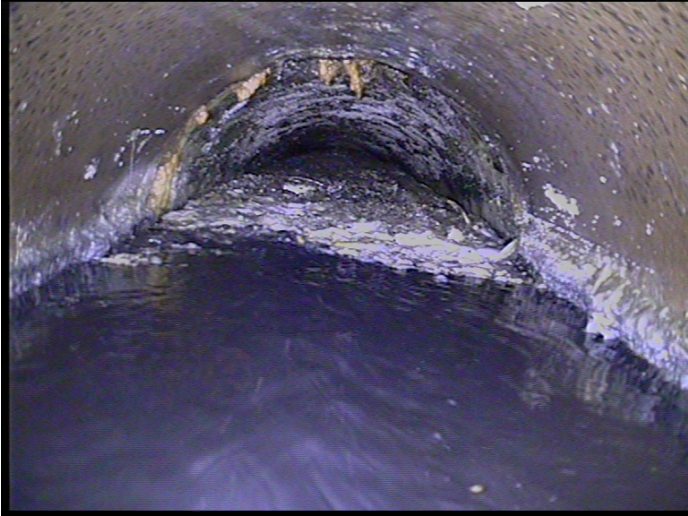
Code:	MSA
Description:	Abandoned Survey
Distance (ft):	267.5
Structural Grade:	0
O&M Grade:	0
Clock Start/From:	
Clock To:	
1st Value:	
2nd Value:	
Value Percent:	
Continuous Index:	
Within 8" of Joint:	NO
Remarks:	sediment and blockage
