Profile/Photo Observation Report

Date:	04/21/2018	Weather:		Coding:	PACP 6.0
Pipe Length (ft):	280.6	Owner:	NA	Pre Clean:	Not Known
P.O.#:		Surveyor:	Mark Ruby	PSR:	P-805-024-023
Customer:		Clean Date:	01/01/1900	Shape:	C

Street:	E 5TH ST	Flow Control:	Not Controlled
City:	Hobart, IN	Year Renewed:	
Location:	Alley	Tape/Media #:	
Purpose:	Maintenance Related	Dia/Height:	10"
Use:	Sanitary	Material:	PVC
Drain Area:	NA	Lining:	Cured in Place
Category:	NA		
Comment:	unknown near tap at 124'.		
Location Details:		Direction of Survey:	Upstream
US MH:	M-805-023	DS MH:	M-805-024
		Total Length Surveyed (ft):	125.3

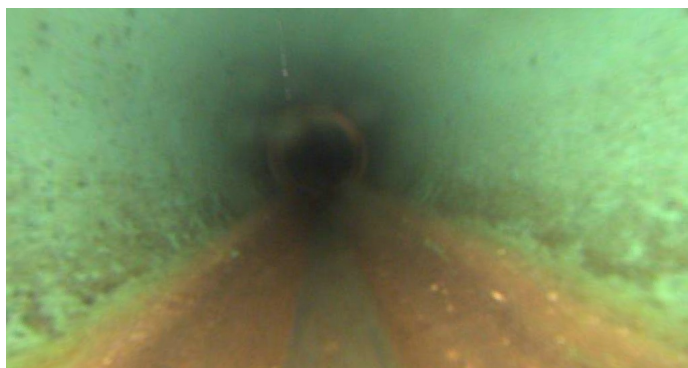
Code: **AMH**
Description: **Manhole**

Distance (ft): **.0**
Structural Grade: **0**
O&M Grade: **0**
Clock Start/From:
Clock To:
1st Value:
2nd Value:
Value Percent:
Continuous Index:
Within 8" of Joint: **NO**
Remarks: **M-805-024**

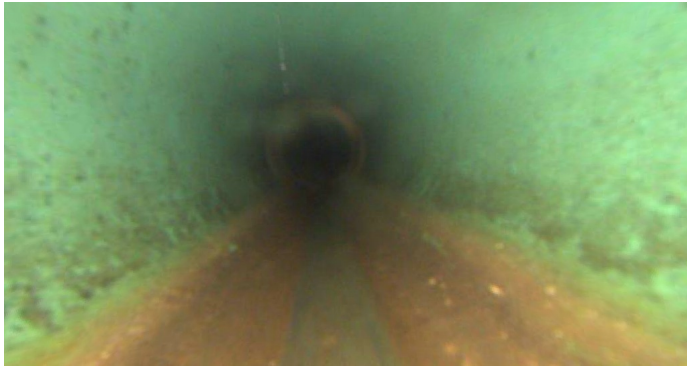
Code:	MWL
Description:	Water Level
Distance (ft):	.0
Structural Grade:	0
O&M Grade:	0
Clock Start/From:	
Clock To:	
1st Value:	
2nd Value:	
Value Percent:	10.000
Continuous Index:	
Within 8" of Joint:	NO
Remarks:

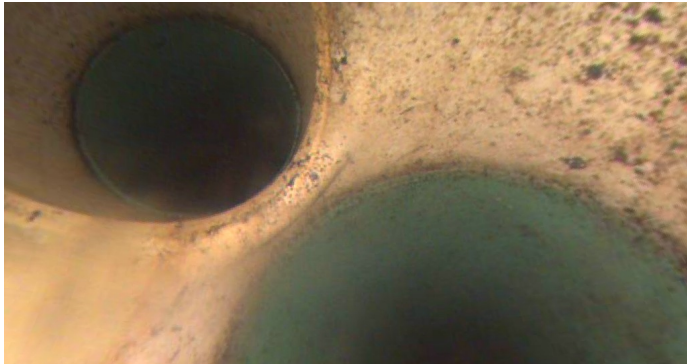
Code:	TF
Description:	Tap Factory
Distance (ft):	4.2
Structural Grade:	0
O&M Grade:	0
Clock Start/From:	2
Clock To:	
1st Value:	4.000
2nd Value:	
Value Percent:	
Continuous Index:	
Within 8" of Joint:	
Remarks:

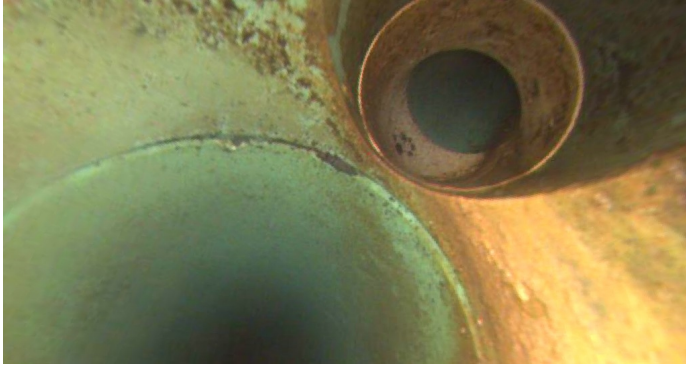
Code: **TF**
Description: **Tap Factory**

Distance (ft): **14.3**
Structural Grade: **0**
O&M Grade: **0**
Clock Start/From: **10**
Clock To:
1st Value: **4.000**
2nd Value:
Value Percent:
Continuous Index:
Within 8" of Joint:
Remarks:

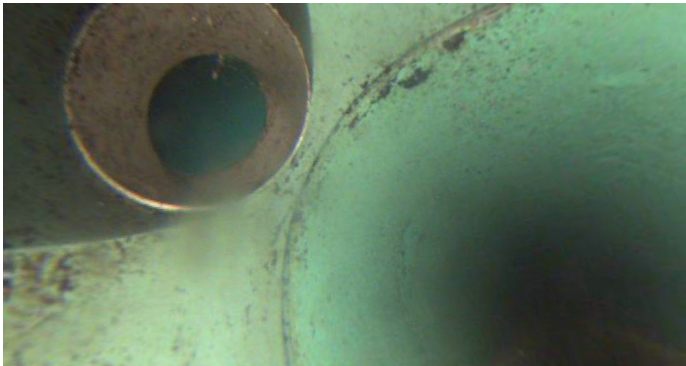
Code: **TF**
Description: **Tap Factory**

Distance (ft): **44.4**
Structural Grade: **0**
O&M Grade: **0**
Clock Start/From: **2**
Clock To:
1st Value: **4.000**
2nd Value:
Value Percent:
Continuous Index:
Within 8" of Joint:
Remarks:

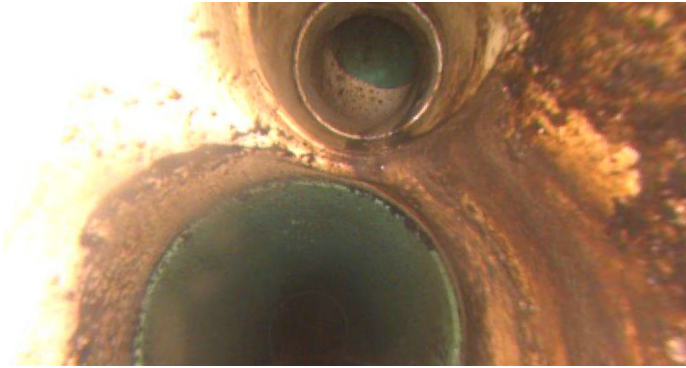
Code: **TF**
Description: **Tap Factory**

Distance (ft): **57.2**
Structural Grade: **0**
O&M Grade: **0**
Clock Start/From: **11**
Clock To:
1st Value: **4.000**
2nd Value:
Value Percent:
Continuous Index:
Within 8" of Joint:
Remarks:

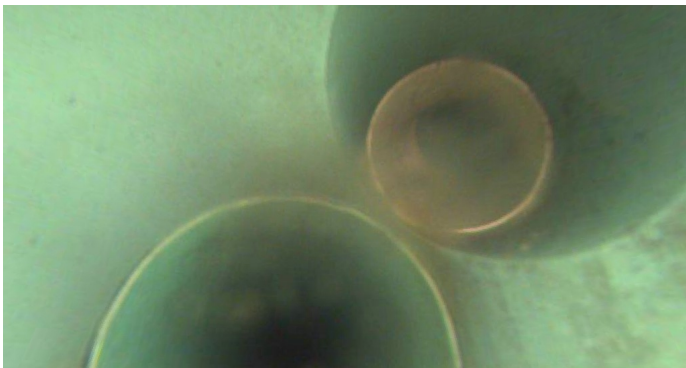
Code: **TF**
Description: **Tap Factory**

Distance (ft): **122.6**
Structural Grade: **0**
O&M Grade: **0**
Clock Start/From: **2**
Clock To:
1st Value: **4.000**
2nd Value:
Value Percent:
Continuous Index:
Within 8" of Joint:
Remarks:

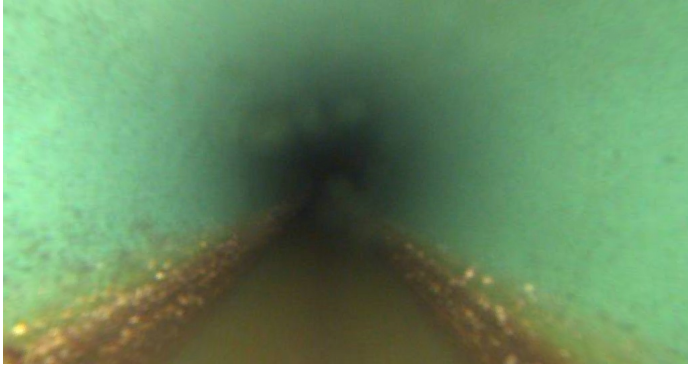
Code:	MSA
Description:	Abandoned Survey
Distance (ft):	125.3
Structural Grade:	0
O&M Grade:	0
Clock Start/From:	
Clock To:	
1st Value:	
2nd Value:	
Value Percent:	
Continuous Index:	
Within 8" of Joint:	NO
Remarks:	No blockage
