Profile/Photo Observation Report

Date:	09/13/2022	Weather:		Coding:	PACP 7.0
Pipe Length (ft):	281.0	Owner:	City of Hobart	Pre Clean:	Heavy Cleaning
P.O.#:	YES502259	Surveyor:	S. Bucklin	PSR:	P-805-024-023
Customer:	City of Hobart	Clean Date:	08/28/2022	Shape:	C

Location Details:		Direction of Survey:	Downstream
US MH:	M-805-023	DS MH:	M-805-024
		Total Length Surveyed (ft):	275.2

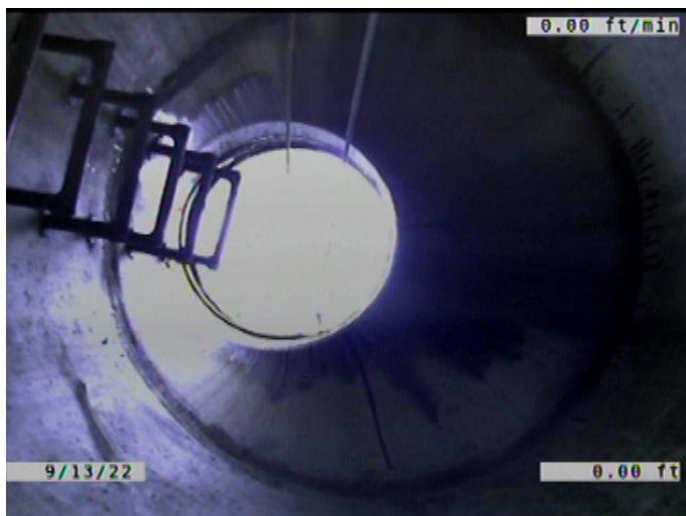
Code: **AMH**
 Description: **Manhole**

Distance (ft): **.0**
 Structural Grade: **0**
 O&M Grade: **0**
 Clock Start/From:
 Clock To:
 1st Value:
 2nd Value:
 Value Percent:
 Continuous Index:
 Within 8" of Joint: **NO**
 Remarks: **M-805-023**

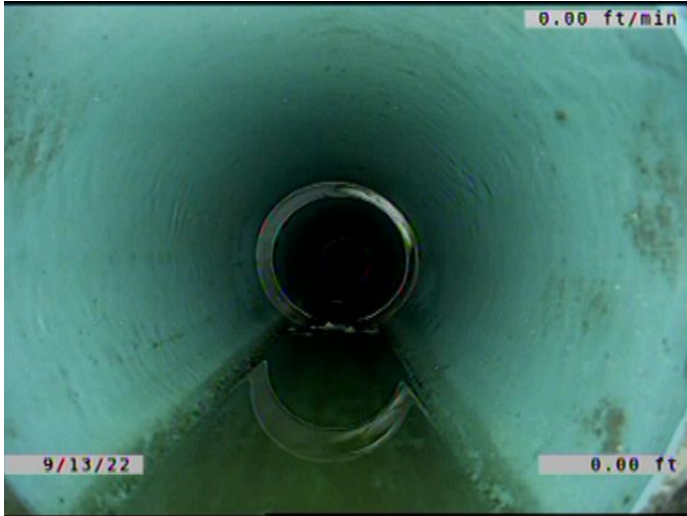
Code: **MWL**
Description: **Miscellaneous Water Level**

Distance (ft): **.0**
Structural Grade: **0**
O&M Grade: **0**
Clock Start/From:
Clock To:
1st Value:
2nd Value:
Value Percent: **5.000**
Continuous Index:
Within 8" of Joint: **NO**
Remarks:

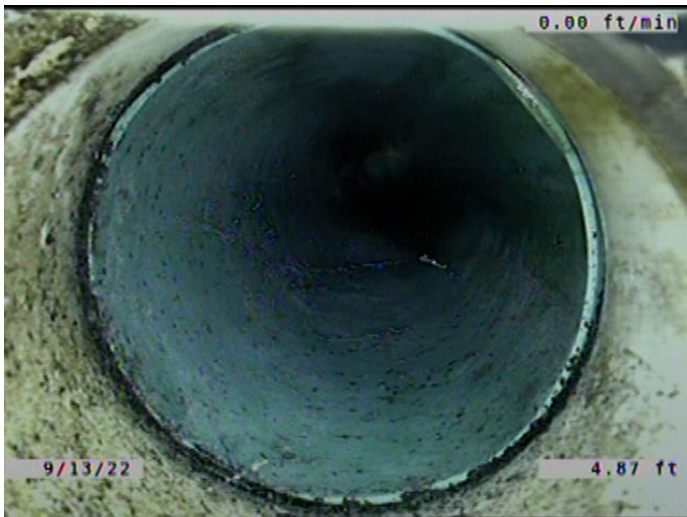
Code: **TF**
Description: **Tap Factory**

Distance (ft): **4.9**
Structural Grade: **0**
O&M Grade: **0**
Clock Start/From: **1**
Clock To:
1st Value: **6.000**
2nd Value:
Value Percent:
Continuous Index:
Within 8" of Joint: **YES**
Remarks:

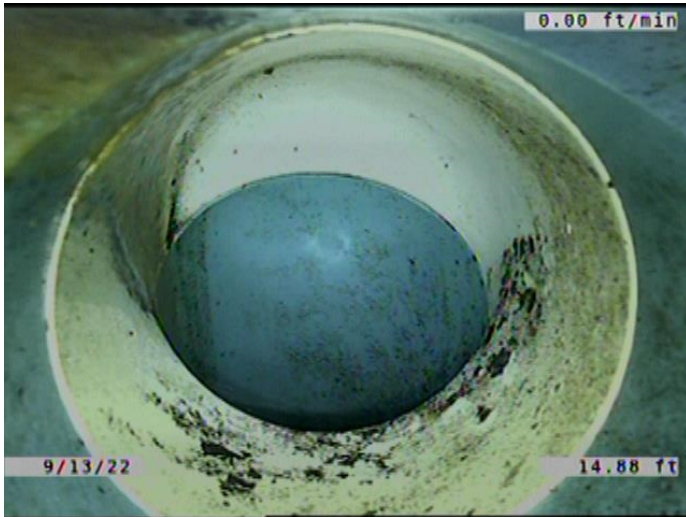
Code: **TF**
Description: **Tap Factory**

Distance (ft): **14.9**
Structural Grade: **0**
O&M Grade: **0**
Clock Start/From: **11**
Clock To:
1st Value: **6.000**
2nd Value:
Value Percent:
Continuous Index:
Within 8" of Joint: **YES**
Remarks: **CONSTANTLY RUNNING WATER.**

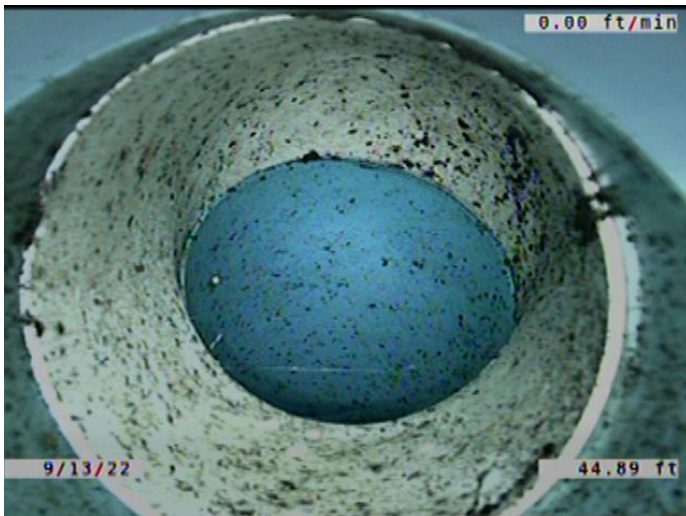
Code: **TF**
Description: **Tap Factory**

Distance (ft): **44.9**
Structural Grade: **0**
O&M Grade: **0**
Clock Start/From: **1**
Clock To:
1st Value: **6.000**
2nd Value:
Value Percent:
Continuous Index:
Within 8" of Joint: **YES**
Remarks:

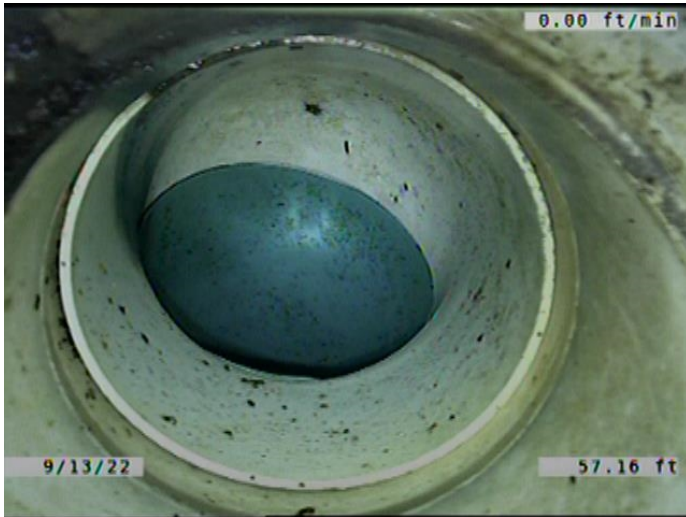
Code: **TF**
Description: **Tap Factory**

Distance (ft): **57.2**
Structural Grade: **0**
O&M Grade: **0**
Clock Start/From: **11**
Clock To:
1st Value: **6.000**
2nd Value:
Value Percent:
Continuous Index:
Within 8" of Joint: **YES**
Remarks:

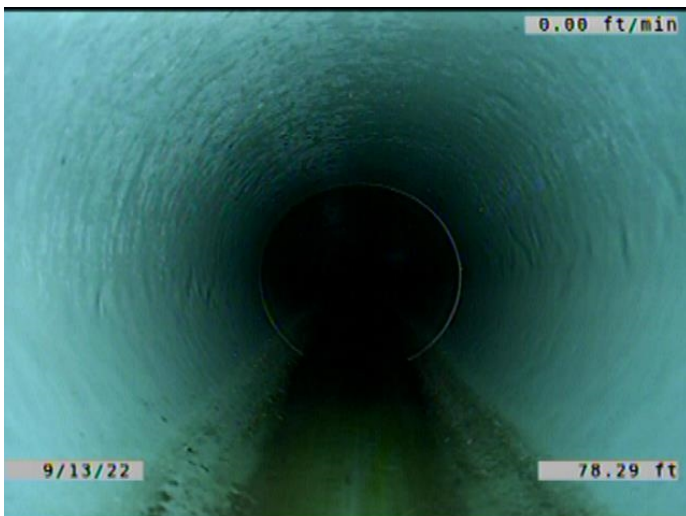
Code: **MWLS**
Description: **Miscellaneous Water Level Sag**

Distance (ft): **78.3**
Structural Grade: **2**
O&M Grade: **0**
Clock Start/From:
Clock To:
1st Value:
2nd Value:
Value Percent: **5.000**
Continuous Index: **S01**
Within 8" of Joint: **NO**
Remarks:

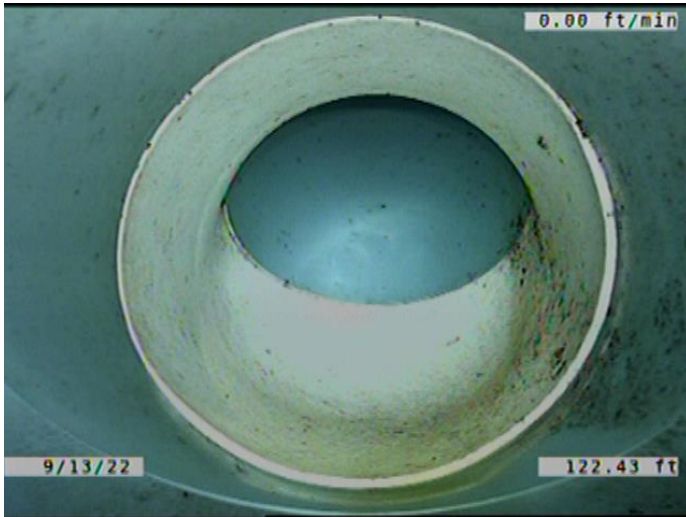
Code: **TF**
 Description: **Tap Factory**

Distance (ft): **122.4**
 Structural Grade: **0**
 O&M Grade: **0**
 Clock Start/From: **1**
 Clock To:
 1st Value: **6.000**
 2nd Value:
 Value Percent:
 Continuous Index:
 Within 8" of Joint: **YES**
 Remarks:

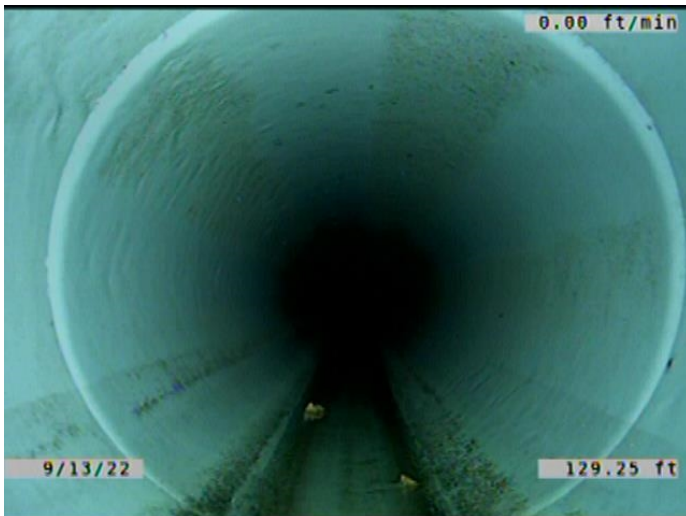
Code: **MWLS**
 Description: **Miscellaneous Water Level Sag**

Distance (ft): **129.2**
 Structural Grade: **2**
 O&M Grade: **0**
 Clock Start/From:
 Clock To:
 1st Value:
 2nd Value:
 Value Percent: **5.000**
 Continuous Index: **F01**
 Within 8" of Joint: **NO**
 Remarks:

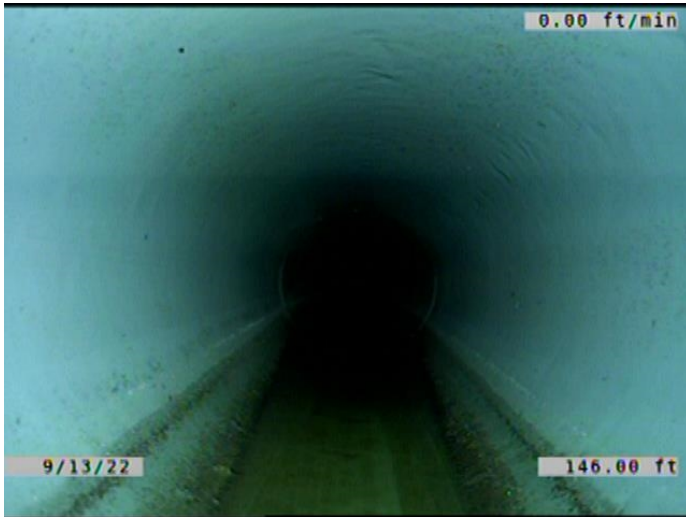
Code: **MWLS**
Description: **Miscellaneous Water Level Sag**

Distance (ft): **146.0**
Structural Grade: **2**
O&M Grade: **0**
Clock Start/From:
Clock To:
1st Value:
2nd Value:
Value Percent: **10.000**
Continuous Index: **S02**
Within 8" of Joint: **NO**
Remarks:

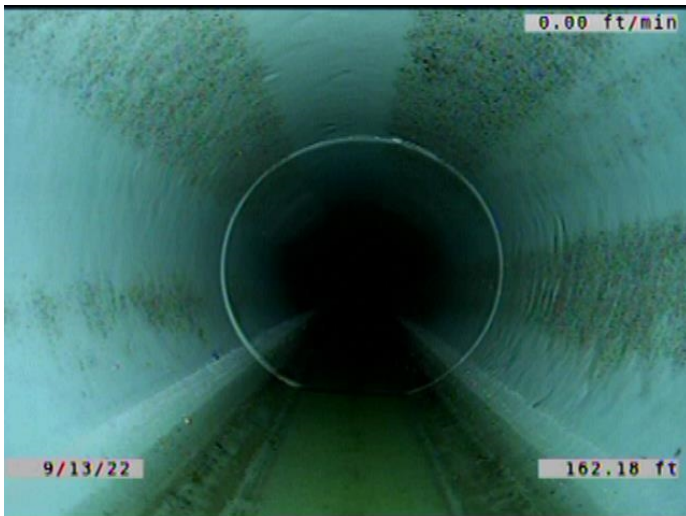
Code: **MWLS**
Description: **Miscellaneous Water Level Sag**

Distance (ft): **162.2**
Structural Grade: **2**
O&M Grade: **0**
Clock Start/From:
Clock To:
1st Value:
2nd Value:
Value Percent: **10.000**
Continuous Index: **F02**
Within 8" of Joint: **NO**
Remarks:

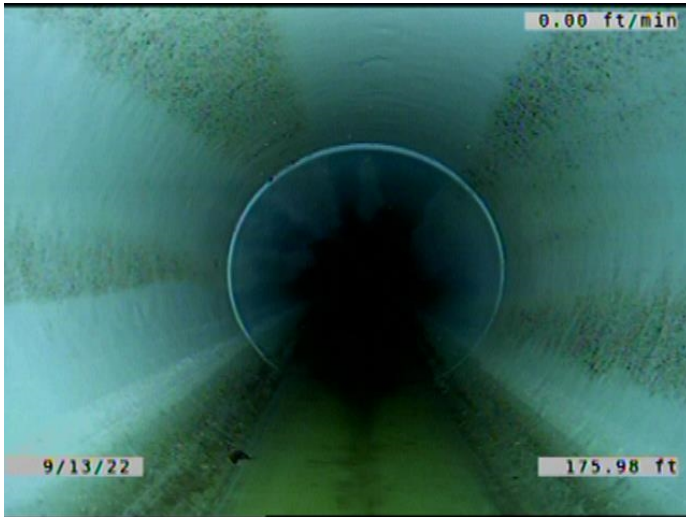
Code: **MWLS**
Description: **Miscellaneous Water Level Sag**

Distance (ft): **176.0**
Structural Grade: **2**
O&M Grade: **0**
Clock Start/From:
Clock To:
1st Value:
2nd Value:
Value Percent: **10.000**
Continuous Index: **S03**
Within 8" of Joint: **NO**
Remarks:

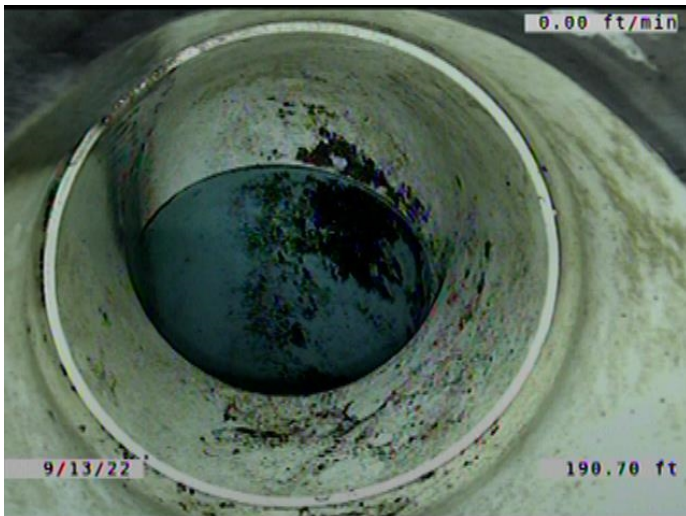
Code: **TF**
Description: **Tap Factory**

Distance (ft): **190.7**
Structural Grade: **0**
O&M Grade: **0**
Clock Start/From: **11**
Clock To:
1st Value: **6.000**
2nd Value:
Value Percent:
Continuous Index:
Within 8" of Joint: **YES**
Remarks:

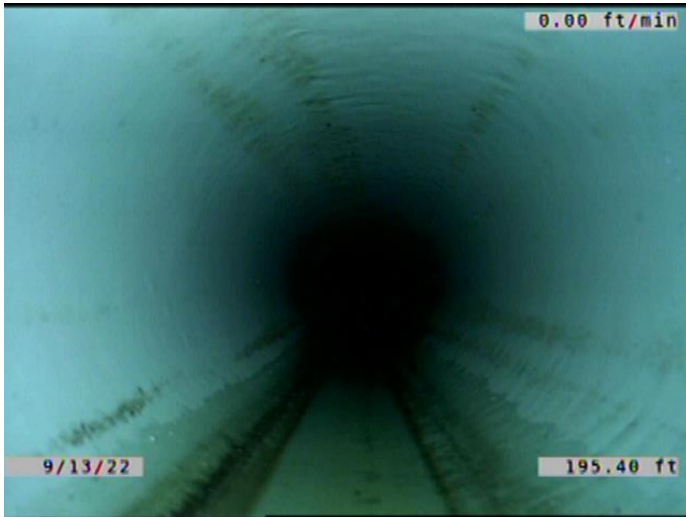
Code: **MWLS**
Description: **Miscellaneous Water Level Sag**

Distance (ft): **195.4**
Structural Grade: **2**
O&M Grade: **0**
Clock Start/From:
Clock To:
1st Value:
2nd Value:
Value Percent: **10.000**
Continuous Index: **F03**
Within 8" of Joint: **NO**
Remarks:

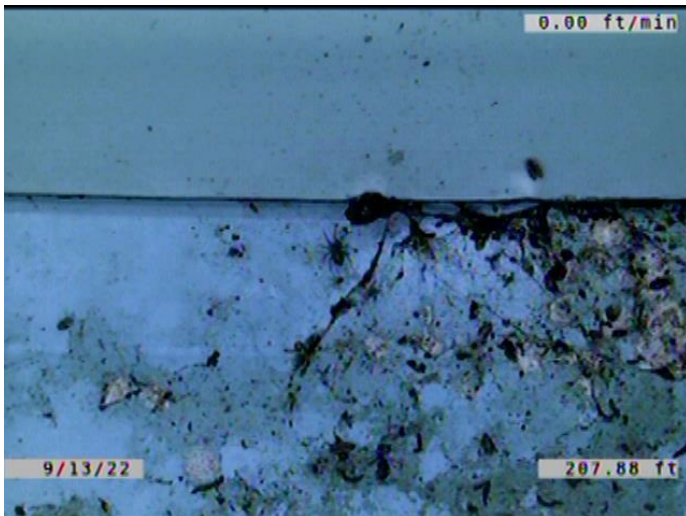
Code: **MGO**
Description: **Miscellaneous General Observation**

Distance (ft): **207.9**
Structural Grade: **0**
O&M Grade: **0**
Clock Start/From:
Clock To:
1st Value:
2nd Value:
Value Percent:
Continuous Index:
Within 8" of Joint: **NO**
Remarks: **JOINT/ PIPES NOT PUSHED ALL THE WAY TOGETHER WHEN INSTALLED**

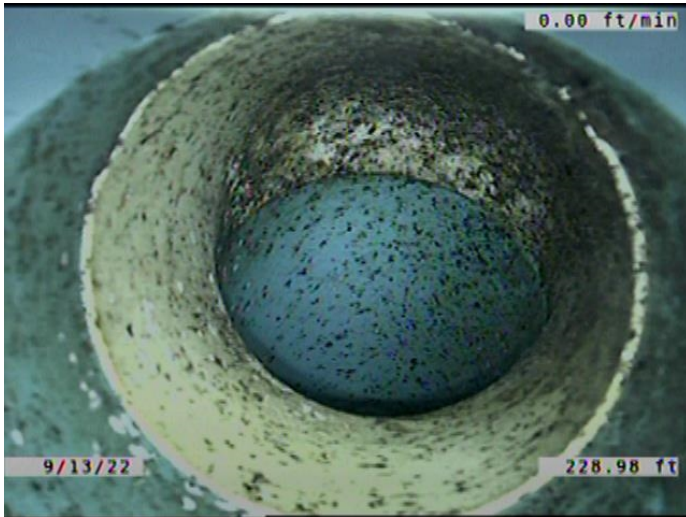
Code: **TF**
Description: **Tap Factory**

Distance (ft): **229.0**
Structural Grade: **0**
O&M Grade: **0**
Clock Start/From: **1**
Clock To:
1st Value: **6.000**
2nd Value:
Value Percent:
Continuous Index:
Within 8" of Joint: **YES**
Remarks:

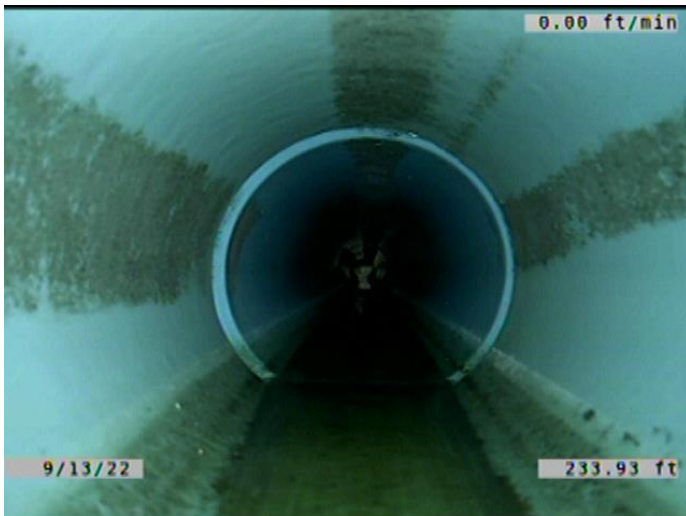
Code: **MWLS**
Description: **Miscellaneous Water Level Sag**

Distance (ft): **233.9**
Structural Grade: **2**
O&M Grade: **0**
Clock Start/From:
Clock To:
1st Value:
2nd Value:
Value Percent: **5.000**
Continuous Index:
Within 8" of Joint: **NO**
Remarks:

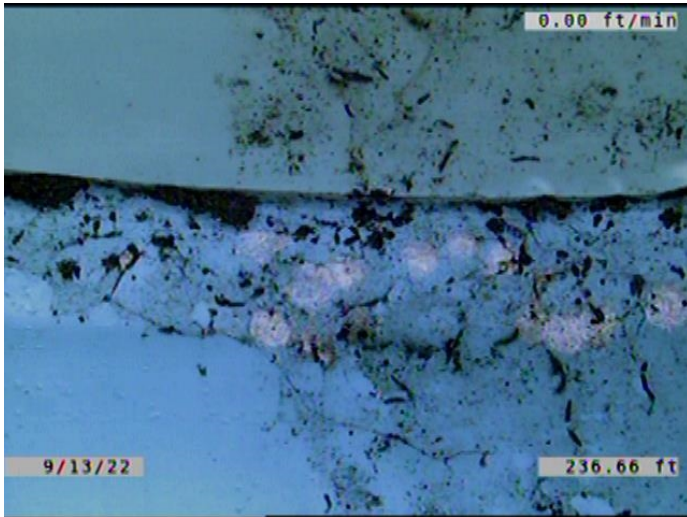
Code: **MGO**
 Description: **Miscellaneous General Observation**

Distance (ft): **236.7**
 Structural Grade: **0**
 O&M Grade: **0**
 Clock Start/From:
 Clock To:
 1st Value:
 2nd Value:
 Value Percent:
 Continuous Index:
 Within 8" of Joint: **NO**
 Remarks: **JOINT/ PIPES NOT PUSHED ALL THE WAY TOGETHER WHEN INSTALLED**

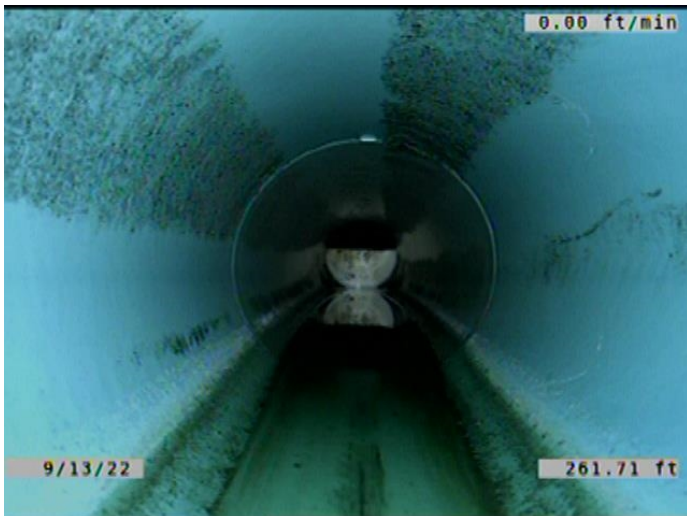
Code: **MWLS**
 Description: **Miscellaneous Water Level Sag**

Distance (ft): **261.1**
 Structural Grade: **2**
 O&M Grade: **0**
 Clock Start/From:
 Clock To:
 1st Value:
 2nd Value:
 Value Percent: **10.000**
 Continuous Index: **S04**
 Within 8" of Joint: **NO**
 Remarks:

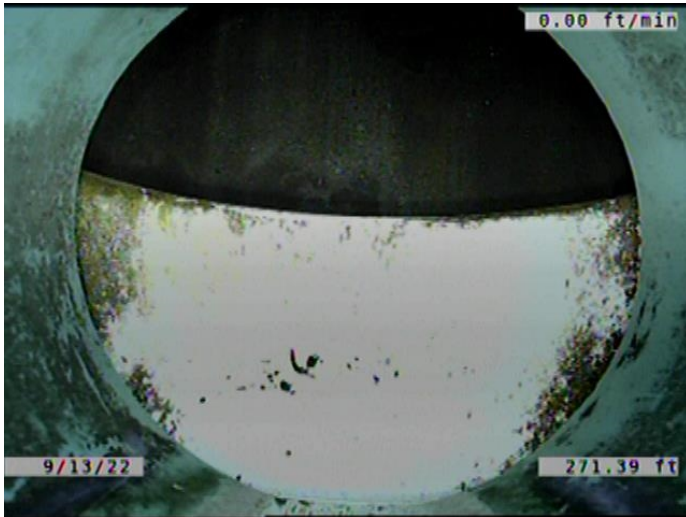
Code: **MWLS**
 Description: **Miscellaneous Water Level Sag**

Distance (ft): **271.4**
 Structural Grade: **2**
 O&M Grade: **0**
 Clock Start/From:
 Clock To:
 1st Value:
 2nd Value:
 Value Percent: **10.000**
 Continuous Index: **F04**
 Within 8" of Joint: **NO**
 Remarks:

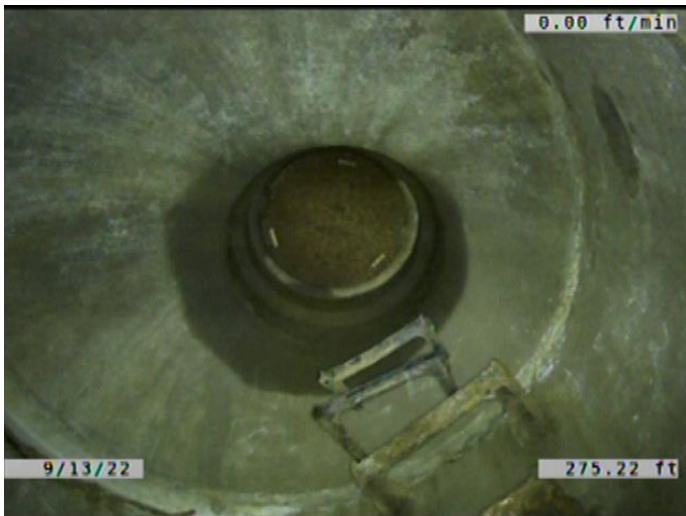
Code: **AMH**
 Description: **Manhole**

Distance (ft): **275.2**
 Structural Grade: **0**
 O&M Grade: **0**
 Clock Start/From:
 Clock To:
 1st Value:
 2nd Value:
 Value Percent:
 Continuous Index:
 Within 8" of Joint: **NO**
 Remarks: **M-805-024**
