Profile/Photo Observation Report

Street:	OFF S JOLIET ST	Flow Control:	Not Controlled
City:	Hobart, IN	Year Renewed:	
Location:	Alley	Tape/Media #:	
Purpose:	Maintenance Related	Dia/Height:	10"
Use:	Sanitary	Material:	PVC
Drain Area:	NA	Lining:	Cured in Place
Category:	NA		
Comment:

Location Details:		Direction of Survey:	Downstream
US MH:	M-805-024	DS MH:	M-805-025
		Total Length Surveyed (ft):	274.2

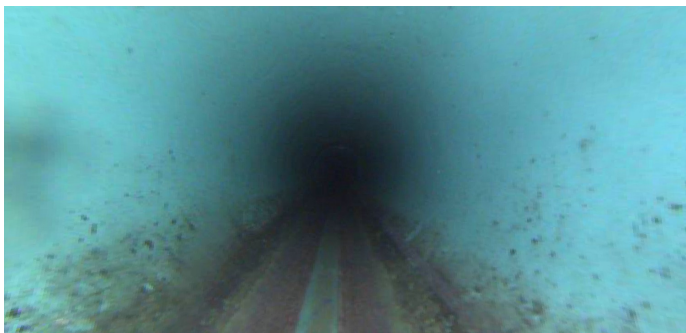
Code: **AMH**
Description: **Manhole**

Distance (ft): **.0**
Structural Grade: **0**
O&M Grade: **0**
Clock Start/From:
Clock To:
1st Value:
2nd Value:
Value Percent:
Continuous Index:
Within 8" of Joint: **NO**
Remarks: **M-805-024**

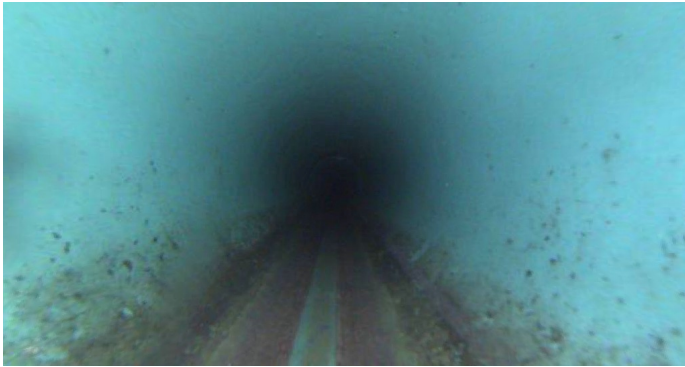
Code:	MWL
Description:	Water Level

Distance (ft):	.0
Structural Grade:	0
O&M Grade:	0
Clock Start/From:	
Clock To:	
1st Value:	
2nd Value:	
Value Percent:	10.000
Continuous Index:	
Within 8" of Joint:	NO
Remarks:

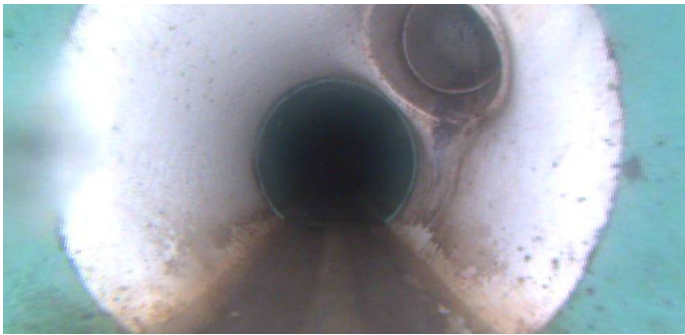
Code:	TF
Description:	Tap Factory

Distance (ft):	52.1
Structural Grade:	0
O&M Grade:	0
Clock Start/From:	2
Clock To:	
1st Value:	4.000
2nd Value:	
Value Percent:	
Continuous Index:	
Within 8" of Joint:	YES
Remarks:

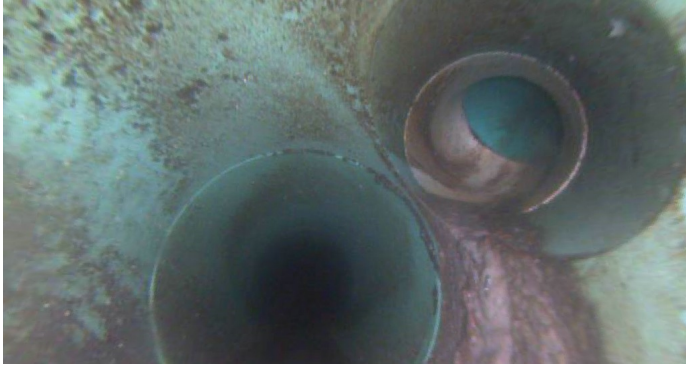
Code: **TF**
Description: **Tap Factory**

Distance (ft): **60.7**
Structural Grade: **0**
O&M Grade: **0**
Clock Start/From: **2**
Clock To:
1st Value: **4.000**
2nd Value:
Value Percent:
Continuous Index:
Within 8" of Joint:
Remarks:

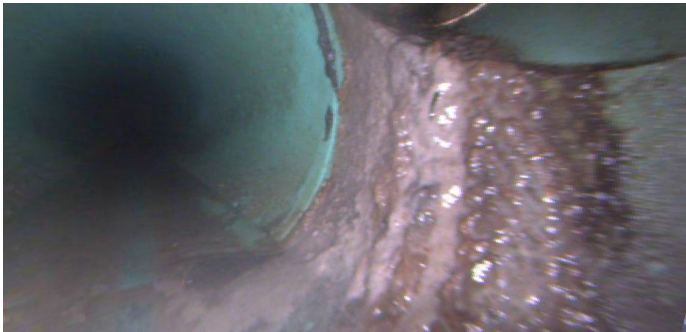
Code: **DAGS**
Description: **Deposits Attached Grease**

Distance (ft): **61.1**
Structural Grade: **0**
O&M Grade: **2**
Clock Start/From: **3**
Clock To: **5**
1st Value:
2nd Value:
Value Percent: **5.000**
Continuous Index:
Within 8" of Joint: **NO**
Remarks:

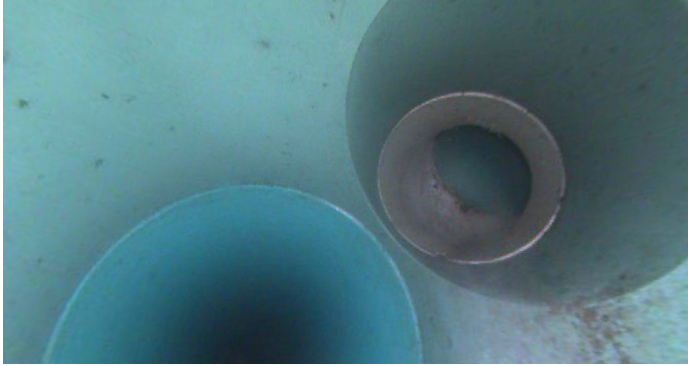
Code: **TF**
Description: **Tap Factory**

Distance (ft): **127.6**
Structural Grade: **0**
O&M Grade: **0**
Clock Start/From: **2**
Clock To:
1st Value: **4.000**
2nd Value:
Value Percent:
Continuous Index:
Within 8" of Joint:
Remarks:

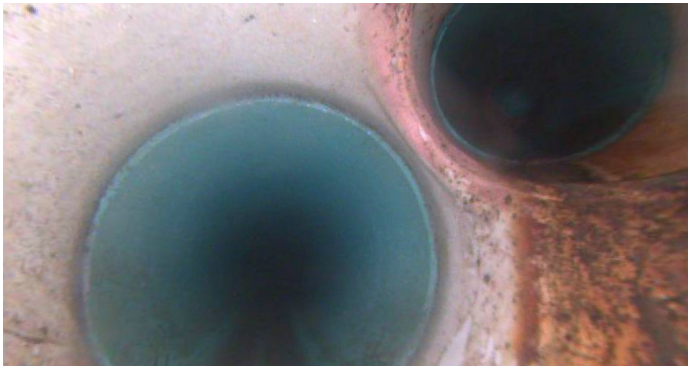
Code: **TF**
Description: **Tap Factory**

Distance (ft): **156.7**
Structural Grade: **0**
O&M Grade: **0**
Clock Start/From: **2**
Clock To:
1st Value: **4.000**
2nd Value:
Value Percent:
Continuous Index:
Within 8" of Joint:
Remarks:

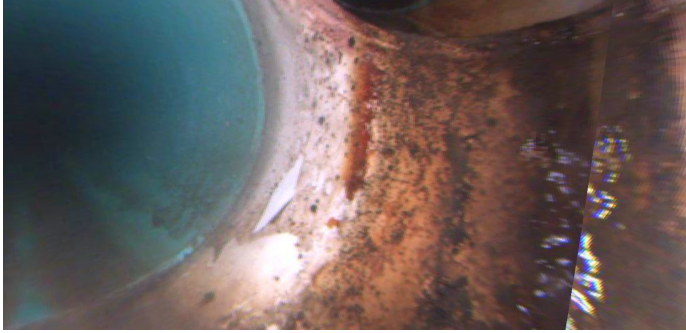
Code: **IS**
Description: **Infil Stain**

Distance (ft): **156.9**
Structural Grade: **0**
O&M Grade: **0**
Clock Start/From: **3**
Clock To: **5**
1st Value:
2nd Value:
Value Percent:
Continuous Index:
Within 8" of Joint:
Remarks:

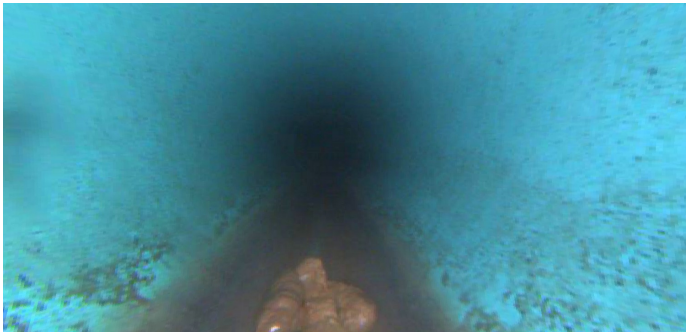
Code: **DSZ**
Description: **Deposits Settled Other**

Distance (ft): **181.2**
Structural Grade: **0**
O&M Grade: **2**
Clock Start/From: **6**
Clock To:
1st Value:
2nd Value:
Value Percent: **5.000**
Continuous Index:
Within 8" of Joint: **NO**
Remarks: **debris**

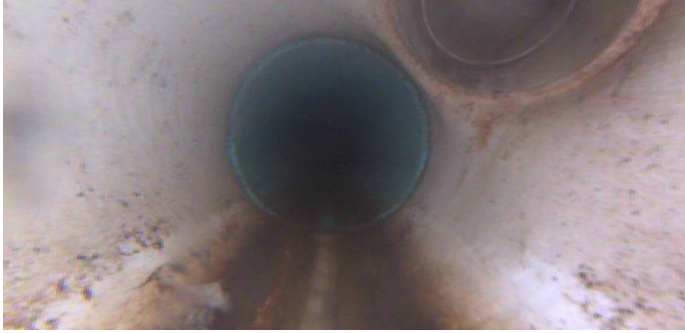
Code: **TF**
Description: **Tap Factory**

Distance (ft): **220.0**
Structural Grade: **0**
O&M Grade: **0**
Clock Start/From: **1**
Clock To:
1st Value: **4.000**
2nd Value:
Value Percent:
Continuous Index:
Within 8" of Joint: **YES**
Remarks:

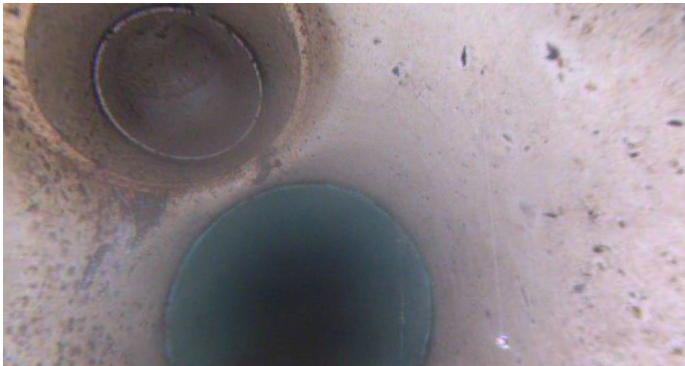
Code: **TF**
Description: **Tap Factory**

Distance (ft): **255.3**
Structural Grade: **0**
O&M Grade: **0**
Clock Start/From: **10**
Clock To:
1st Value: **4.000**
2nd Value:
Value Percent:
Continuous Index:
Within 8" of Joint:
Remarks:

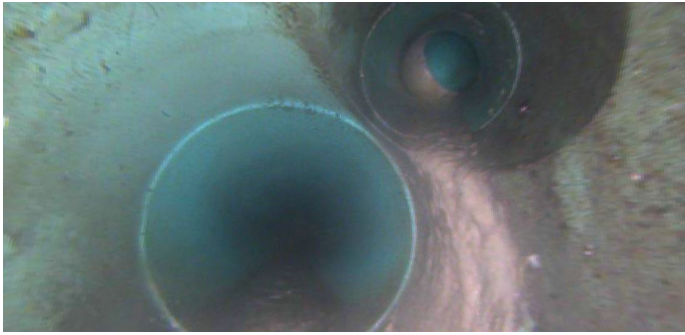
Code: **TF**
Description: **Tap Factory**

Distance (ft): **265.2**
Structural Grade: **0**
O&M Grade: **0**
Clock Start/From: **1**
Clock To:
1st Value: **4.000**
2nd Value:
Value Percent:
Continuous Index:
Within 8" of Joint: **YES**
Remarks:

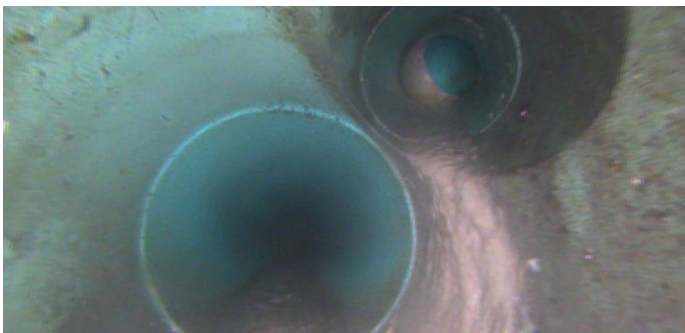
Code: **DAGS**
Description: **Deposits Attached Grease**

Distance (ft): **265.2**
Structural Grade: **0**
O&M Grade: **2**
Clock Start/From: **2**
Clock To: **5**
1st Value:
2nd Value:
Value Percent: **5.000**
Continuous Index:
Within 8" of Joint: **NO**
Remarks:

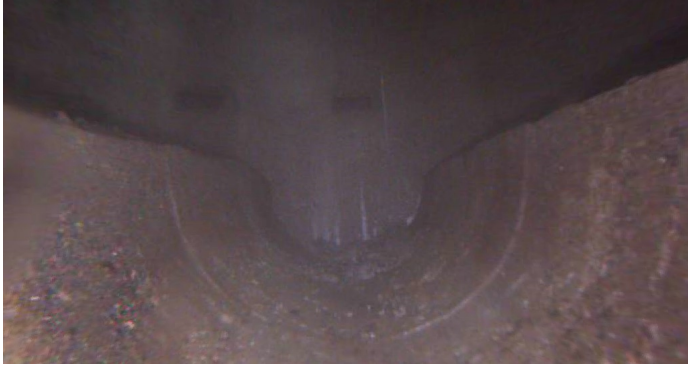
Code:	AMH
Description:	Manhole
Distance (ft):	274.2
Structural Grade:	0
O&M Grade:	0
Clock Start/From:	
Clock To:	
1st Value:	
2nd Value:	
Value Percent:	
Continuous Index:	
Within 8" of Joint:	NO
Remarks:	M-805-025
