Profile/Photo Observation Report

Date:	04/21/2018	Weather:		Coding:	PACP 6.0
Pipe Length (ft):	272.9	Owner:	NA	Pre Clean:	Not Known
P.O.#:		Surveyor:	Mark Ruby	PSR:	P-805-025-024
Customer:		Clean Date:	01/01/1900	Shape:	C

Street:	Capitol	Flow Control:	Not Controlled
City:	Hobart, IN	Year Renewed:	
Location:	Alley	Tape/Media #:	
Purpose:	Maintenance Related	Dia/Height:	10"
Use:	Sanitary	Material:	PVC
Drain Area:	NA	Lining:	Cured in Place
Category:	NA		
Comment:

Location Details:		Direction of Survey:	Downstream
US MH:	M-805-024	DS MH:	M-805-025
		Total Length Surveyed (ft):	274.2

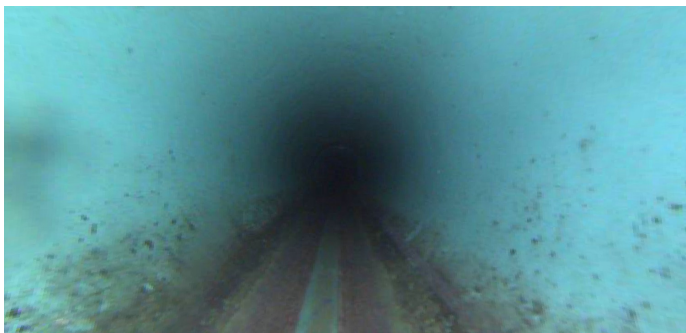
Code: **AMH**
Description: **Manhole**

Distance (ft): **.0**
Structural Grade: **0**
O&M Grade: **0**
Clock Start/From:
Clock To:
1st Value:
2nd Value:
Value Percent:
Continuous Index:
Within 8" of Joint: **NO**
Remarks: **M-805-024**

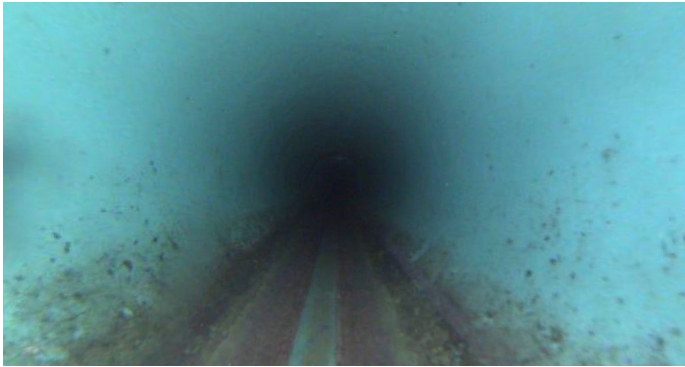
Code: **MWL**
Description: **Water Level**

Distance (ft): **.0**
Structural Grade: **0**
O&M Grade: **0**
Clock Start/From:
Clock To:
1st Value:
2nd Value:
Value Percent: **10.000**
Continuous Index:
Within 8" of Joint: **NO**
Remarks:

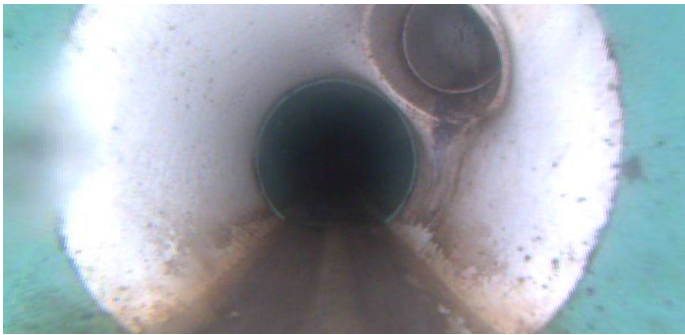
Code: **TF**
Description: **Tap Factory**

Distance (ft): **52.1**
Structural Grade: **0**
O&M Grade: **0**
Clock Start/From: **2**
Clock To:
1st Value: **4.000**
2nd Value:
Value Percent:
Continuous Index:
Within 8" of Joint: **YES**
Remarks:

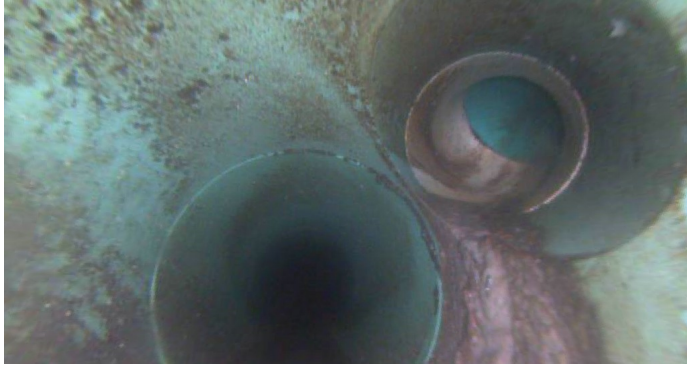
Code: **TF**
Description: **Tap Factory**

Distance (ft): **60.7**
Structural Grade: **0**
O&M Grade: **0**
Clock Start/From: **2**
Clock To:
1st Value: **4.000**
2nd Value:
Value Percent:
Continuous Index:
Within 8" of Joint:
Remarks:

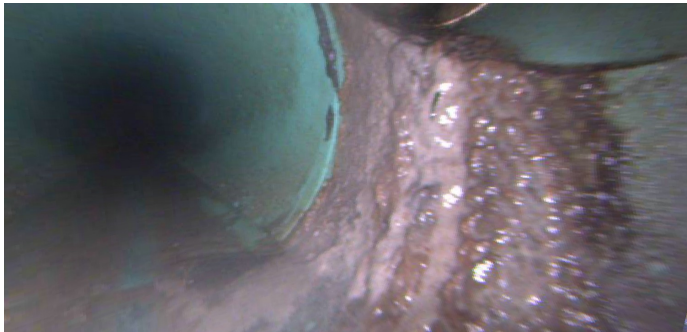
Code: **DAGS**
Description: **Deposits Attached Grease**

Distance (ft): **61.1**
Structural Grade: **0**
O&M Grade: **2**
Clock Start/From: **3**
Clock To: **5**
1st Value:
2nd Value:
Value Percent: **5.000**
Continuous Index:
Within 8" of Joint: **NO**
Remarks:

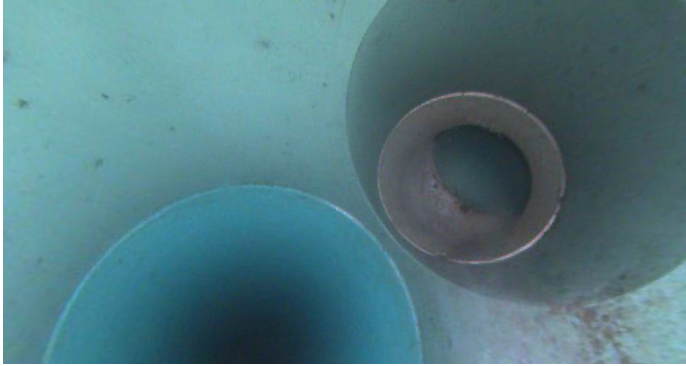
Code: **TF**
Description: **Tap Factory**

Distance (ft): **127.6**
Structural Grade: **0**
O&M Grade: **0**
Clock Start/From: **2**
Clock To:
1st Value: **4.000**
2nd Value:
Value Percent:
Continuous Index:
Within 8" of Joint:
Remarks:

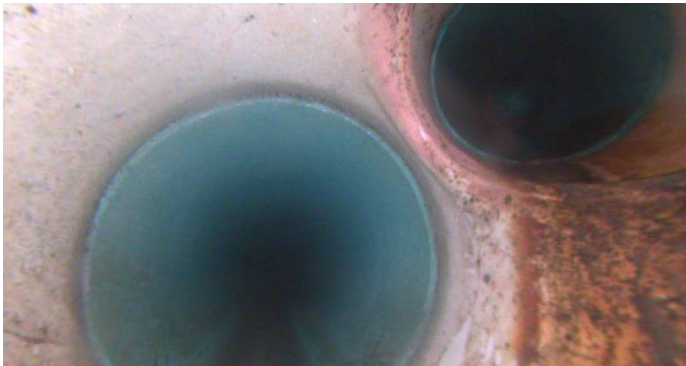
Code: **TF**
Description: **Tap Factory**

Distance (ft): **156.7**
Structural Grade: **0**
O&M Grade: **0**
Clock Start/From: **2**
Clock To:
1st Value: **4.000**
2nd Value:
Value Percent:
Continuous Index:
Within 8" of Joint:
Remarks:

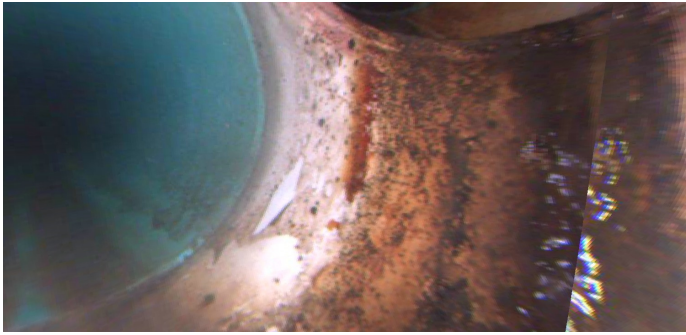
Code: **IS**
Description: **Infil Stain**

Distance (ft): **156.9**
Structural Grade: **0**
O&M Grade: **0**
Clock Start/From: **3**
Clock To: **5**
1st Value:
2nd Value:
Value Percent:
Continuous Index:
Within 8" of Joint:
Remarks:

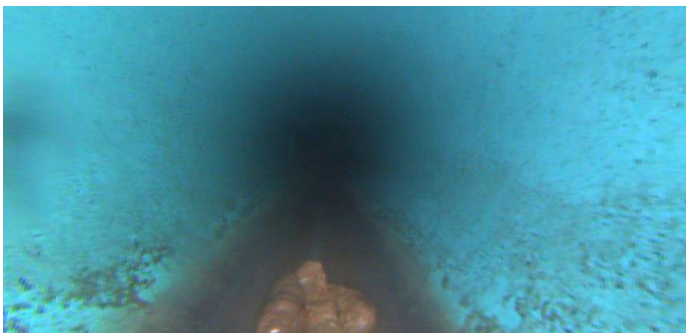
Code: **DSZ**
Description: **Deposits Settled Other**

Distance (ft): **181.2**
Structural Grade: **0**
O&M Grade: **2**
Clock Start/From: **6**
Clock To:
1st Value:
2nd Value:
Value Percent: **5.000**
Continuous Index:
Within 8" of Joint: **NO**
Remarks: **debris**

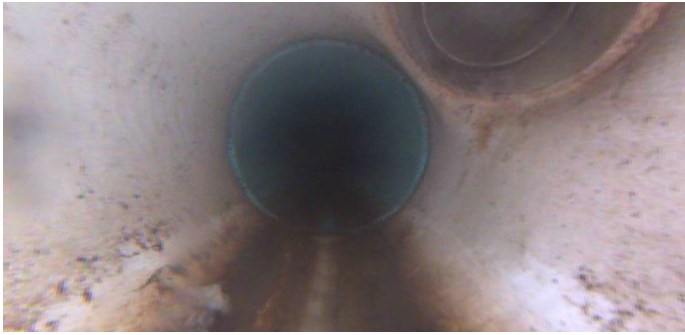
Code: **TF**
Description: **Tap Factory**

Distance (ft): **220.0**
Structural Grade: **0**
O&M Grade: **0**
Clock Start/From: **1**
Clock To:
1st Value: **4.000**
2nd Value:
Value Percent:
Continuous Index:
Within 8" of Joint: **YES**
Remarks:

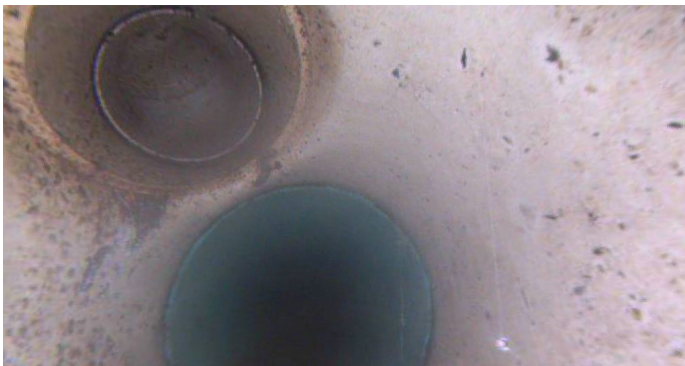
Code: **TF**
Description: **Tap Factory**

Distance (ft): **255.3**
Structural Grade: **0**
O&M Grade: **0**
Clock Start/From: **10**
Clock To:
1st Value: **4.000**
2nd Value:
Value Percent:
Continuous Index:
Within 8" of Joint:
Remarks:

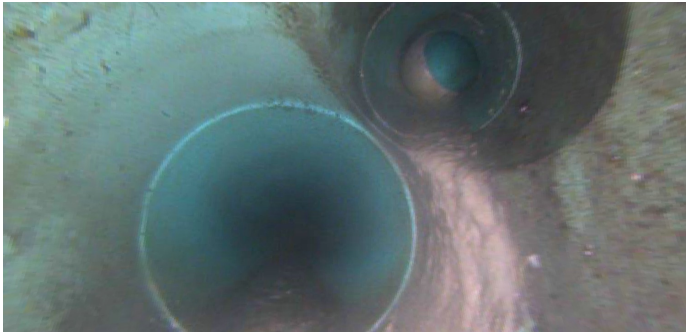
Code: **TF**
Description: **Tap Factory**

Distance (ft): **265.2**
Structural Grade: **0**
O&M Grade: **0**
Clock Start/From: **1**
Clock To:
1st Value: **4.000**
2nd Value:
Value Percent:
Continuous Index:
Within 8" of Joint: **YES**
Remarks:

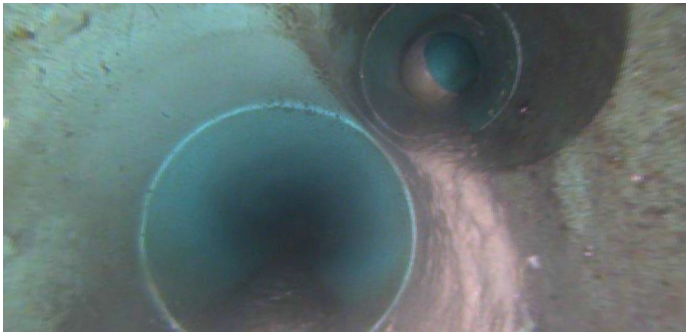
Code: **DAGS**
Description: **Deposits Attached Grease**

Distance (ft): **265.2**
Structural Grade: **0**
O&M Grade: **2**
Clock Start/From: **2**
Clock To: **5**
1st Value:
2nd Value:
Value Percent: **5.000**
Continuous Index:
Within 8" of Joint: **NO**
Remarks:

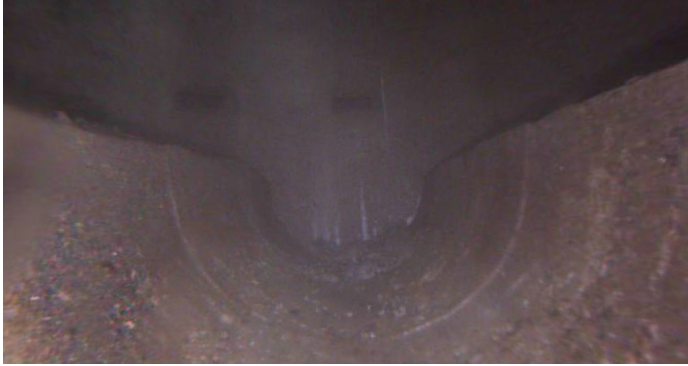
Code:	AMH
Description:	Manhole
Distance (ft):	274.2
Structural Grade:	0
O&M Grade:	0
Clock Start/From:	
Clock To:	
1st Value:	
2nd Value:	
Value Percent:	
Continuous Index:	
Within 8" of Joint:	NO
Remarks:	M-805-025
