Profile/Photo Observation Report

Date:	05/05/2018	Weather:		Coding:	PACP 6.0
Pipe Length (ft):		Owner:	City of Hobart	Pre Clean:	No Pre-Cleaning
P.O.#:	188	Surveyor:	M. Pielacha	PSR:	P-805-023-027
Customer:	City of Hobart	Clean Date:		Shape:	C

Street:	5th Street	Flow Control:	Not Controlled
City:	Hobart, IN	Year Renewed:	
Location:	Light Highway	Tape/Media #:	DEP 188
Purpose:	Routine Assessment	Dia/Height:	20"
Use:	Sanitary	Material:	VCP
Drain Area:		Lining:	
Category:	NA		
Comment:	5-21-2018		
Location Details:		Direction of Survey:	Downstream
US MH:	M-805-027	DS MH:	M-805-023
		Total Length Surveyed (ft):	146.4

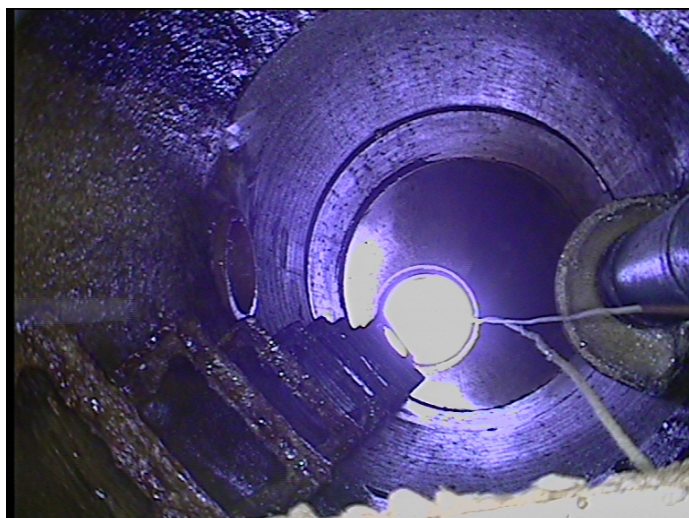
Code: **AMH**
Description: **Manhole**

Distance (ft): **.0**
Structural Grade: **0**
O&M Grade: **0**
Clock Start/From:
Clock To:
1st Value:
2nd Value:
Value Percent:
Continuous Index:
Within 8" of Joint: **NO**
Remarks: **M-805-023**

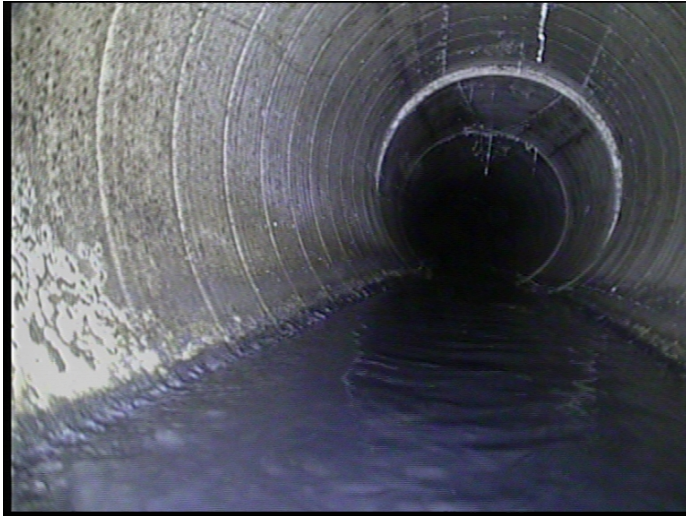
Code: **MWL**
Description: **Water Level**

Distance (ft): **.0**
Structural Grade: **0**
O&M Grade: **0**
Clock Start/From:
Clock To:
1st Value:
2nd Value:
Value Percent: **15.000**
Continuous Index:
Within 8" of Joint: **NO**
Remarks:

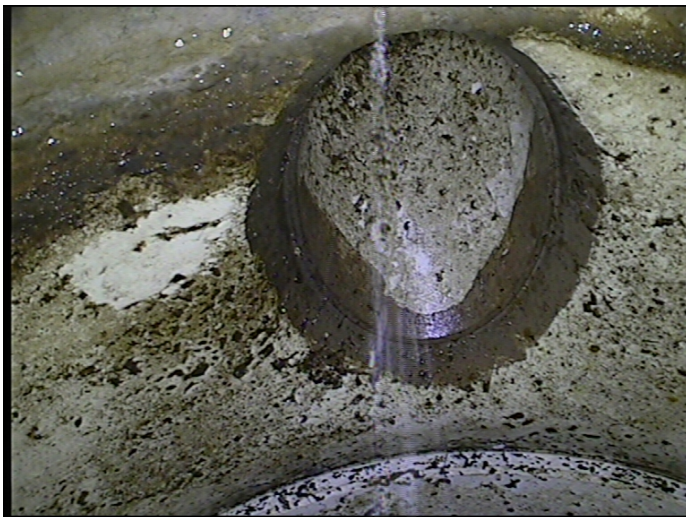
Code: **TFA**
Description: **Tap Factory Active**

Distance (ft): **103.5**
Structural Grade: **0**
O&M Grade: **0**
Clock Start/From: **12**
Clock To:
1st Value: **4.000**
2nd Value:
Value Percent:
Continuous Index:
Within 8" of Joint: **NO**
Remarks:

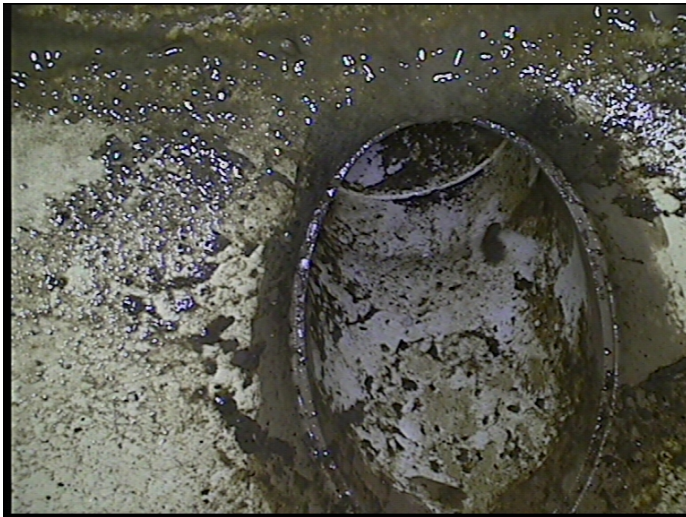
Code: **TF**
Description: **Tap Factory**

Distance (ft): **108.5**
Structural Grade: **0**
O&M Grade: **0**
Clock Start/From: **12**
Clock To:
1st Value: **4.000**
2nd Value:
Value Percent:
Continuous Index:
Within 8" of Joint: **NO**
Remarks:

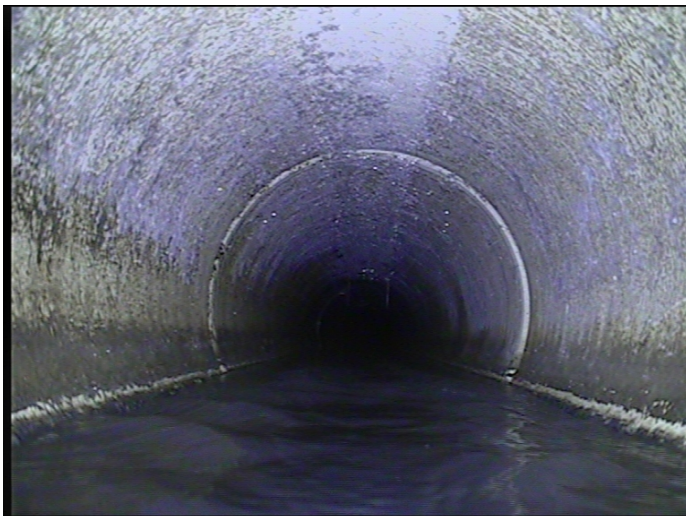
Code: **MSA**
Description: **Abandoned Survey**

Distance (ft): **146.4**
Structural Grade: **0**
O&M Grade: **0**
Clock Start/From:
Clock To:
1st Value:
2nd Value:
Value Percent:
Continuous Index:
Within 8" of Joint: **NO**
Remarks: **sediment**
