## Profile/Photo Observation Report

Street:	<b>5th Street</b>	Flow Control:	
City:	<b>Hobart, IN</b>	Year Renewed:	
Location:	<b>Light Highway</b>	Tape/Media #:	<b>919</b>
Purpose:	<b>Routine Assessment</b>	Dia/Height:	<b>21"</b>
Use:	<b>Sanitary</b>	Material:	<b>VCP</b>
Drain Area:		Lining:

US MH: **M-805-33** DS MH: **M-805-27** Total Length Surveyed (ft): **145.2**

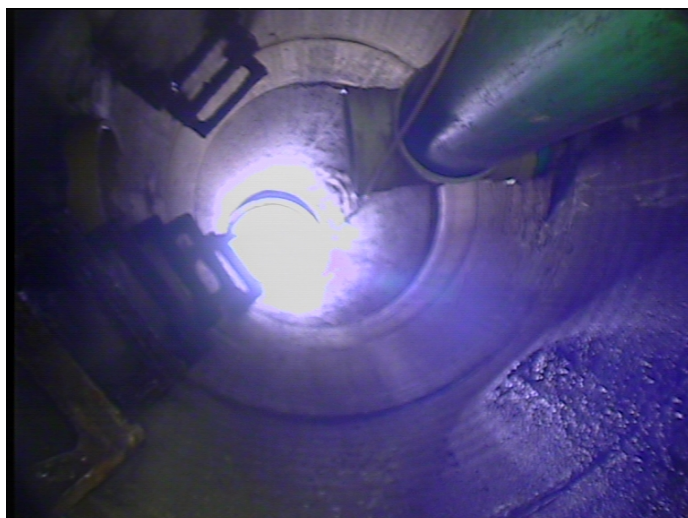
Code: **AMH**  
Description: **Manhole**

Distance (ft): **.0**  
Structural Grade: **0**  
O&M Grade: **0**  
Clock Start/From:  
Clock To:  
1st Value:  
2nd Value:  
Value Percent:  
Continuous Index:  
Within 8" of Joint: **NO**  
Remarks: **M-805-33**

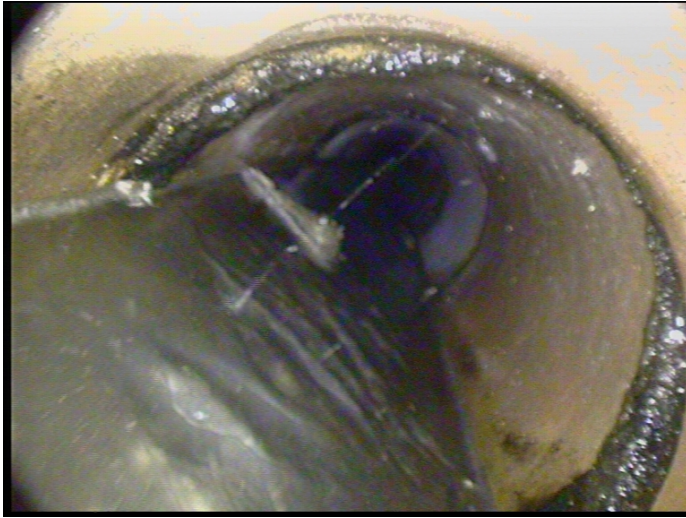
Code:	<b>MWL</b>
Description:	<b>Water Level</b>
Distance (ft):	<b>.0</b>
Structural Grade:	<b>0</b>
O&M Grade:	<b>0</b>
Clock Start/From:	
Clock To:	
1st Value:	
2nd Value:	
Value Percent:	<b>15.000</b>
Continuous Index:	
Within 8" of Joint:	<b>NO</b>
Remarks:

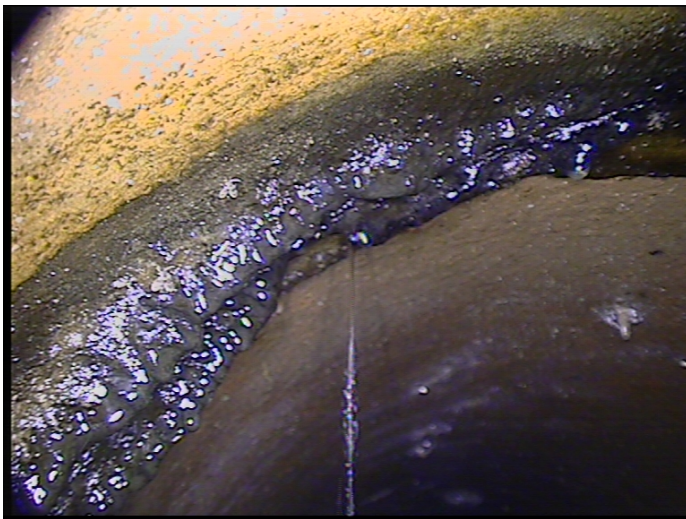
Code:	<b>ID</b>
Description:	<b>Infil Dripper</b>
Distance (ft):	<b>2.4</b>
Structural Grade:	<b>0</b>
O&M Grade:	<b>3</b>
Clock Start/From:	<b>11</b>
Clock To:	
1st Value:	
2nd Value:	
Value Percent:	
Continuous Index:	
Within 8" of Joint:	<b>YES</b>
Remarks:

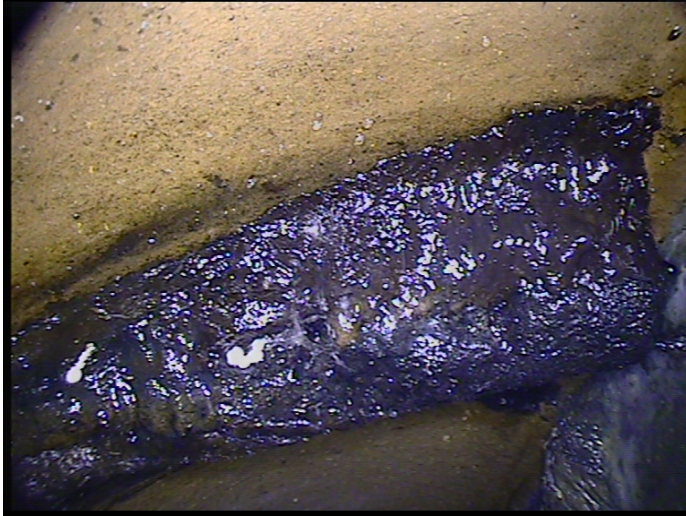
Code:	<b>DAE</b>
Description:	<b>Deposits Attached Encrustation</b>
Distance (ft):	<b>12.2</b>
Structural Grade:	<b>0</b>
O&M Grade:	<b>2</b>
Clock Start/From:	<b>2</b>
Clock To:	<b>5</b>
1st Value:	
2nd Value:	
Value Percent:	<b>5.000</b>
Continuous Index:	<b>S01</b>
Within 8" of Joint:	<b>YES</b>
Remarks:

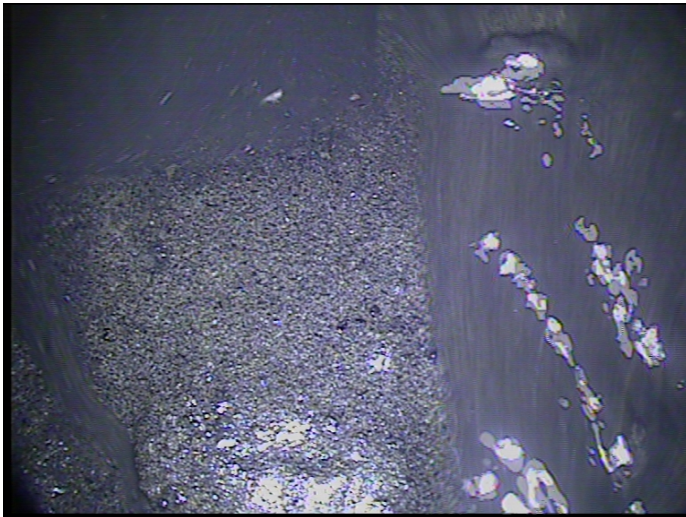
Code:	<b>DSF</b>
Description:	<b>Deposits Settled Fine</b>
Distance (ft):	<b>43.3</b>
Structural Grade:	<b>0</b>
O&M Grade:	<b>3</b>
Clock Start/From:	<b>5</b>
Clock To:	<b>7</b>
1st Value:	
2nd Value:	
Value Percent:	<b>15.000</b>
Continuous Index:	<b>S02</b>
Within 8" of Joint:	<b>YES</b>
Remarks:

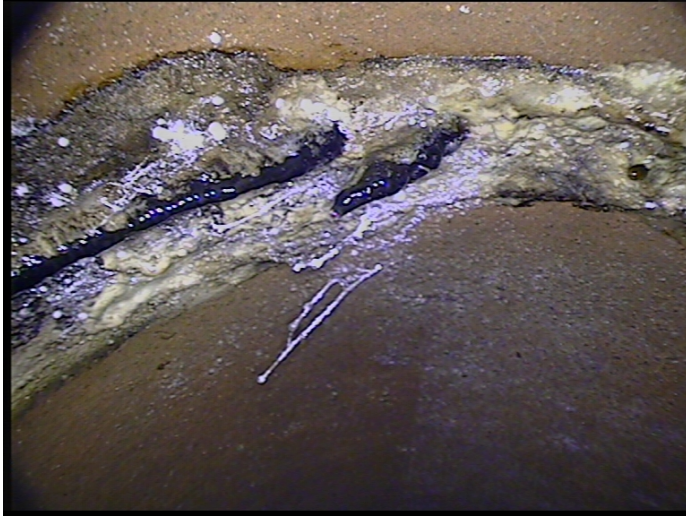
Code:	ID
Description:	Infil Dripper
Distance (ft):	72.7
Structural Grade:	0
O&M Grade:	3
Clock Start/From:	11
Clock To:	
1st Value:	
2nd Value:	
Value Percent:	
Continuous Index:	
Within 8" of Joint:	YES
Remarks:

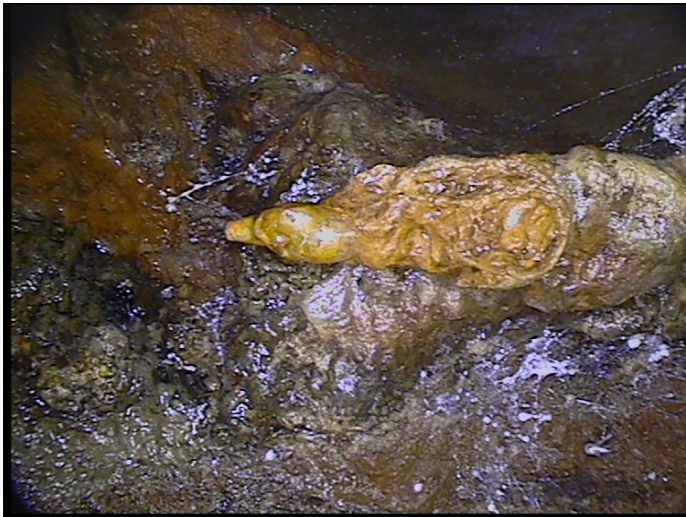
Code:	ID
Description:	Infil Dripper
Distance (ft):	77.8
Structural Grade:	0
O&M Grade:	3
Clock Start/From:	3
Clock To:	
1st Value:	
2nd Value:	
Value Percent:	
Continuous Index:	
Within 8" of Joint:	YES
Remarks:

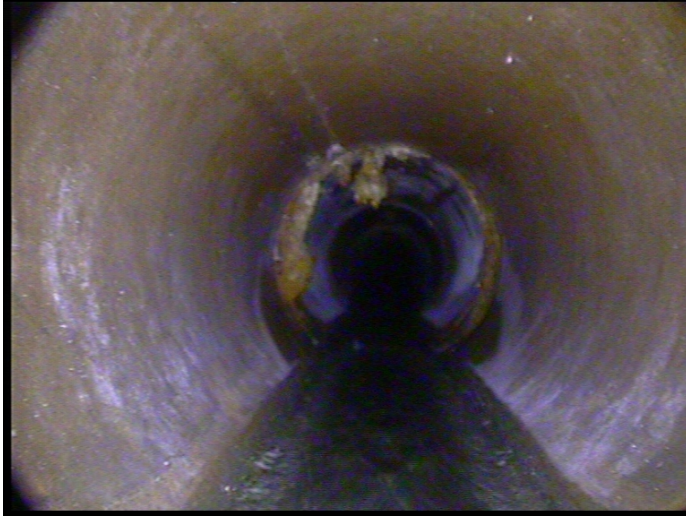
Code: **DSF**  
Description: **Deposits Settled Fine**

Distance (ft): **82.1**  
Structural Grade: **0**  
O&M Grade: **3**  
Clock Start/From: **5**  
Clock To: **7**  
1st Value:  
2nd Value:  
Value Percent: **15.000**  
Continuous Index: **F02**  
Within 8" of Joint: **NO**  
Remarks:

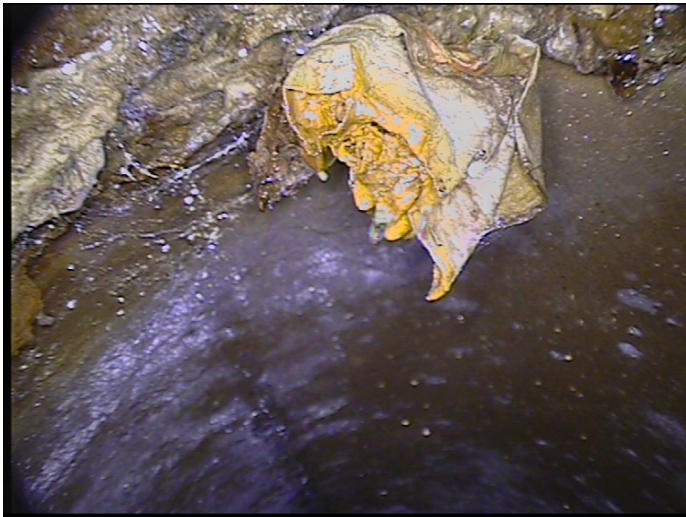
Code: **ID**  
Description: **Infil Dripper**

Distance (ft): **87.6**  
Structural Grade: **0**  
O&M Grade: **3**  
Clock Start/From: **11**  
Clock To:  
1st Value:  
2nd Value:  
Value Percent:  
Continuous Index:  
Within 8" of Joint: **YES**  
Remarks:

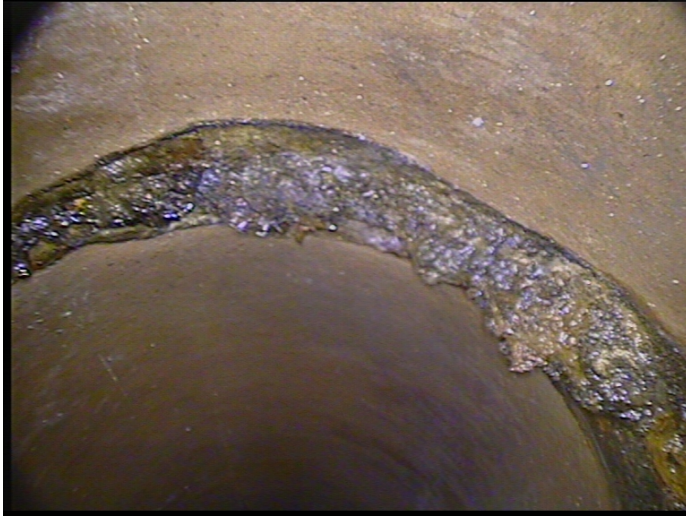
Code: **DAE**  
Description: **Deposits Attached Encrustation**

Distance (ft): **136.6**  
Structural Grade: **0**  
O&M Grade: **2**  
Clock Start/From: **2**  
Clock To: **5**  
1st Value:  
2nd Value:  
Value Percent: **5.000**  
Continuous Index: **F01**  
Within 8" of Joint: **NO**  
Remarks:

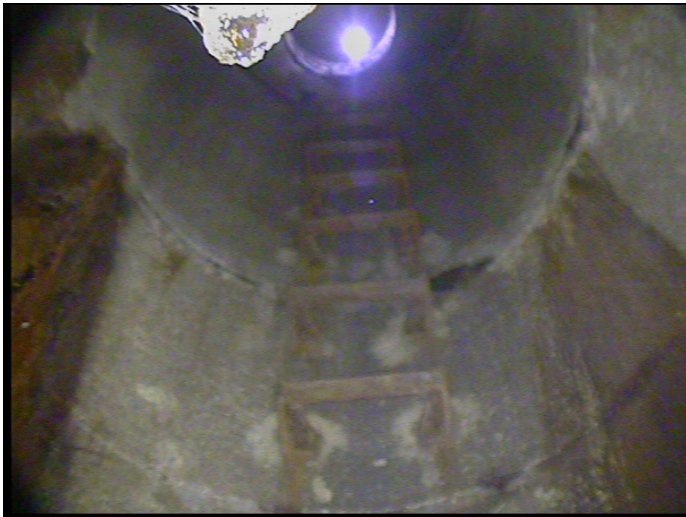
Code: **AMH**  
Description: **Manhole**

Distance (ft): **145.1**  
Structural Grade: **0**  
O&M Grade: **0**  
Clock Start/From:  
Clock To:  
1st Value:  
2nd Value:  
Value Percent:  
Continuous Index:  
Within 8" of Joint: **NO**  
Remarks: **M-805-27**
