Profile/Photo Observation Report

Street:	E CLEVELAND AVE & S LIBERTY PL	Flow Control:	Not Controlled
City:	Hobart, IN	Year Renewed:	
Location:	Other	Tape/Media #:	
Purpose:	Not Known	Dia/Height:	12"
Use:	Sanitary	Material:	PVC
Drain Area:	NA	Lining:	
Category:	NA		
Comment:

Location Details:		Direction of Survey:	Upstream
US MH:	M-805-037	DS MH:	M-804-002
		Total Length Surveyed (ft):	5.1

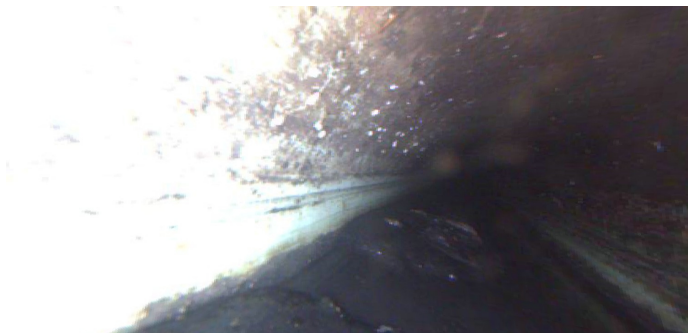
Code: **AMH**
Description: **Manhole**

Distance (ft): **.0**
Structural Grade: **0**
O&M Grade: **0**
Clock Start/From:
Clock To:
1st Value:
2nd Value:
Value Percent:
Continuous Index:
Within 8" of Joint: **NO**
Remarks: **M-804-002**

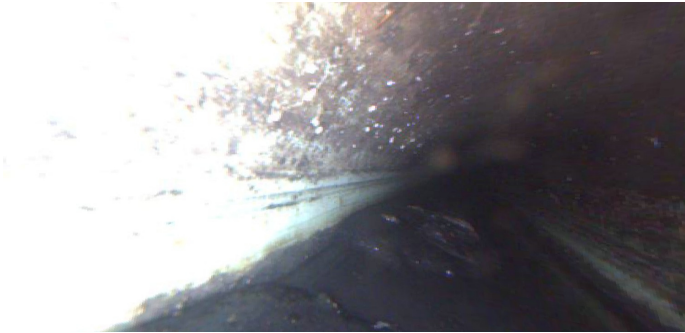
Code:	MWL
Description:	Water Level

Distance (ft):	.0
Structural Grade:	0
O&M Grade:	0
Clock Start/From:	
Clock To:	
1st Value:	
2nd Value:	
Value Percent:	5.000
Continuous Index:	
Within 8" of Joint:	NO
Remarks:

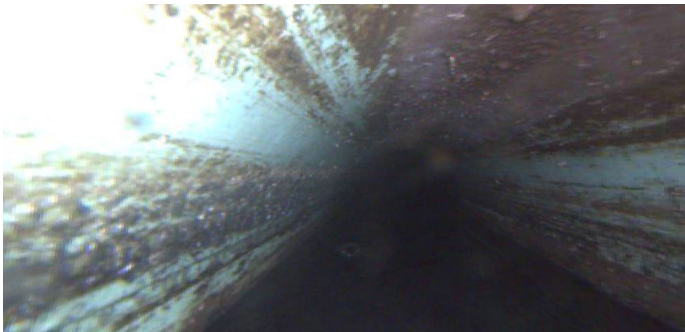
Code:	MSA
Description:	Abandoned Survey

Distance (ft):	5.1
Structural Grade:	0
O&M Grade:	0
Clock Start/From:	
Clock To:	
1st Value:	
2nd Value:	
Value Percent:	
Continuous Index:	
Within 8" of Joint:	NO
Remarks:	camera stopped
