Profile/Photo Observation Report

Street:	S Liberty Pl.	Flow Control:	Not Controlled
City:	Hobart, IN	Year Renewed:	
Location:	Other	Tape/Media #:	
Purpose:	Not Known	Dia/Height:	12"
Use:	Sanitary	Material:	PVC
Drain Area:	NA	Lining:	
Category:	NA		
Comment:

Location Details:		Direction of Survey:	Upstream
US MH:	M-805-037	DS MH:	M-804-002
		Total Length Surveyed (ft):	5.1

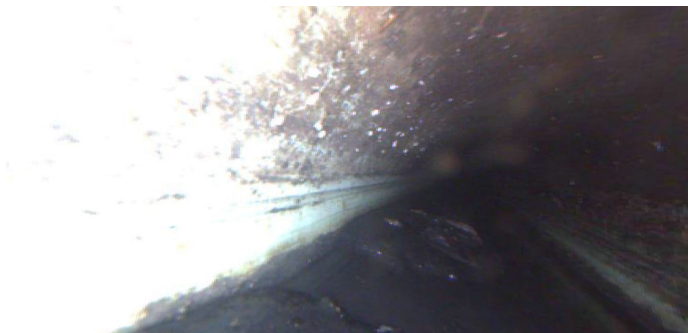
Code: **AMH**
Description: **Manhole**

Distance (ft): **.0**
Structural Grade: **0**
O&M Grade: **0**
Clock Start/From:
Clock To:
1st Value:
2nd Value:
Value Percent:
Continuous Index:
Within 8" of Joint: **NO**
Remarks: **M-804-002**

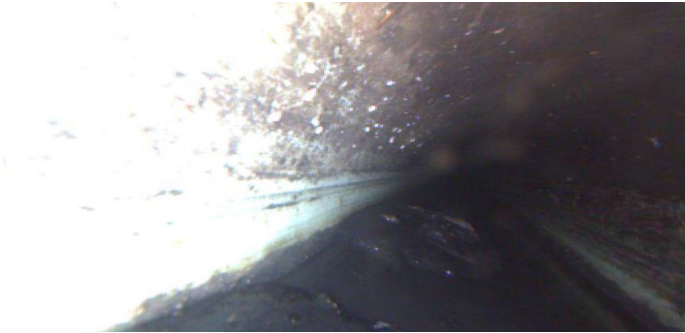
Code:	MWL
Description:	Water Level

Distance (ft):	.0
Structural Grade:	0
O&M Grade:	0
Clock Start/From:	
Clock To:	
1st Value:	
2nd Value:	
Value Percent:	5.000
Continuous Index:	
Within 8" of Joint:	NO
Remarks:

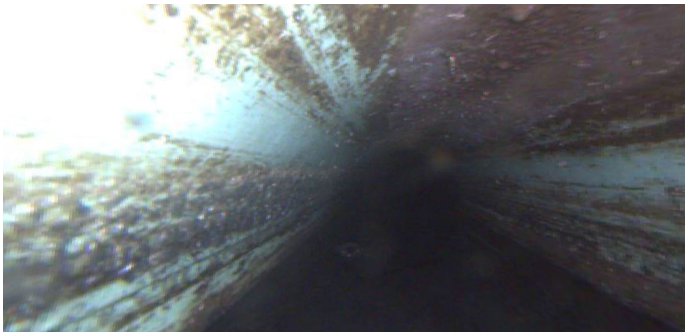
Code:	MSA
Description:	Abandoned Survey

Distance (ft):	5.1
Structural Grade:	0
O&M Grade:	0
Clock Start/From:	
Clock To:	
1st Value:	
2nd Value:	
Value Percent:	
Continuous Index:	
Within 8" of Joint:	NO
Remarks:	camera stopped
