Profile/Photo Observation Report

Date:	04/20/2018	Weather:		Coding:	PACP 6.0
Pipe Length (ft):	156.1	Owner:	NA	Pre Clean:	Not Known
P.O.#:		Surveyor:	Jen Costello	PSR:	P-805-037-038
Customer:		Clean Date:	01/01/1900	Shape:	C

Street:	Devonshire St.	Flow Control:	Not Controlled
City:	Hobart, IN	Year Renewed:	
Location:	Other	Tape/Media #:	
Purpose:	Not Known	Dia/Height:	12"
Use:	Sanitary	Material:	VCP
Drain Area:	NA	Lining:	
Category:	NA		
Comment:

Location Details:		Direction of Survey:	Downstream
US MH:	M-805-038	DS MH:	M-805-037
		Total Length Surveyed (ft):	12.6

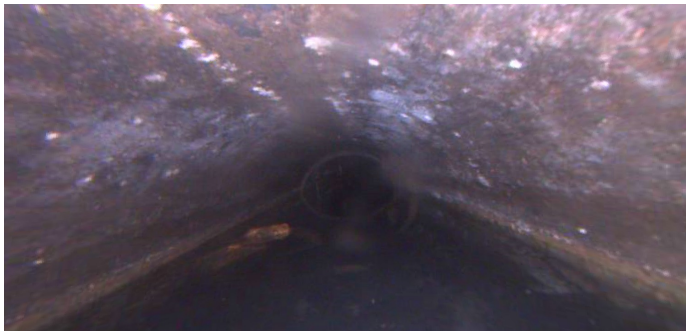
Code: **AMH**
Description: **Manhole**

Distance (ft): **.0**
Structural Grade: **0**
O&M Grade: **0**
Clock Start/From:
Clock To:
1st Value:
2nd Value:
Value Percent:
Continuous Index:
Within 8" of Joint: **NO**
Remarks: **M-805-038**

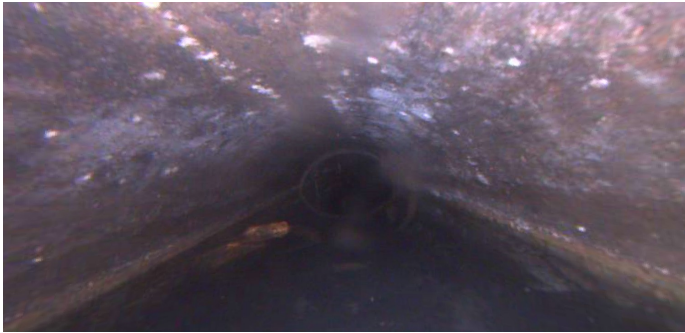
Code:	MWL
Description:	Water Level

Distance (ft):	.0
Structural Grade:	0
O&M Grade:	0
Clock Start/From:	
Clock To:	
1st Value:	
2nd Value:	
Value Percent:	30.000
Continuous Index:	
Within 8" of Joint:	NO
Remarks:

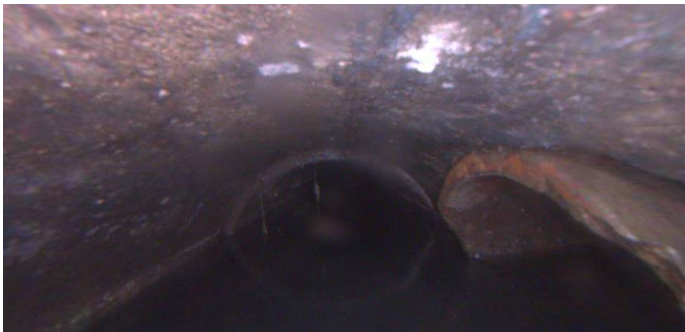
Code:	TBI
Description:	Tap Break-in Intruding

Distance (ft):	2.9
Structural Grade:	0
O&M Grade:	2
Clock Start/From:	3
Clock To:	
1st Value:	4.000
2nd Value:	1.000
Value Percent:	
Continuous Index:	
Within 8" of Joint:	NO
Remarks:

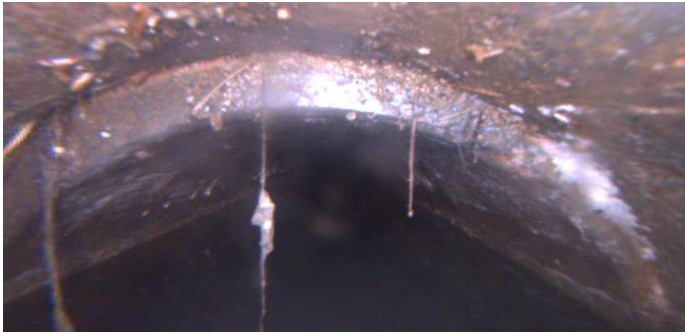
Code: **RFJ**
Description: **Roots Fine Joint**

Distance (ft): **3.8**
Structural Grade: **0**
O&M Grade: **1**
Clock Start/From: **10**
Clock To: **2**
1st Value:
2nd Value:
Value Percent:
Continuous Index:
Within 8" of Joint: **YES**
Remarks:

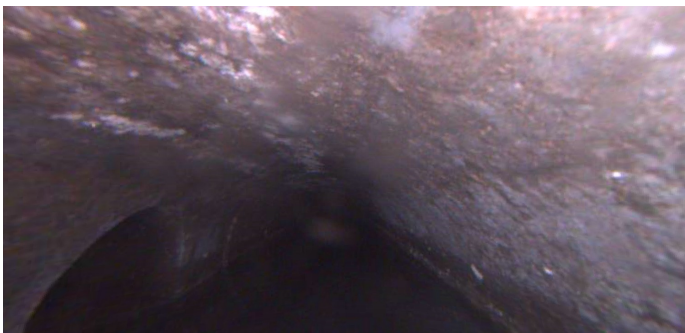
Code: **TFA**
Description: **Tap Factory Active**

Distance (ft): **7.4**
Structural Grade: **0**
O&M Grade: **0**
Clock Start/From: **9**
Clock To:
1st Value: **4.000**
2nd Value:
Value Percent:
Continuous Index:
Within 8" of Joint:
Remarks:

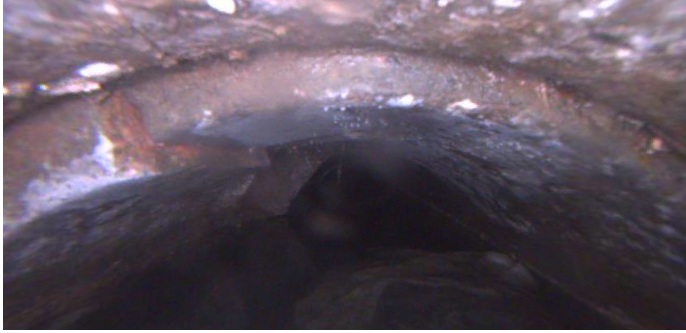
Code: **B**
Description: **Broken**

Distance (ft): **12.1**
Structural Grade: **3**
O&M Grade: **0**
Clock Start/From: **11**
Clock To:
1st Value:
2nd Value:
Value Percent:
Continuous Index:
Within 8" of Joint: **YES**
Remarks:

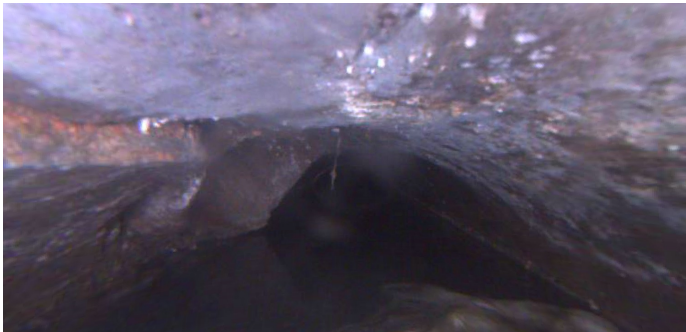
Code: **MSA**
Description: **Abandoned Survey**

Distance (ft): **12.6**
Structural Grade: **0**
O&M Grade: **0**
Clock Start/From:
Clock To:
1st Value:
2nd Value:
Value Percent:
Continuous Index:
Within 8" of Joint: **NO**
Remarks: **broken**
