## Profile/Photo Observation Report

Street:	<b>Joliet St.</b>	Flow Control:	<b>Not Controlled</b>
City:	<b>Hobart, IN</b>	Year Renewed:	
Location:	<b>Other</b>	Tape/Media #:	
Purpose:	<b>Not Known</b>	Dia/Height:	<b>8"</b>
Use:	<b>Sanitary</b>	Material:	<b>VCP</b>
Drain Area:	<b>NA</b>	Lining:	
Category:	<b>NA</b>		
Comment:

Location Details:		Direction of Survey:	<b>Upstream</b>
US MH:	<b>M-805-039</b>	DS MH:	<b>M-805-044</b>
		Total Length Surveyed (ft):	<b>105.3</b>

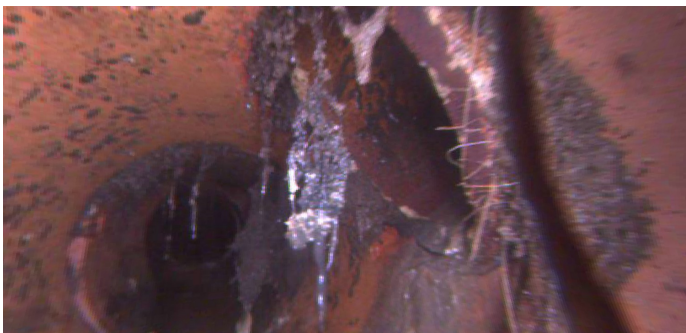
Code: **RFC**  
Description: **Roots Fine Connection**

Distance (ft): **2.8**  
Structural Grade: **0**  
O&M Grade: **1**  
Clock Start/From: **7**  
Clock To: **5**  
1st Value:  
2nd Value:  
Value Percent:  
Continuous Index:  
Within 8" of Joint: **NO**  
Remarks:

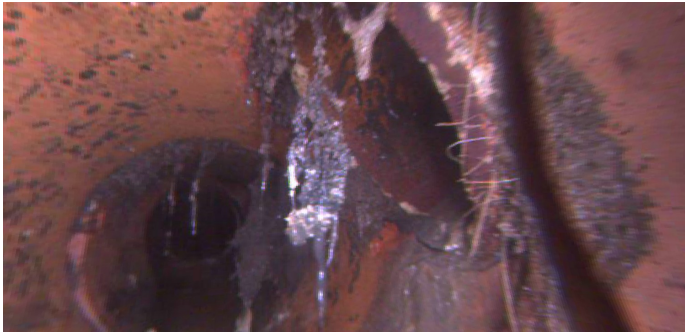
Code: **TBD**  
Description: **Tap Break-in Defective**

Distance (ft): **2.8**  
Structural Grade: **0**  
O&M Grade: **3**  
Clock Start/From: **2**  
Clock To:  
1st Value: **4.000**  
2nd Value:  
Value Percent:  
Continuous Index:  
Within 8" of Joint:  
Remarks: **rfc**

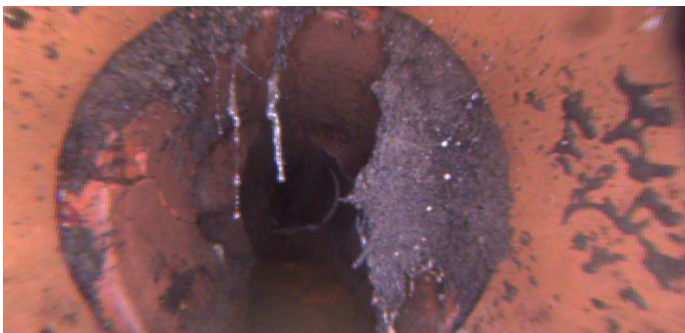
Code: **RMJ**  
Description: **Roots Medium Joint**

Distance (ft): **3.3**  
Structural Grade: **0**  
O&M Grade: **3**  
Clock Start/From: **8**  
Clock To: **5**  
1st Value:  
2nd Value:  
Value Percent: **15.000**  
Continuous Index:  
Within 8" of Joint: **YES**  
Remarks:

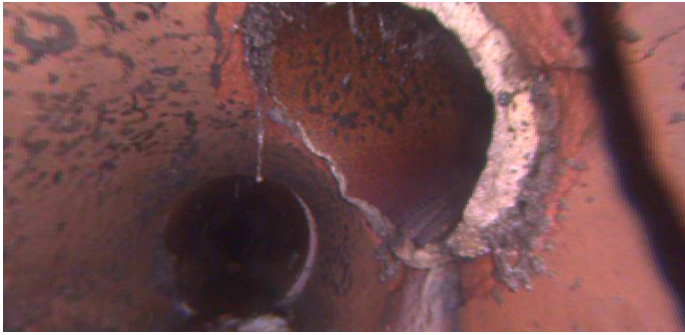
Code: **TBI**  
Description: **Tap Break-in Intruding**

Distance (ft): **4.5**  
Structural Grade: **0**  
O&M Grade: **2**  
Clock Start/From: **2**  
Clock To:  
1st Value: **4.000**  
2nd Value: **1.000**  
Value Percent:  
Continuous Index:  
Within 8" of Joint:  
Remarks:

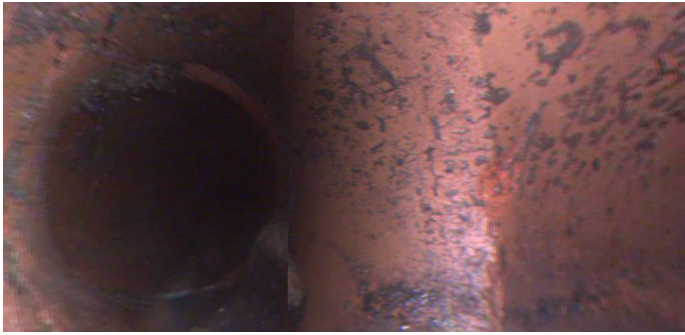
Code: **TF**  
Description: **Tap Factory**

Distance (ft): **4.5**  
Structural Grade: **0**  
O&M Grade: **0**  
Clock Start/From: **9**  
Clock To:  
1st Value: **4.000**  
2nd Value:  
Value Percent:  
Continuous Index:  
Within 8" of Joint:  
Remarks:

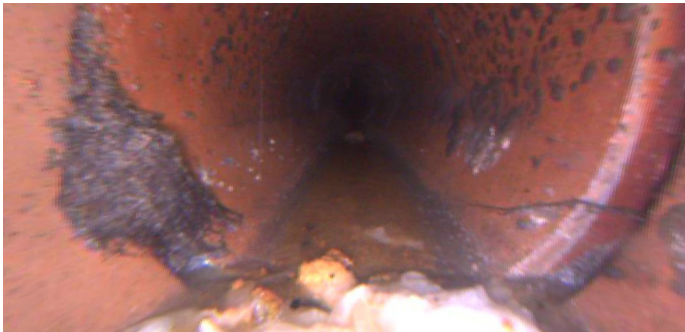
Code: **RFJ**  
Description: **Roots Fine Joint**

Distance (ft): **5.5**  
Structural Grade: **0**  
O&M Grade: **1**  
Clock Start/From: **7**  
Clock To: **8**  
1st Value:  
2nd Value:  
Value Percent:  
Continuous Index:  
Within 8" of Joint: **YES**  
Remarks:

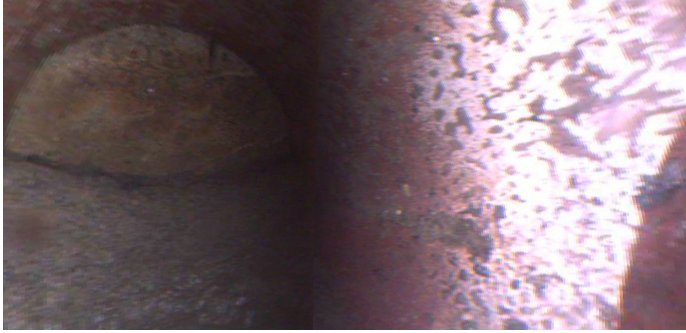
Code: **TFC**  
Description: **Tap Factory Capped**

Distance (ft): **38.8**  
Structural Grade: **0**  
O&M Grade: **0**  
Clock Start/From: **9**  
Clock To:  
1st Value: **4.000**  
2nd Value:  
Value Percent:  
Continuous Index:  
Within 8" of Joint:  
Remarks:

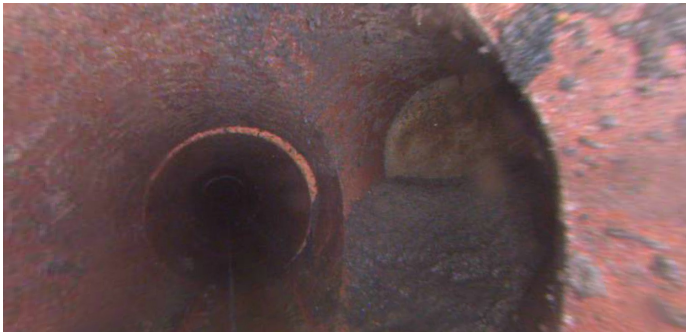
Code: **TFC**  
Description: **Tap Factory Capped**

Distance (ft): **39.3**  
Structural Grade: **0**  
O&M Grade: **0**  
Clock Start/From: **9**  
Clock To:  
1st Value: **4.000**  
2nd Value:  
Value Percent:  
Continuous Index:  
Within 8" of Joint:  
Remarks:

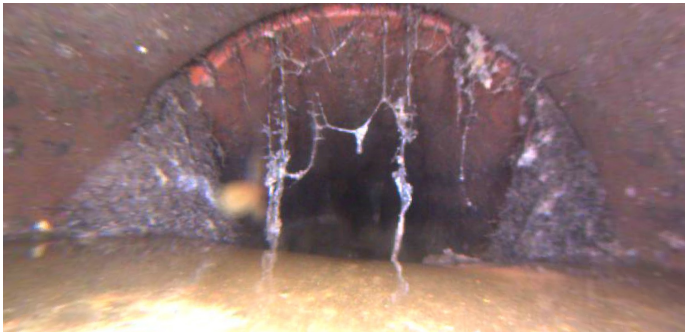
Code:	<b>RMJ</b>
Description:	<b>Roots Medium Joint</b>

Distance (ft):	<b>104.0</b>
Structural Grade:	<b>0</b>
O&M Grade:	<b>3</b>
Clock Start/From:	<b>8</b>
Clock To:	<b>4</b>
1st Value:	
2nd Value:	
Value Percent:	<b>10.000</b>
Continuous Index:	
Within 8" of Joint:	<b>YES</b>
Remarks:

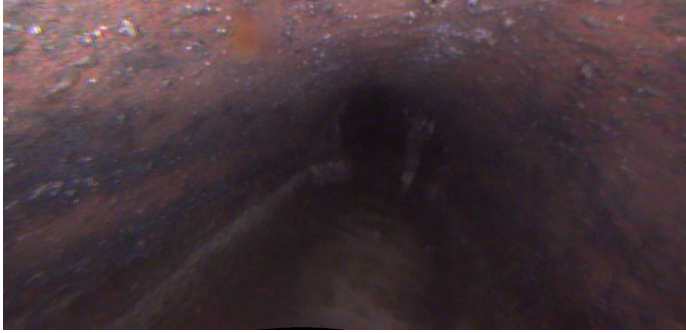
Code: **MSA**  
Description: **Abandoned Survey**

Distance (ft): **105.3**  
Structural Grade: **0**  
O&M Grade: **0**  
Clock Start/From:  
Clock To:  
1st Value:  
2nd Value:  
Value Percent:  
Continuous Index:  
Within 8" of Joint: **NO**  
Remarks: **roots**
