Profile/Photo Observation Report

Date:	05/07/2018	Weather:		Coding:	PACP 6.0
Pipe Length (ft):		Owner:	City of Hobart	Pre Clean:	No Pre-Cleaning
P.O.#:	615	Surveyor:	M. Pielacha	PSR:	P-805-LMP-048
Customer:	City of Hobart	Clean Date:		Shape:	C

Street:	Gerogianna Street	Flow Control:	Not Controlled
City:	Hobart, IN	Year Renewed:	
Location:	Light Highway	Tape/Media #:	dep 615
Purpose:	Routine Assessment	Dia/Height:	6"
Use:	Sanitary	Material:	VCP
Drain Area:		Lining:	
Category:	NA		
Comment:	5-21-2018		
Location Details:		Direction of Survey:	Upstream
US MH:	m-805-048	DS MH:	M-805-048
		Total Length Surveyed (ft):	3.2

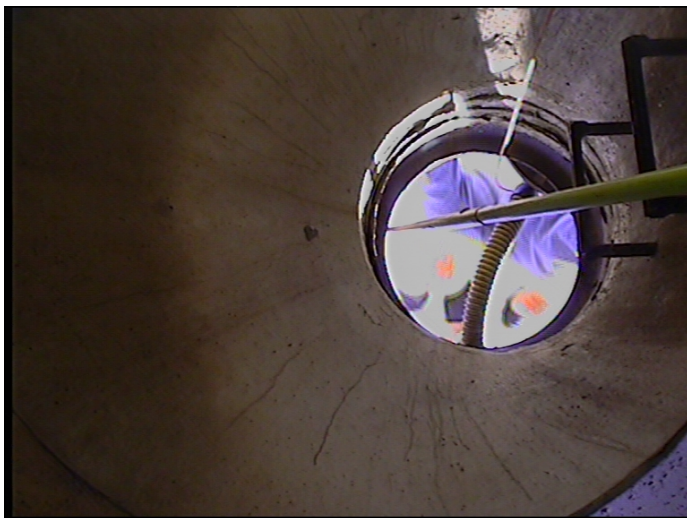
Code: **AMH**
 Description: **Manhole**

Distance (ft): **.0**
 Structural Grade: **0**
 O&M Grade: **0**
 Clock Start/From:
 Clock To:
 1st Value:
 2nd Value:
 Value Percent:
 Continuous Index:
 Within 8" of Joint: **NO**
 Remarks: **M-805-048**

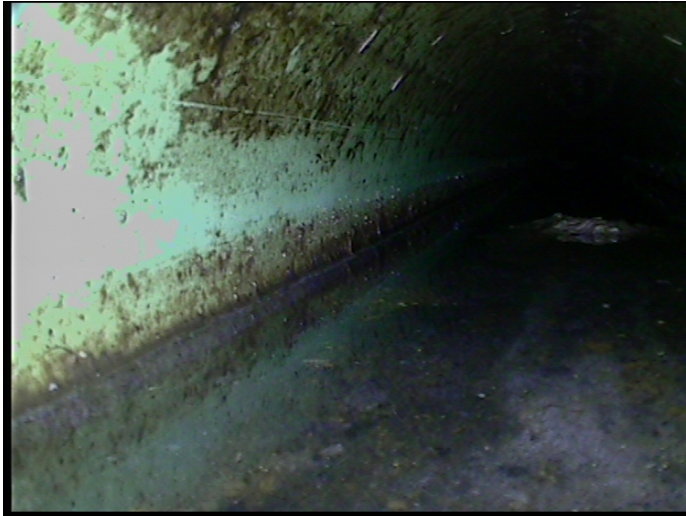
Code: **MWL**
Description: **Water Level**

Distance (ft): **.0**
Structural Grade: **0**
O&M Grade: **0**
Clock Start/From:
Clock To:
1st Value:
2nd Value:
Value Percent: **10.000**
Continuous Index:
Within 8" of Joint: **NO**
Remarks:

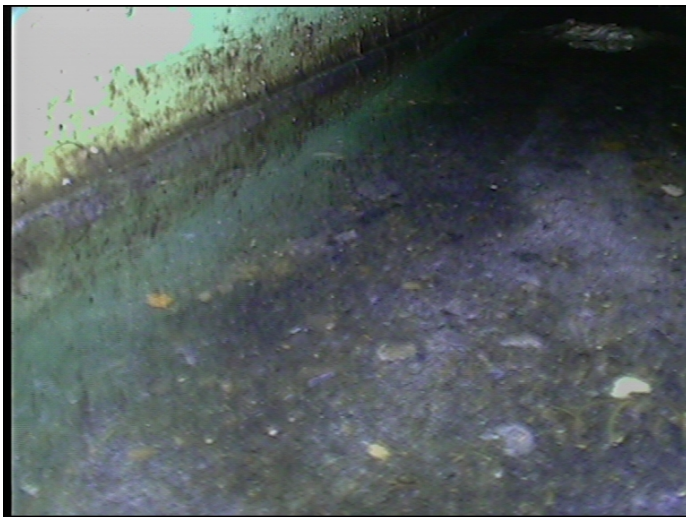
Code: **DSF**
Description: **Deposits Settled Fine**

Distance (ft): **.0**
Structural Grade: **0**
O&M Grade: **3**
Clock Start/From: **4**
Clock To: **8**
1st Value:
2nd Value:
Value Percent: **20.000**
Continuous Index: **S01**
Within 8" of Joint: **YES**
Remarks:

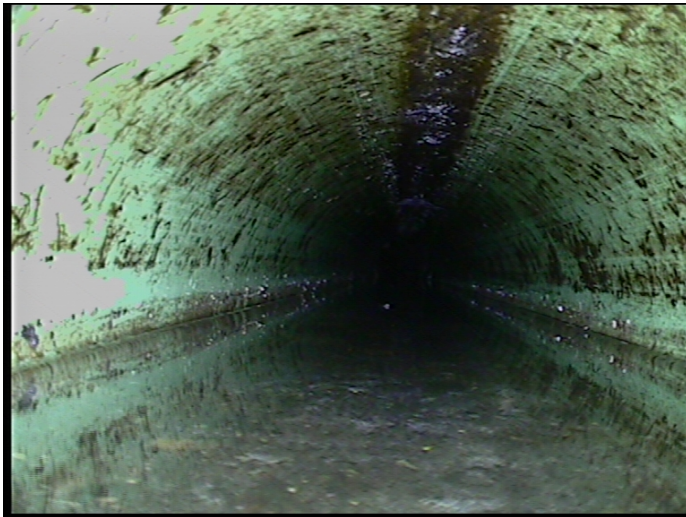
Code: **DSF**
Description: **Deposits Settled Fine**

Distance (ft): **3.2**
Structural Grade: **0**
O&M Grade: **3**
Clock Start/From: **4**
Clock To: **8**
1st Value:
2nd Value:
Value Percent: **20.000**
Continuous Index: **F01**
Within 8" of Joint: **NO**
Remarks:

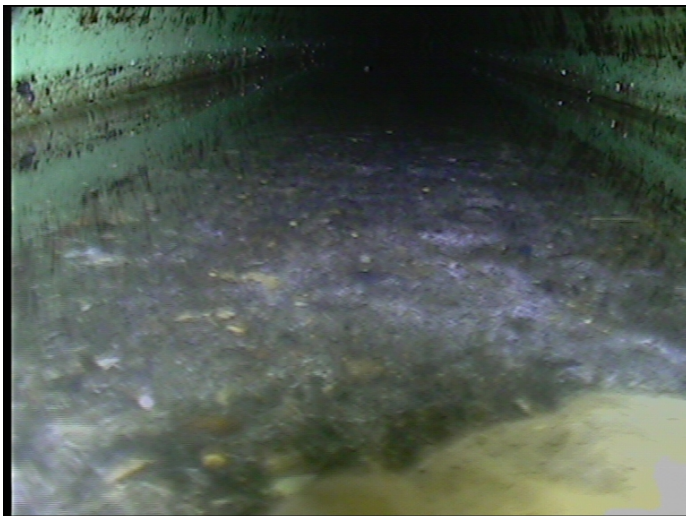
Code: **MSA**
Description: **Abandoned Survey**

Distance (ft): **3.2**
Structural Grade: **0**
O&M Grade: **0**
Clock Start/From:
Clock To:
1st Value:
2nd Value:
Value Percent:
Continuous Index:
Within 8" of Joint: **NO**
Remarks: **SEDIMENT.**
