Profile/Photo Observation Report

| Street: | GEORGIANNA ST & S ILLINOIS ST | Flow Control: | Not Controlled |
| City: | Hobart, IN | Year Renewed: | |

| US MH: | M-805-049 | DS MH: | M-805-048 |

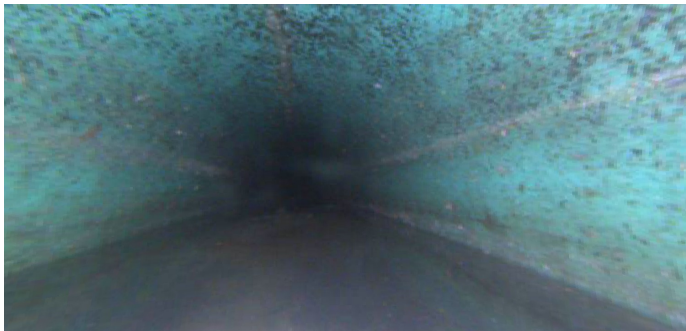
Code: **AMH**
Description: **Manhole**

Distance (ft): **.0**
Structural Grade: **0**
O&M Grade: **0**
Clock Start/From:
Clock To:
1st Value:
2nd Value:
Value Percent:
Continuous Index:
Within 8" of Joint: **NO**
Remarks: **M-805-049**

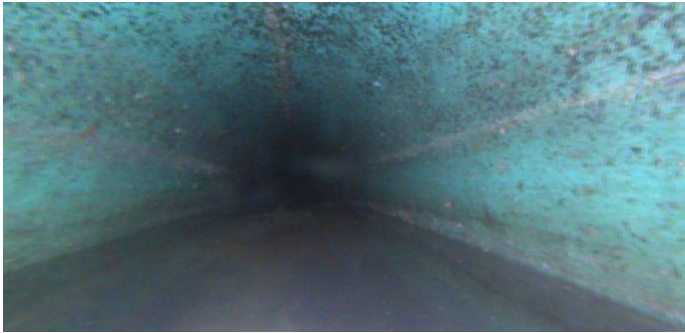
| Code: | MWL |
| Description: | Water Level |

| Distance (ft): | .0 |
| Value Percent: | 10.000 |

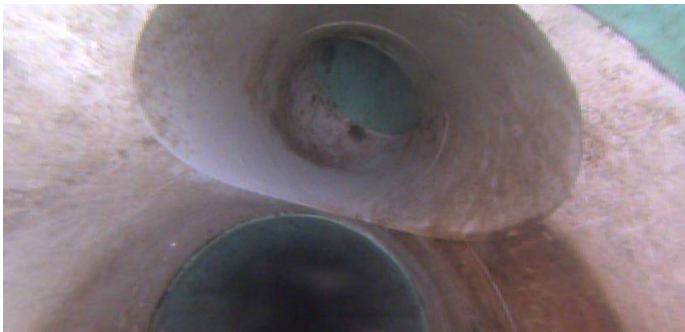
| Code: | TF |
| Description: | Tap Factory |

| Distance (ft): | 90.0 |
| Clock Start/From: | 12 |
| 1st Value: | 4.000 |

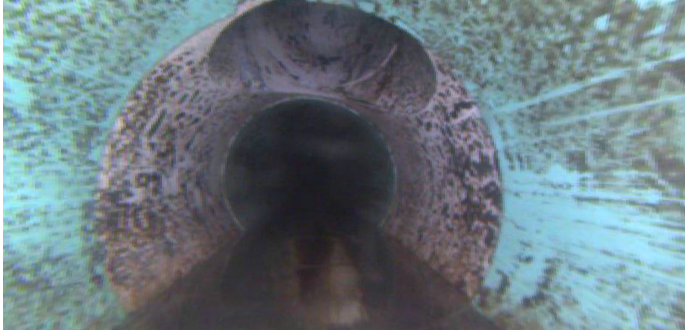
Code: **TF**
Description: **Tap Factory**

Distance (ft): **125.2**
Structural Grade: **0**
O&M Grade: **0**
Clock Start/From: **12**
Clock To:
1st Value: **4.000**
2nd Value:
Value Percent:
Continuous Index:
Within 8" of Joint:
Remarks:

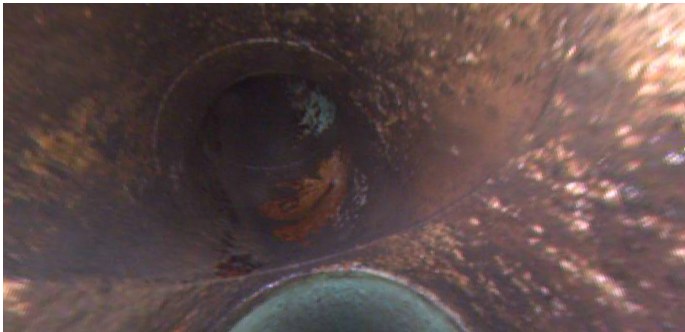
Code: **TF**
Description: **Tap Factory**

Distance (ft): **155.6**
Structural Grade: **0**
O&M Grade: **0**
Clock Start/From: **11**
Clock To:
1st Value: **4.000**
2nd Value:
Value Percent:
Continuous Index:
Within 8" of Joint:
Remarks:

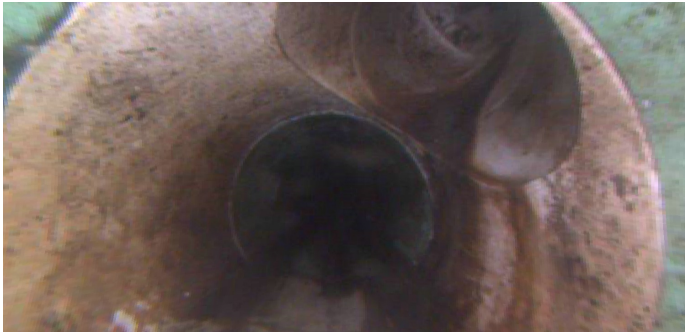
Code: **TF**
Description: **Tap Factory**

Distance (ft): **159.0**
Structural Grade: **0**
O&M Grade: **0**
Clock Start/From: **1**
Clock To:
1st Value: **4.000**
2nd Value:
Value Percent:
Continuous Index:
Within 8" of Joint:
Remarks:

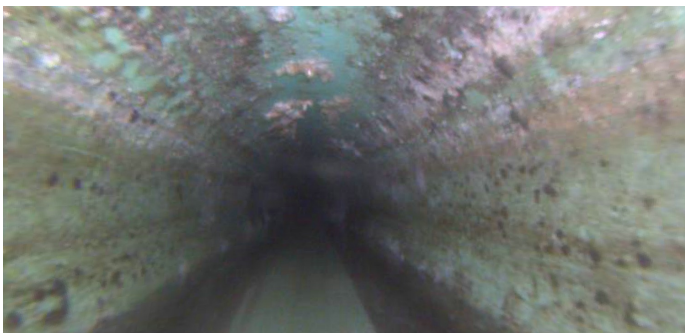
| | Position | Code | Observation | Video (sec) | Grade |
|--|---|---|---|---|---|
| | 196.6 | DAGS(S01) | Deposits Attached Grease | 474 | M 2 |

Code: **DAGS**
Description: **Deposits Attached Grease**

Distance (ft): **196.6**
Structural Grade: **0**
O&M Grade: **2**
Clock Start/From: **8**
Clock To: **4**
1st Value:
2nd Value:
Value Percent: **5.000**
Continuous Index: **S01**
Within 8" of Joint: **NO**
Remarks:

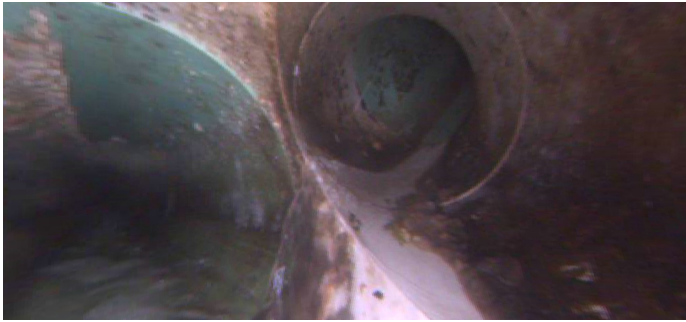
Code: **TF**
Description: **Tap Factory**

Distance (ft): **207.7**
Structural Grade: **0**
O&M Grade: **0**
Clock Start/From: **2**
Clock To:
1st Value: **4.000**
2nd Value:
Value Percent:
Continuous Index:
Within 8" of Joint:
Remarks:

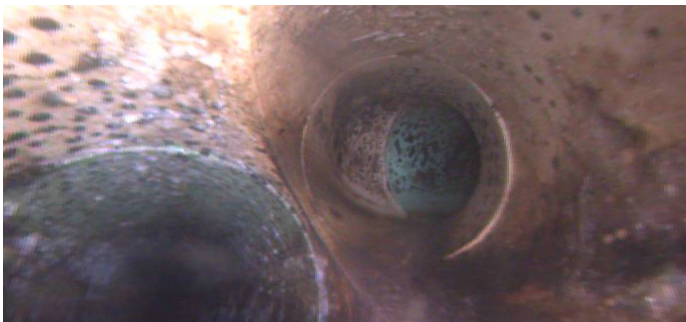
Code: **TF**
Description: **Tap Factory**

Distance (ft): **225.9**
Structural Grade: **0**
O&M Grade: **0**
Clock Start/From: **2**
Clock To:
1st Value: **4.000**
2nd Value:
Value Percent:
Continuous Index:
Within 8" of Joint:
Remarks:

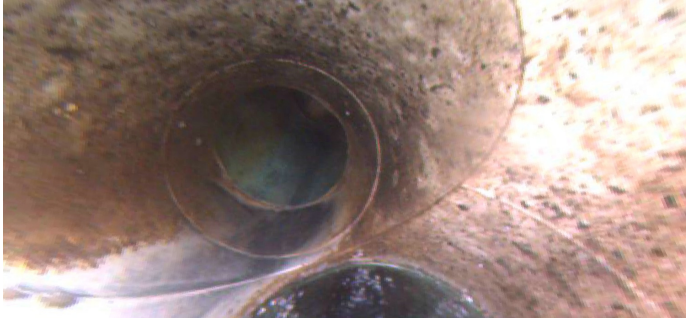
Code: **TF**
Description: **Tap Factory**

Distance (ft): **246.1**
Structural Grade: **0**
O&M Grade: **0**
Clock Start/From: **11**
Clock To:
1st Value: **4.000**
2nd Value:
Value Percent:
Continuous Index:
Within 8" of Joint:
Remarks:

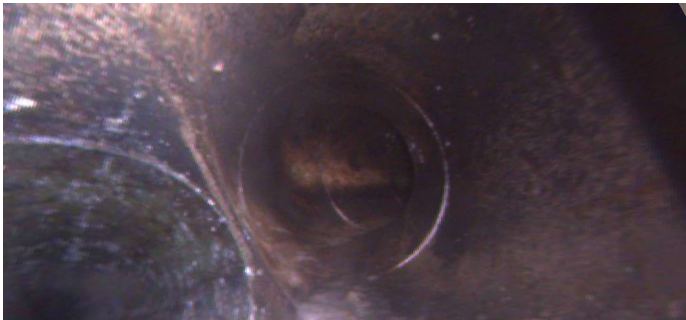
Code: **TF**
Description: **Tap Factory**

Distance (ft): **267.0**
Structural Grade: **0**
O&M Grade: **0**
Clock Start/From: **2**
Clock To:
1st Value: **4.000**
2nd Value:
Value Percent:
Continuous Index:
Within 8" of Joint:
Remarks:

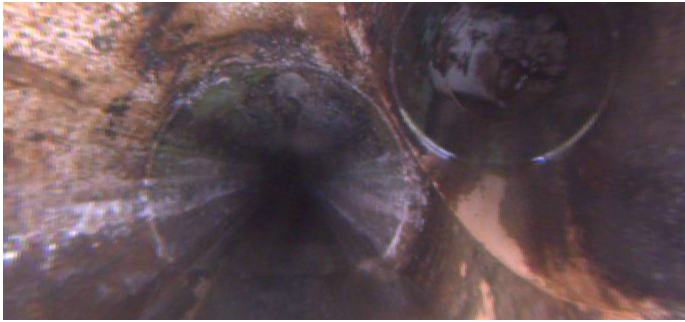
Code: **TF**
Description: **Tap Factory**

Distance (ft): **287.3**
Structural Grade: **0**
O&M Grade: **0**
Clock Start/From: **2**
Clock To:
1st Value: **4.000**
2nd Value:
Value Percent:
Continuous Index:
Within 8" of Joint:
Remarks:

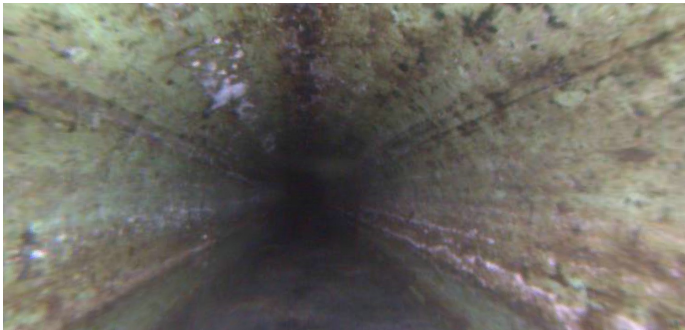
| | Position | Code | Observation | Video (sec) | Grade |
|--|---|---|---|---|---|
| | 297.7 | DAGS(F01) | Deposits Attached Grease | 748 | M 2 |

Code: **DAGS**
Description: **Deposits Attached Grease**

Distance (ft): **297.7**
Structural Grade: **0**
O&M Grade: **2**
Clock Start/From: **8**
Clock To: **4**
1st Value:
2nd Value:
Value Percent: **5.000**
Continuous Index: **F01**
Within 8" of Joint: **NO**
Remarks:

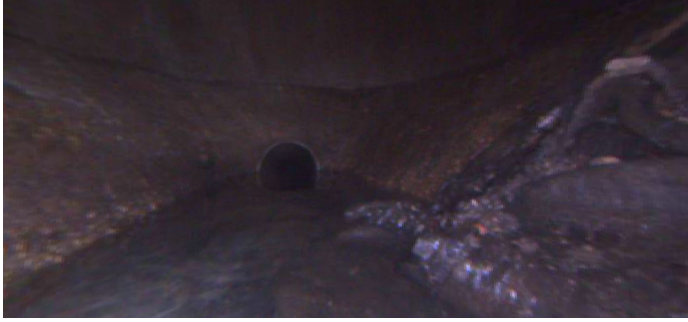
| Code: | AMH |
| Description: | Manhole |
| Distance (ft): | 337.9 |
| Remarks: | M-805-048 |
