Profile/Photo Observation Report

Street:	Georgianna St.	Flow Control:	Not Controlled
City:	Hobart, IN	Year Renewed:	
Location:	Other	Tape/Media #:	
Purpose:	Not Known	Dia/Height:	8"
Use:	Sanitary	Material:	VCP
Drain Area:	NA	Lining:	
Category:	NA		
Comment:

Location Details:		Direction of Survey:	Downstream
US MH:	M-805-049	DS MH:	M-805-048
		Total Length Surveyed (ft):	337.9

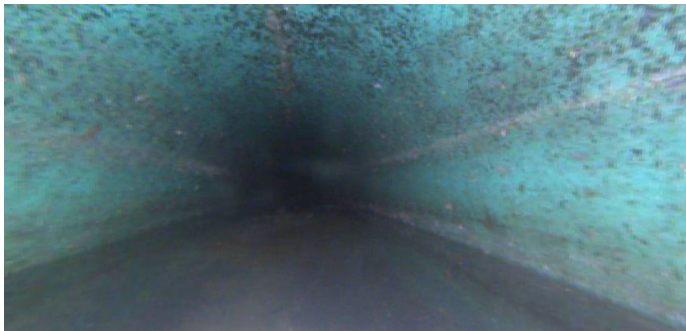
Code: **AMH**
Description: **Manhole**

Distance (ft): **.0**
Structural Grade: **0**
O&M Grade: **0**
Clock Start/From:
Clock To:
1st Value:
2nd Value:
Value Percent:
Continuous Index:
Within 8" of Joint: **NO**
Remarks: **M-805-049**

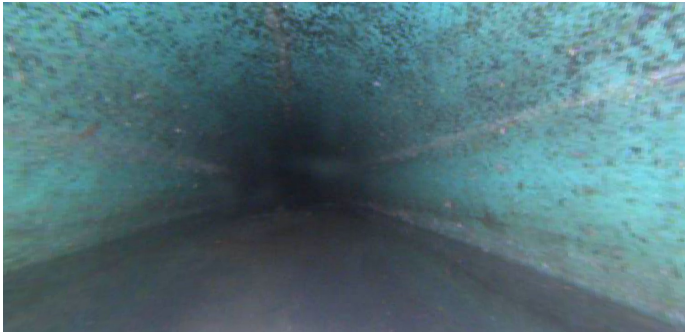
Code:	MWL
Description:	Water Level

Distance (ft):	.0
Structural Grade:	0
O&M Grade:	0
Clock Start/From:	
Clock To:	
1st Value:	
2nd Value:	
Value Percent:	10.000
Continuous Index:	
Within 8" of Joint:	NO
Remarks:

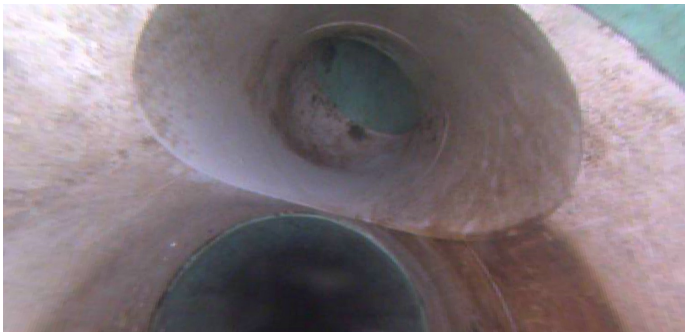
Code:	TF
Description:	Tap Factory

Distance (ft):	90.0
Structural Grade:	0
O&M Grade:	0
Clock Start/From:	12
Clock To:	
1st Value:	4.000
2nd Value:	
Value Percent:	
Continuous Index:	
Within 8" of Joint:	
Remarks:

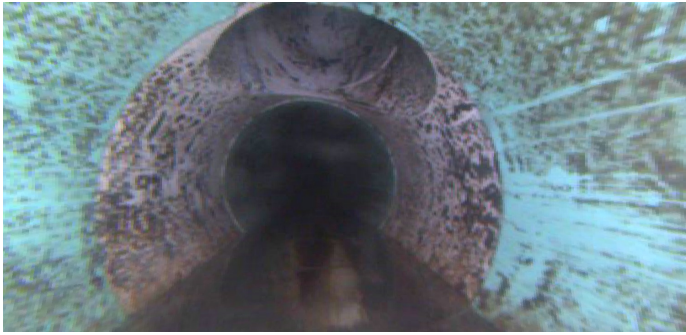
Code: **TF**
Description: **Tap Factory**

Distance (ft): **125.2**
Structural Grade: **0**
O&M Grade: **0**
Clock Start/From: **12**
Clock To:
1st Value: **4.000**
2nd Value:
Value Percent:
Continuous Index:
Within 8" of Joint:
Remarks:

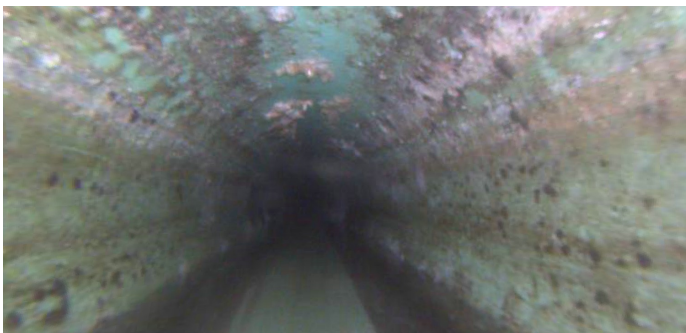
Code: **DAGS**
Description: **Deposits Attached Grease**

Distance (ft): **196.6**
Structural Grade: **0**
O&M Grade: **2**
Clock Start/From: **8**
Clock To: **4**
1st Value:
2nd Value:
Value Percent: **5.000**
Continuous Index: **S01**
Within 8" of Joint: **NO**
Remarks:

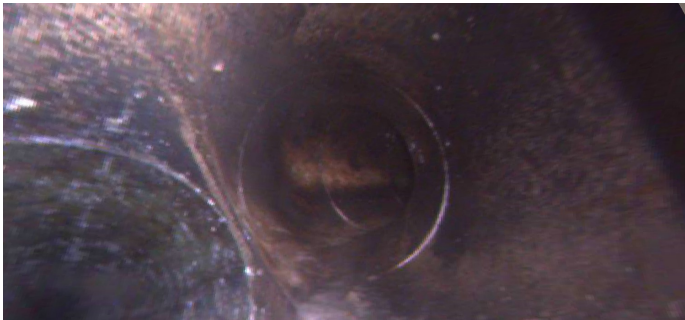
Code: **TF**
Description: **Tap Factory**

Distance (ft): **267.0**
Structural Grade: **0**
O&M Grade: **0**
Clock Start/From: **2**
Clock To:
1st Value: **4.000**
2nd Value:
Value Percent:
Continuous Index:
Within 8" of Joint:
Remarks:

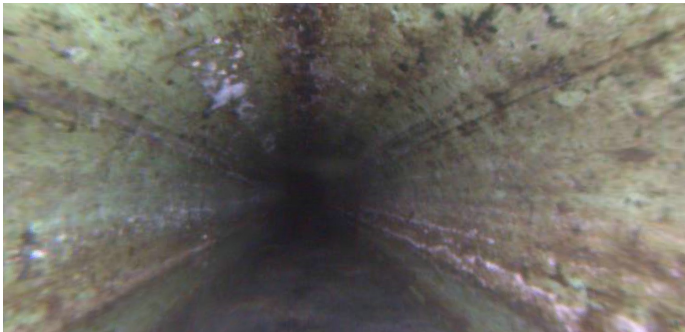
Code: **DAGS**
Description: **Deposits Attached Grease**

Distance (ft): **297.7**
Structural Grade: **0**
O&M Grade: **2**
Clock Start/From: **8**
Clock To: **4**
1st Value:
2nd Value:
Value Percent: **5.000**
Continuous Index: **F01**
Within 8" of Joint: **NO**
Remarks:

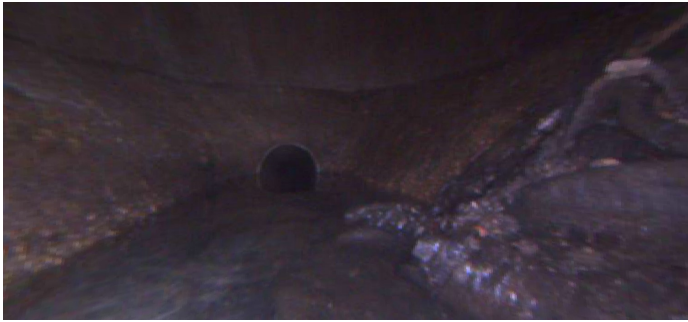
Code:	AMH
Description:	Manhole
Distance (ft):	337.9
Structural Grade:	0
O&M Grade:	0
Clock Start/From:	
Clock To:	
1st Value:	
2nd Value:	
Value Percent:	
Continuous Index:	
Within 8" of Joint:	NO
Remarks:	M-805-048
