Profile/Photo Observation Report

Data	04/20/2019	\Mootho:		Coding	ROBOTIC
Date:	04/30/2018	Weather:	City, of Habant	Coding:	PACP 6.0
Pipe Length (ft)		Owner:	City of Hobart	Pre Clean:	No Pre-Cleaning
P.O.#:	141	Surveyor:	M. Pielacha	PSR:	P-805-051-052
Customer:	City of Hobart	Clean Date:		Shape:	С
Street:	Linda Street		Flow Control:	Not Controlle	d
City:	Hobart, IN		Year Renewed:		
Location:	Light Highway		Tape/Media #:	DEP 141	
Purpose:	Routine Assessment		Dia/Height:	15"	
Use:	Sanitary		Material:	VCP	
Drain Area:			Lining:		
Category:	NA				
Comment:	5-21-2018				
Location Details:			Direction of Surve	y: Downstream	
US MH:	M-805-052	DS MH:	M-805-051	Total Length Surveyed (fi	t): 122.4
D&M Index:	0.00	O&M Quick:	0000	O&M Rating:	0.00
tructural Index:	0.00	— Structural Qı	uick: 0000	Structural Rating	. 0.00

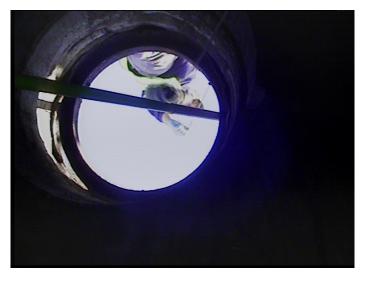
AMH

Description:	Manhole
Distance (ft):	.0
Structural Grade:	0
O&M Grade:	0
Clock Start/From:	
Clock To:	
1st Value:	
2nd Value:	
Value Percent:	
Continuous Index:	
Within 8" of Joint:	NO
Remarks:	M-805-052

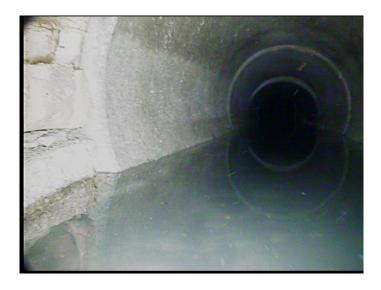
Code: MWL
Description: Water Level

Distance (ft): .0
Structural Grade: 0
O&M Grade: 0
Clock Start/From:

Value Percent: 15.000

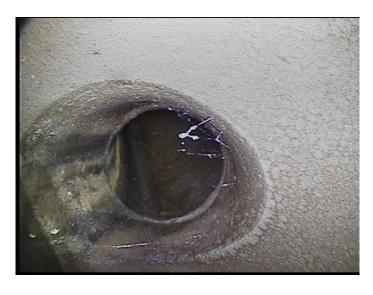
Code: **TF**

Description: Tap Factory

Distance (ft): 34.9
Structural Grade: 0
O&M Grade: 0
Clock Start/From: 9

1st Value: **5.000**

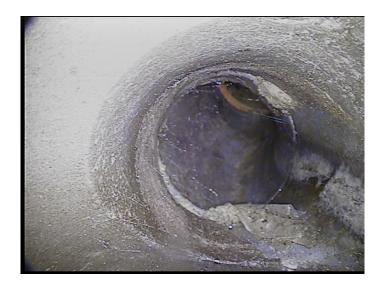
Code: TF

Description: **Tap Factory**

Distance (ft): 65.7 Structural Grade: 0 O&M Grade: 0 Clock Start/From: 3

1st Value: 4.000

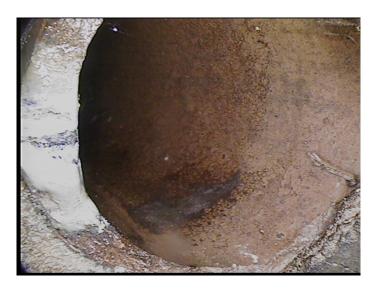
TB Code:

Description: Tap Break-in

Distance (ft): 71.3 Structural Grade: 0 O&M Grade: 0 Clock Start/From: 10

4.000 1st Value:

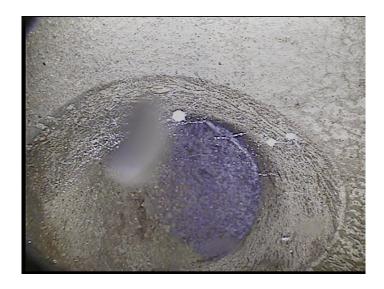
Code: TFC

Description: Tap Factory Capped

Distance (ft): 96.2
Structural Grade: 0

Clock Start/From: 9

1st Value: **4.000**

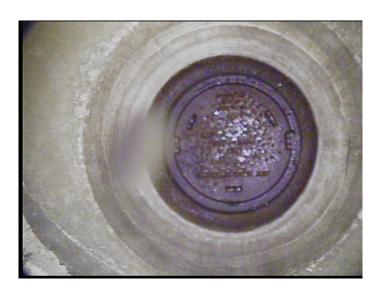
Code: AMH
Description: Manhole

Distance (ft): 122.4
Structural Grade: 0
O&M Grade: 0

Remarks: M-805-051
