Profile/Photo Observation Report

Date:	04/21/2018	Weather:		Coding:	PACP 6.0
Pipe Length (ft):	449.2	Owner:	NA	Pre Clean:	Not Known
P.O.#:		Surveyor:	Mark Ruby	PSR:	P-805-047-053
Customer:		Clean Date:	01/01/1900	Shape:	C

Location Details:		Direction of Survey:	Upstream
US MH:	M-805-053	DS MH:	M-805-047
		Total Length Surveyed (ft):	111.2

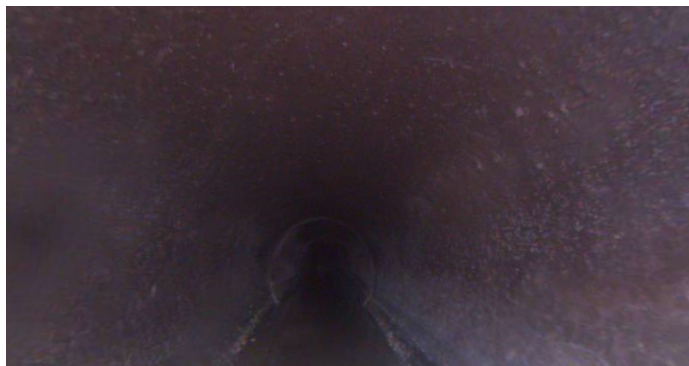
Code: **AMH**
 Description: **Manhole**

Distance (ft): **.0**
 Structural Grade: **0**
 O&M Grade: **0**
 Clock Start/From:
 Clock To:
 1st Value:
 2nd Value:
 Value Percent:
 Continuous Index:
 Within 8" of Joint: **NO**
 Remarks: **M-805-047**

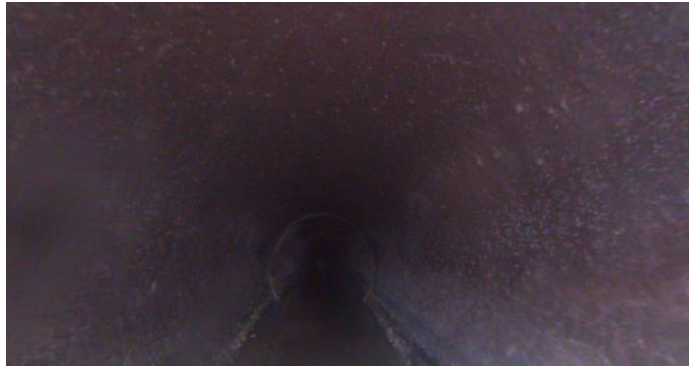
Code: **MWL**
Description: **Water Level**

Distance (ft): **.0**
Structural Grade: **0**
O&M Grade: **0**
Clock Start/From:
Clock To:
1st Value:
2nd Value:
Value Percent: **10.000**
Continuous Index:
Within 8" of Joint: **NO**
Remarks:

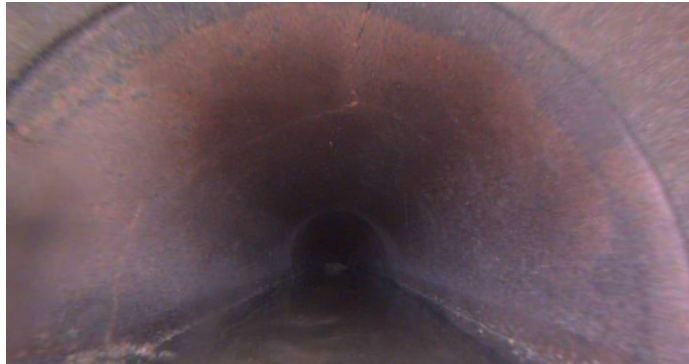
Code: **CM**
Description: **Crack Multiple**

Distance (ft): **5.1**
Structural Grade: **3**
O&M Grade: **0**
Clock Start/From: **7**
Clock To: **1**
1st Value:
2nd Value:
Value Percent:
Continuous Index:
Within 8" of Joint: **YES**
Remarks:

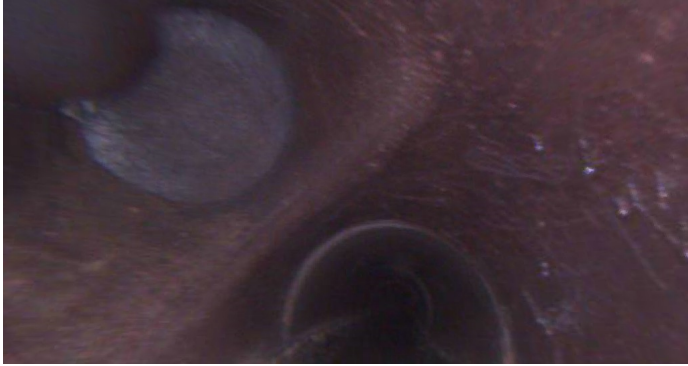
Code: **TFC**
Description: **Tap Factory Capped**

Distance (ft): **31.5**
Structural Grade: **0**
O&M Grade: **0**
Clock Start/From: **10**
Clock To:
1st Value: **4.000**
2nd Value:
Value Percent:
Continuous Index:
Within 8" of Joint:
Remarks:

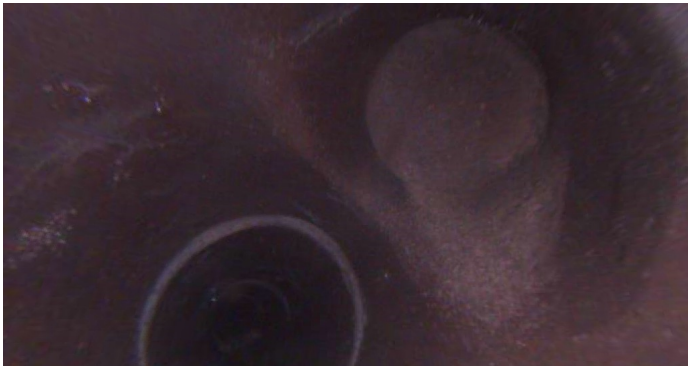
Code: **TFC**
Description: **Tap Factory Capped**

Distance (ft): **37.7**
Structural Grade: **0**
O&M Grade: **0**
Clock Start/From: **10**
Clock To:
1st Value: **4.000**
2nd Value:
Value Percent:
Continuous Index:
Within 8" of Joint:
Remarks:

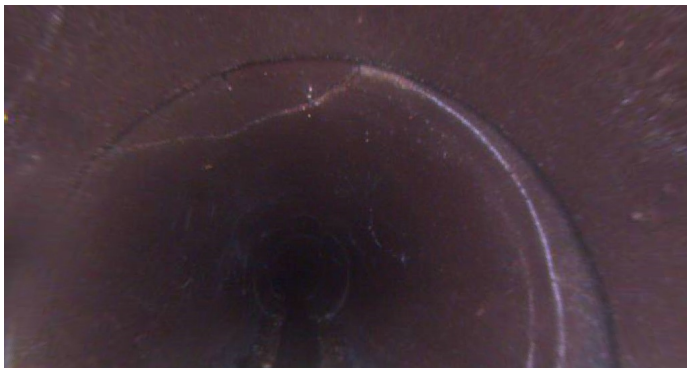
Code: **CM**
Description: **Crack Multiple**

Distance (ft): **40.1**
Structural Grade: **3**
O&M Grade: **0**
Clock Start/From: **10**
Clock To: **1**
1st Value:
2nd Value:
Value Percent:
Continuous Index:
Within 8" of Joint: **YES**
Remarks:

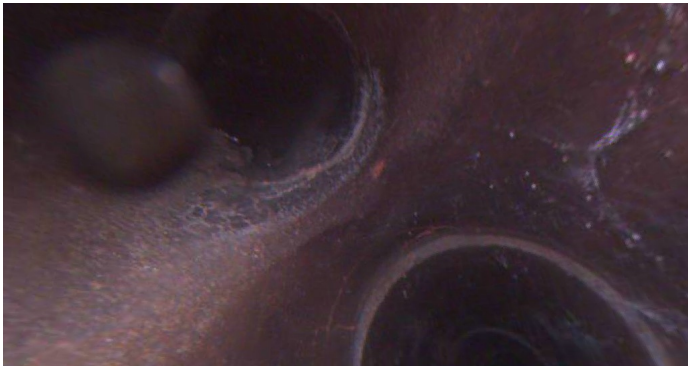
Code: **TF**
Description: **Tap Factory**

Distance (ft): **53.9**
Structural Grade: **0**
O&M Grade: **0**
Clock Start/From: **2**
Clock To:
1st Value: **4.000**
2nd Value:
Value Percent:
Continuous Index:
Within 8" of Joint:
Remarks:

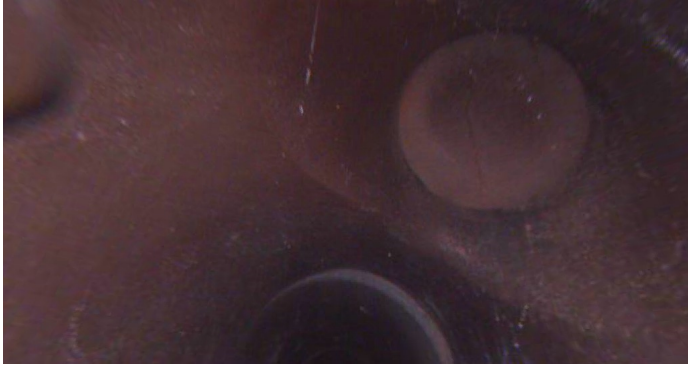
Code: **TFC**
Description: **Tap Factory Capped**

Distance (ft): **66.5**
Structural Grade: **0**
O&M Grade: **0**
Clock Start/From: **10**
Clock To:
1st Value: **4.000**
2nd Value:
Value Percent:
Continuous Index:
Within 8" of Joint:
Remarks:

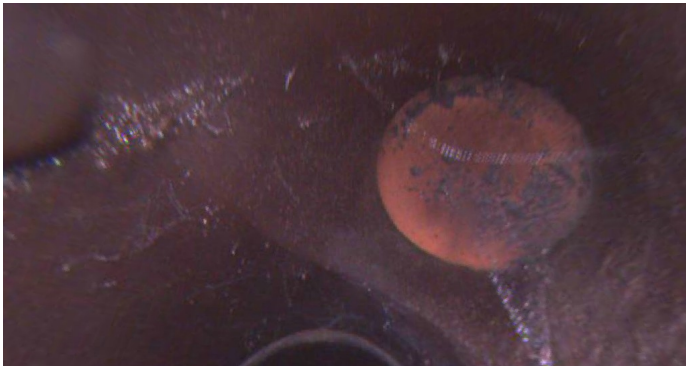
Code: **TFC**
Description: **Tap Factory Capped**

Distance (ft): **82.8**
Structural Grade: **0**
O&M Grade: **0**
Clock Start/From: **11**
Clock To:
1st Value: **4.000**
2nd Value:
Value Percent:
Continuous Index:
Within 8" of Joint:
Remarks:

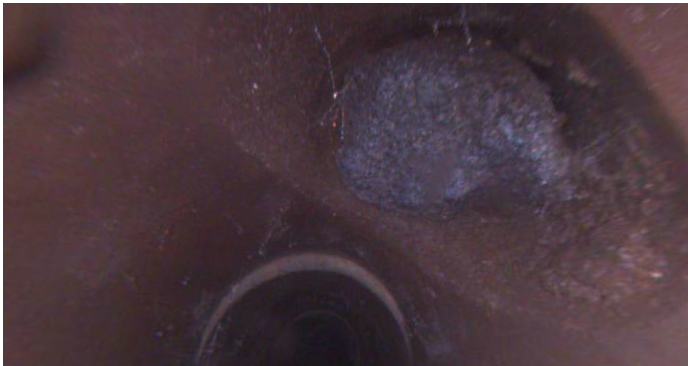
Code: **TFC**
Description: **Tap Factory Capped**

Distance (ft): **101.7**
Structural Grade: **0**
O&M Grade: **0**
Clock Start/From: **11**
Clock To:
1st Value: **4.000**
2nd Value:
Value Percent:
Continuous Index:
Within 8" of Joint:
Remarks:
