Profile/Photo Observation Report

Street:	E 1ST PL & S INDIANA ST	Flow Control:	Not Controlled
City:	Hobart, IN	Year Renewed:	
Location:	Other	Tape/Media #:	
Purpose:	Not Known	Dia/Height:	8"
Use:	Sanitary	Material:	PVC
Drain Area:	NA	Lining:	
Category:	NA		
Comment:

Location Details:		Direction of Survey:	Downstream
US MH:	M-805-062	DS MH:	M-805-065
		Total Length Surveyed (ft):	216.3

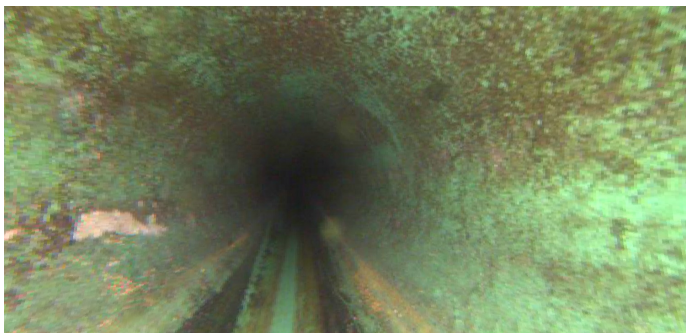
Code: **AMH**
Description: **Manhole**

Distance (ft): **.0**
Structural Grade: **0**
O&M Grade: **0**
Clock Start/From:
Clock To:
1st Value:
2nd Value:
Value Percent:
Continuous Index:
Within 8" of Joint: **NO**
Remarks: **M-805-062**

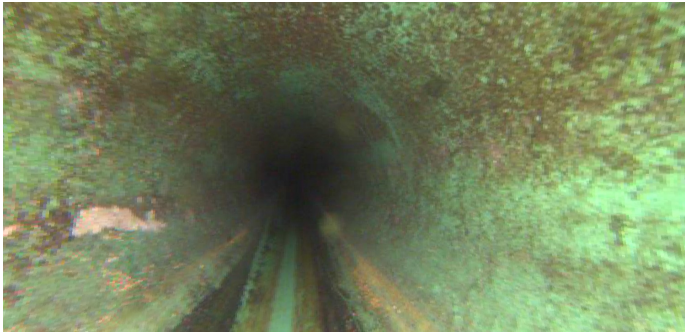
Code:	MWL
Description:	Water Level

Distance (ft):	.0
Structural Grade:	0
O&M Grade:	0
Clock Start/From:	
Clock To:	
1st Value:	
2nd Value:	
Value Percent:	5.000
Continuous Index:	
Within 8" of Joint:	NO
Remarks:

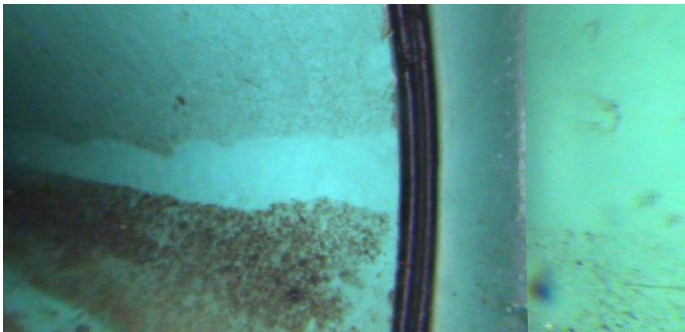
Code:	ISSR
Description:	Intruding Sealing Ring

Distance (ft):	40.5
Structural Grade:	0
O&M Grade:	2
Clock Start/From:	7
Clock To:	10
1st Value:	
2nd Value:	
Value Percent:	5.000
Continuous Index:	
Within 8" of Joint:	NO
Remarks:

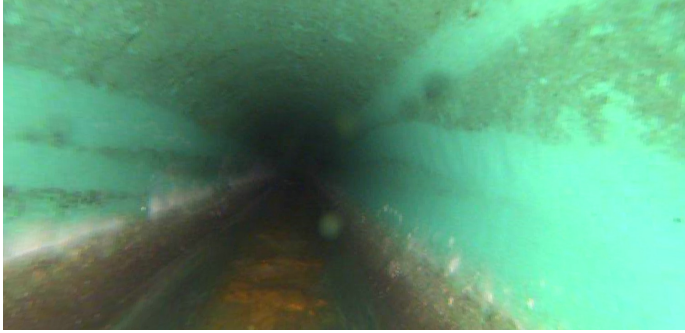
Code: **DSZ**
Description: **Deposits Settled Other**

Distance (ft): **146.2**
Structural Grade: **0**
O&M Grade: **2**
Clock Start/From: **6**
Clock To:
1st Value:
2nd Value:
Value Percent: **5.000**
Continuous Index: **S01**
Within 8" of Joint: **NO**
Remarks: **debris**

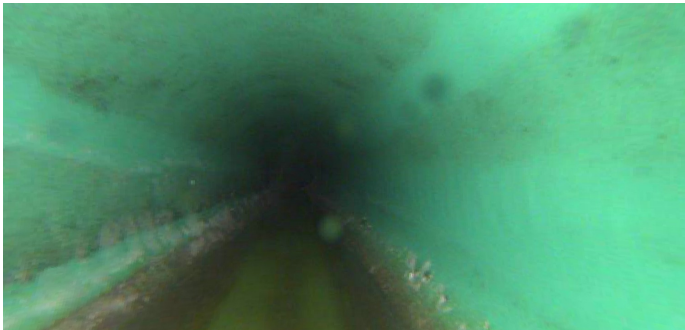
Code: **DSZ**
Description: **Deposits Settled Other**

Distance (ft): **160.9**
Structural Grade: **0**
O&M Grade: **2**
Clock Start/From: **6**
Clock To:
1st Value:
2nd Value:
Value Percent: **5.000**
Continuous Index: **F01**
Within 8" of Joint: **NO**
Remarks: **debris**

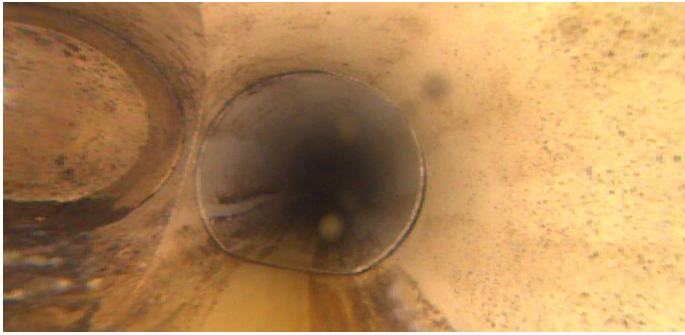
Code: **TFC**
Description: **Tap Factory Capped**

Distance (ft): **165.9**
Structural Grade: **0**
O&M Grade: **0**
Clock Start/From: **10**
Clock To:
1st Value: **4.000**
2nd Value:
Value Percent:
Continuous Index:
Within 8" of Joint: **YES**
Remarks:

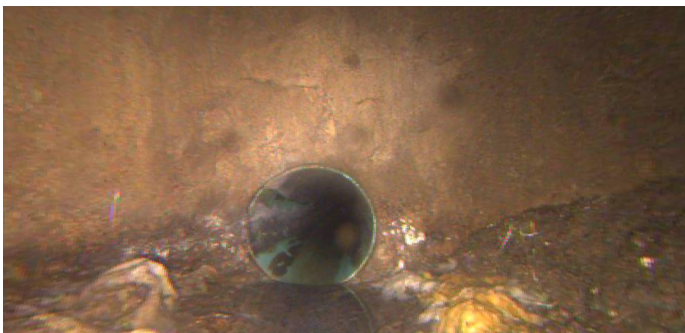
Code: **AMH**
Description: **Manhole**

Distance (ft): **216.3**
Structural Grade: **0**
O&M Grade: **0**
Clock Start/From:
Clock To:
1st Value:
2nd Value:
Value Percent:
Continuous Index:
Within 8" of Joint: **NO**
Remarks: **M-805-065**
