Profile/Photo Observation Report

Street:	S HOBART RD	Flow Control:	Not Controlled
City:	Hobart, IN	Year Renewed:	
Location:	Parking Lot	Tape/Media #:	
Purpose:	Maintenance Related	Dia/Height:	8"
Use:	Sanitary	Material:	PVC
Drain Area:	NA	Lining:	Cured in Place
Category:	NA		
Comment:	Flow direction wrong. Unknown reason for stop.		
Location Details:		Direction of Survey:	Upstream
US MH:	M-805-068	DS MH:	M-905-035
		Total Length Surveyed (ft):	26.1

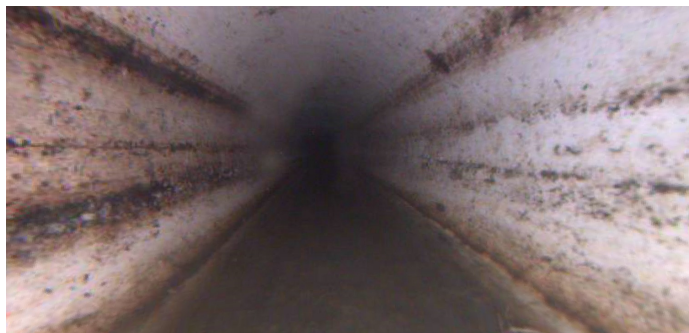
Code: **AMH**
 Description: **Manhole**
 Distance (ft): **.0**
 Structural Grade: **0**
 O&M Grade: **0**
 Clock Start/From:
 Clock To:
 1st Value:
 2nd Value:
 Value Percent:
 Continuous Index:
 Within 8" of Joint: **NO**
 Remarks: **M-905-035**

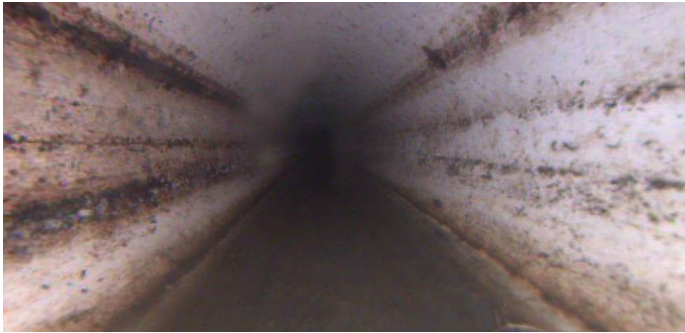
Code:	MWL
Description:	Water Level

Distance (ft):	.0
Structural Grade:	0
O&M Grade:	0
Clock Start/From:	
Clock To:	
1st Value:	
2nd Value:	
Value Percent:	10.000
Continuous Index:	
Within 8" of Joint:	NO
Remarks:

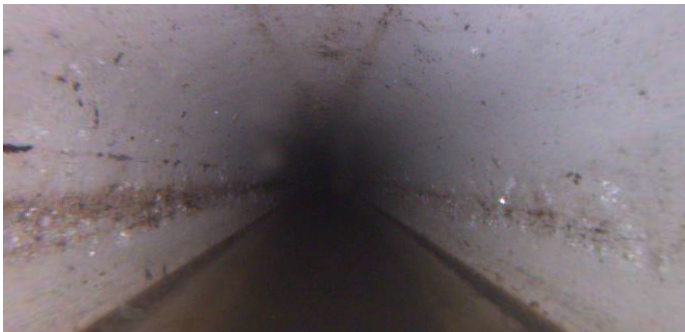
Code:	MSA
Description:	Abandoned Survey

Distance (ft):	26.1
Structural Grade:	0
O&M Grade:	0
Clock Start/From:	
Clock To:	
1st Value:	
2nd Value:	
Value Percent:	
Continuous Index:	
Within 8" of Joint:	NO
Remarks:	DEBRIS UNDER WATER
