## Profile/Photo Observation Report

Date:	<b>09/10/2022</b>	Weather:		Coding:	<b>PACP 7.0</b>
Pipe Length (ft):	<b>456.0</b>	Owner:	<b>City of Hobart</b>	Pre Clean:	<b>Heavy Cleaning</b>
P.O.#:	<b>YES502259</b>	Surveyor:	<b>S. Bucklin</b>	PSR:	<b>P-905-035-068</b>
Customer:	<b>City of Hobart</b>	Clean Date:	<b>08/23/2022</b>	Shape:	<b>C</b>

Street:	<b>East 5th Street</b>	Flow Control:	<b>Not Controlled</b>
City:	<b>Hobart, IN</b>	Year Renewed:	
Location:	<b>Easement/Right of Way</b>	Tape/Media #:	
Purpose:	<b>Routine Assessment</b>	Dia/Height:	<b>8"</b>
Use:	<b>Sanitary Sewage Pipe</b>	Material:	<b>PVC</b>
Drain Area:		Lining:	<b>None</b>
Category:	<b>NA</b>		
Comment:			
Location Details:	<b>JUST NORTH OF THE DRIVEWAY TO</b>	Direction of Survey:	<b>Downstream</b>
US MH:	<b>M-805-068</b>	DS MH:	<b>M-905-035</b>
		Total Length Surveyed (ft):	<b>460.0</b>

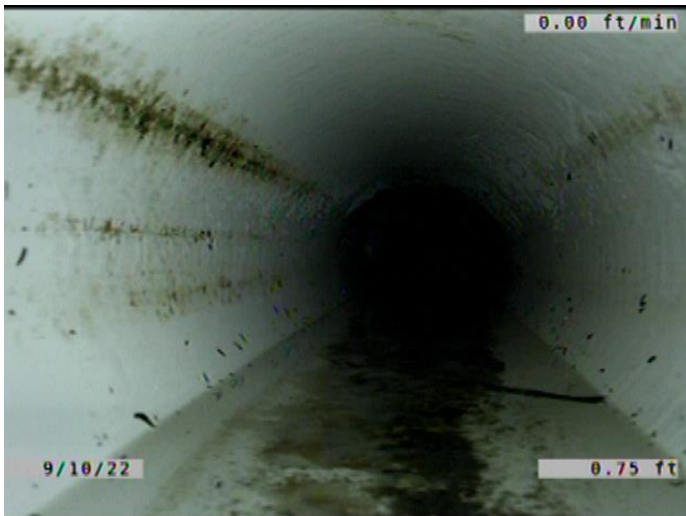
Code: **DSF**  
 Description: **Deposits Settled Fine**

Distance (ft): **.8**  
 Structural Grade: **0**  
 O&M Grade: **2**  
 Clock Start/From: **5**  
 Clock To: **7**  
 1st Value:  
 2nd Value:  
 Value Percent: **5.000**  
 Continuous Index: **S01**  
 Within 8" of Joint: **YES**  
 Remarks:

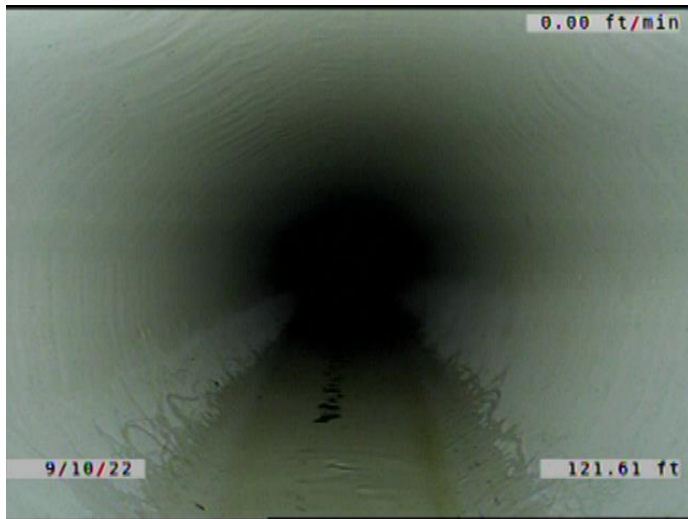
Code: **MWLS**  
Description: **Miscellaneous Water Level Sag**

Distance (ft): **121.6**  
Structural Grade: **2**  
O&M Grade: **0**  
Clock Start/From:  
Clock To:  
1st Value:  
2nd Value:  
Value Percent: **10.000**  
Continuous Index: **S02**  
Within 8" of Joint: **NO**  
Remarks:

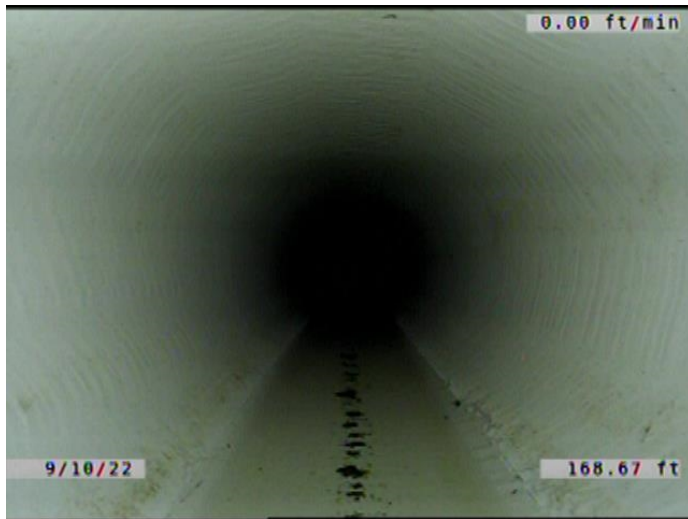
Code: **MWLS**  
Description: **Miscellaneous Water Level Sag**

Distance (ft): **168.7**  
Structural Grade: **2**  
O&M Grade: **0**  
Clock Start/From:  
Clock To:  
1st Value:  
2nd Value:  
Value Percent: **10.000**  
Continuous Index: **S03**  
Within 8" of Joint: **NO**  
Remarks:

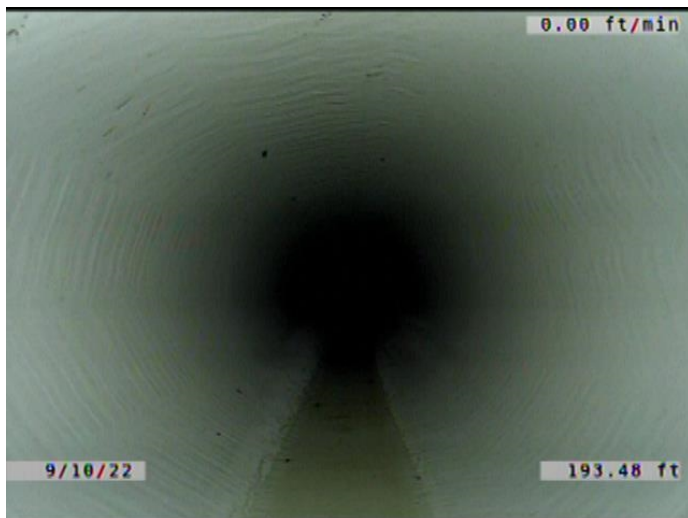
Code: **MWLS**  
Description: **Miscellaneous Water Level Sag**

Distance (ft): **193.5**  
Structural Grade: **2**  
O&M Grade: **0**  
Clock Start/From:  
Clock To:  
1st Value:  
2nd Value:  
Value Percent: **10.000**  
Continuous Index: **F03**  
Within 8" of Joint: **NO**  
Remarks:

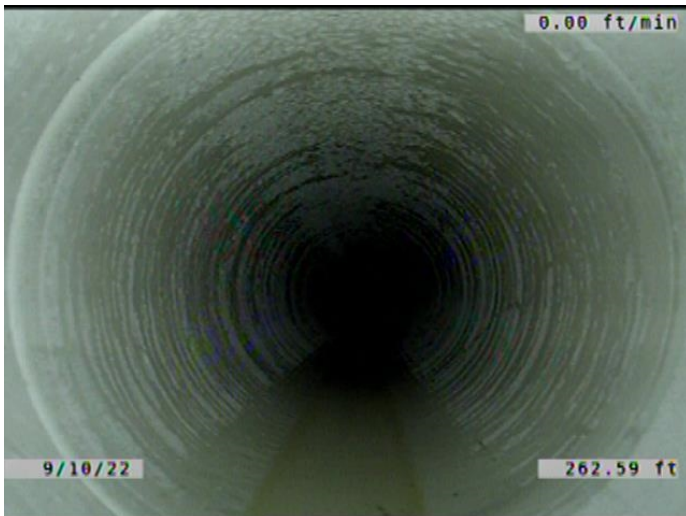
Code:	<b>MWLS</b>
Description:	<b>Miscellaneous Water Level Sag</b>
Distance (ft):	<b>262.6</b>
Structural Grade:	<b>2</b>
O&M Grade:	<b>0</b>
Clock Start/From:	
Clock To:	
1st Value:	
2nd Value:	
Value Percent:	<b>10.000</b>
Continuous Index:	<b>F04</b>
Within 8" of Joint:	<b>NO</b>
Remarks:

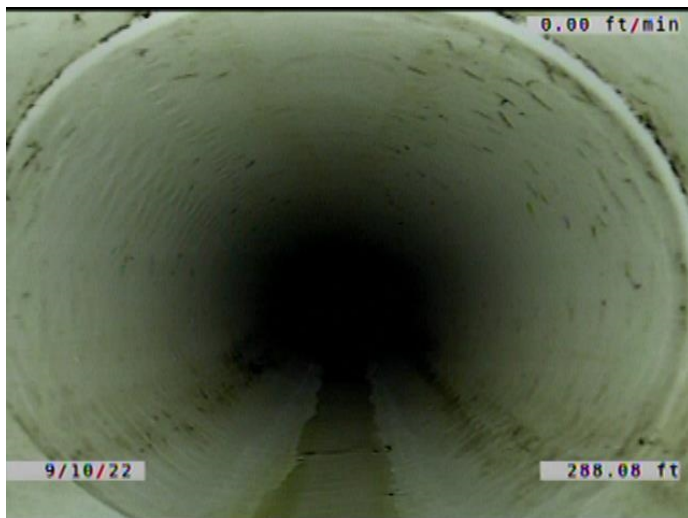
Code: **MWLS**  
Description: **Miscellaneous Water Level Sag**

Distance (ft): **288.1**  
Structural Grade: **2**  
O&M Grade: **0**  
Clock Start/From:  
Clock To:  
1st Value:  
2nd Value:  
Value Percent: **10.000**  
Continuous Index: **F05**  
Within 8" of Joint: **NO**  
Remarks:

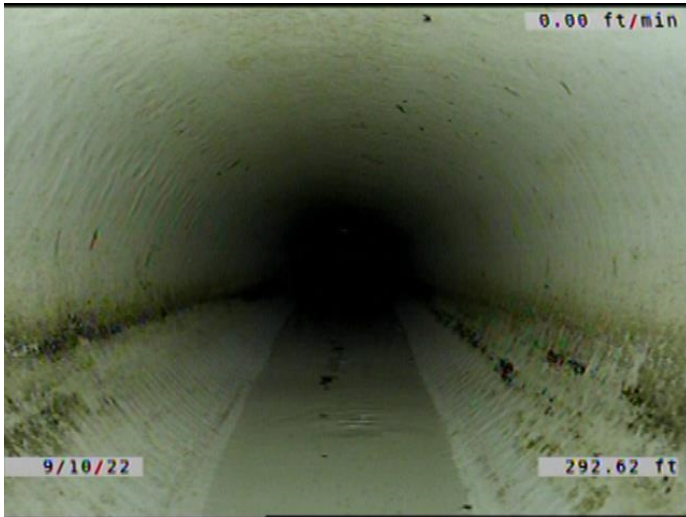
Code: **MWLS**  
Description: **Miscellaneous Water Level Sag**

Distance (ft): **292.6**  
Structural Grade: **2**  
O&M Grade: **0**  
Clock Start/From:  
Clock To:  
1st Value:  
2nd Value:  
Value Percent: **25.000**  
Continuous Index: **S06**  
Within 8" of Joint: **NO**  
Remarks:

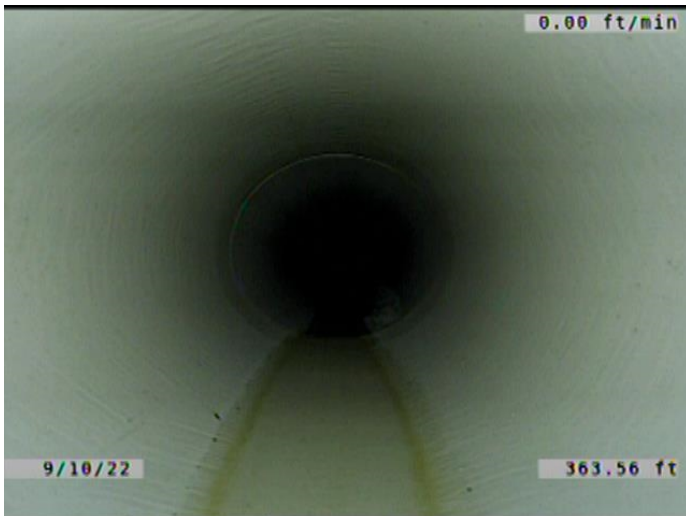
Code: **MWLS**  
Description: **Miscellaneous Water Level Sag**

Distance (ft): **363.6**  
Structural Grade: **2**  
O&M Grade: **0**  
Clock Start/From:  
Clock To:  
1st Value:  
2nd Value:  
Value Percent: **25.000**  
Continuous Index: **F06**  
Within 8" of Joint: **NO**  
Remarks:

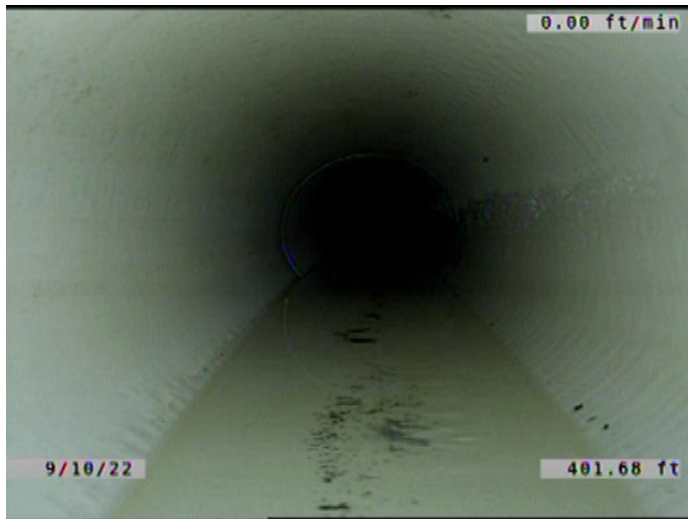
Code: **MWLS**  
Description: **Miscellaneous Water Level Sag**

Distance (ft): **401.7**  
Structural Grade: **2**  
O&M Grade: **0**  
Clock Start/From:  
Clock To:  
1st Value:  
2nd Value:  
Value Percent: **15.000**  
Continuous Index: **S07**  
Within 8" of Joint: **NO**  
Remarks:

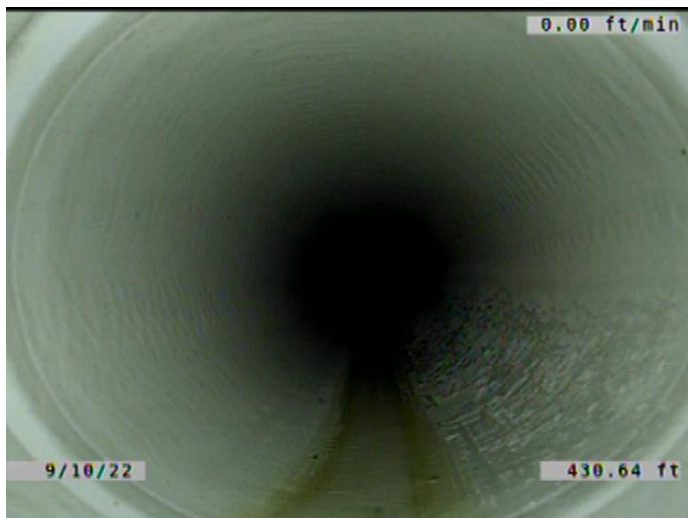
Code: **MWLS**  
Description: **Miscellaneous Water Level Sag**

Distance (ft): **430.6**  
Structural Grade: **2**  
O&M Grade: **0**  
Clock Start/From:  
Clock To:  
1st Value:  
2nd Value:  
Value Percent: **15.000**  
Continuous Index: **F07**  
Within 8" of Joint: **NO**  
Remarks:

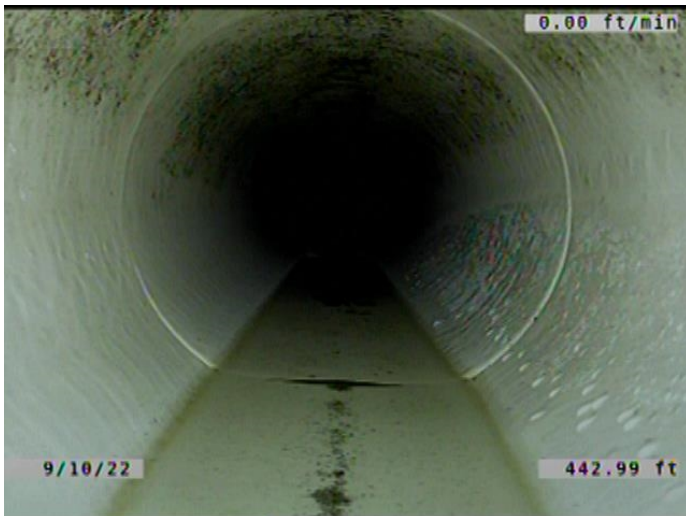
Code: **MWLS**  
Description: **Miscellaneous Water Level Sag**

Distance (ft): **443.0**  
Structural Grade: **2**  
O&M Grade: **0**  
Clock Start/From:  
Clock To:  
1st Value:  
2nd Value:  
Value Percent: **5.000**  
Continuous Index: **S08**  
Within 8" of Joint: **NO**  
Remarks:

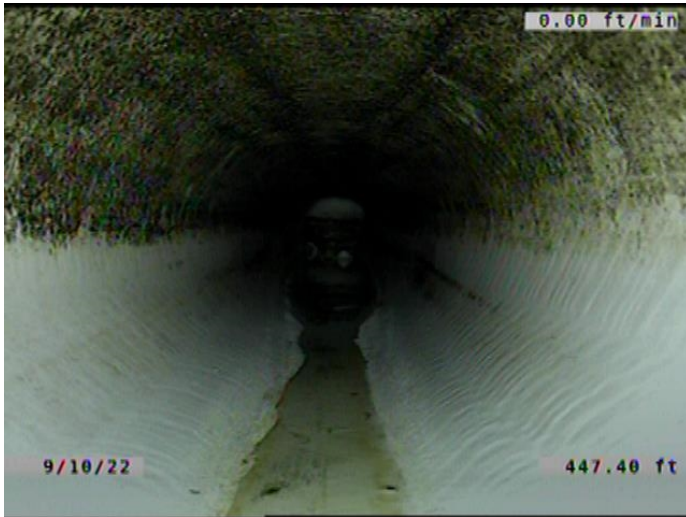
Code: **MWLS**  
Description: **Miscellaneous Water Level Sag**

Distance (ft): **447.4**  
Structural Grade: **2**  
O&M Grade: **0**  
Clock Start/From:  
Clock To:  
1st Value:  
2nd Value:  
Value Percent: **5.000**  
Continuous Index: **F08**  
Within 8" of Joint: **NO**  
Remarks:

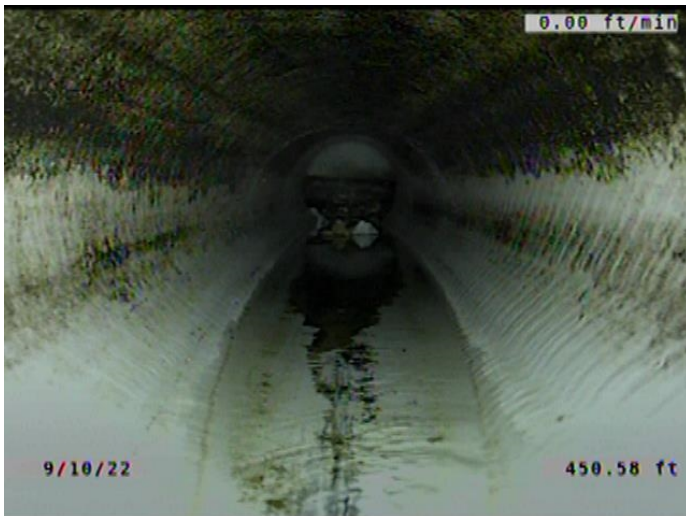
Code: **MWLS**  
Description: **Miscellaneous Water Level Sag**

Distance (ft): **450.6**  
Structural Grade: **2**  
O&M Grade: **0**  
Clock Start/From:  
Clock To:  
1st Value:  
2nd Value:  
Value Percent: **10.000**  
Continuous Index: **S09**  
Within 8" of Joint: **NO**  
Remarks:

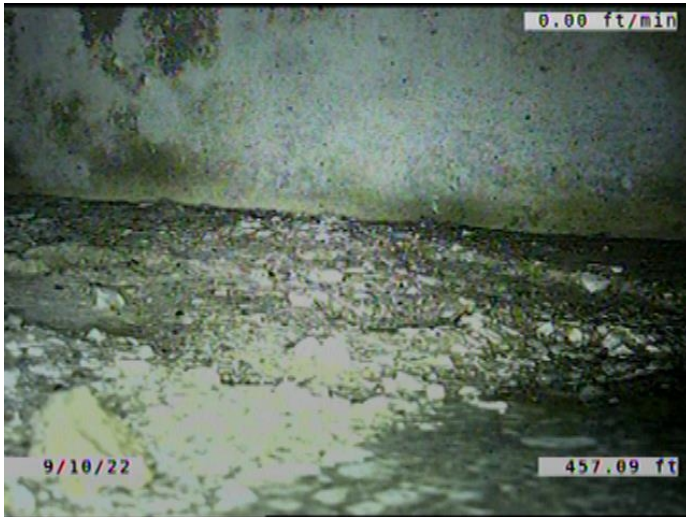
Code: **MWLS**  
 Description: **Miscellaneous Water Level Sag**

Distance (ft): **457.1**  
 Structural Grade: **2**  
 O&M Grade: **0**  
 Clock Start/From:  
 Clock To:  
 1st Value:  
 2nd Value:  
 Value Percent: **10.000**  
 Continuous Index: **F09**  
 Within 8" of Joint: **NO**  
 Remarks:

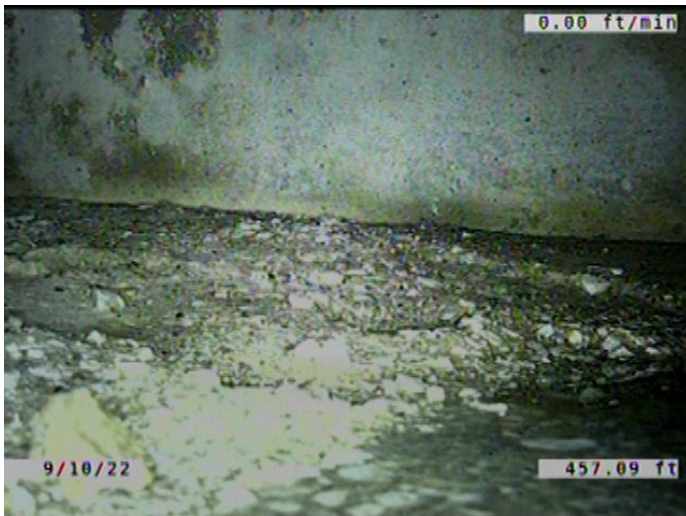
Code: **DSF**  
 Description: **Deposits Settled Fine**

Distance (ft): **457.1**  
 Structural Grade: **0**  
 O&M Grade: **2**  
 Clock Start/From: **5**  
 Clock To: **7**  
 1st Value:  
 2nd Value:  
 Value Percent: **5.000**  
 Continuous Index: **F01**  
 Within 8" of Joint: **YES**  
 Remarks:
