Profile/Photo Observation Report

Date:	04/17/2018	Weather:		Coding:	PACP 6.0
Pipe Length (ft):	146.6	Owner:	NA	Pre Clean:	Not Known
P.O.#:		Surveyor:	Jen Costello	PSR:	P-806-011-012
Customer:		Clean Date:	01/01/1900	Shape:	C

Street:	MEMORY LN & E 8TH ST	Flow Control:	Not Controlled
City:	Hobart, IN	Year Renewed:	
Location:	Ditch	Tape/Media #:	
Purpose:	Maintenance Related	Dia/Height:	10"
Use:	Sanitary	Material:	VCP
Drain Area:	NA	Lining:	Cured in Place
Category:	NA		
Comment:	heavy debris and sludge at 5'.		
Location Details:		Direction of Survey:	Downstream
US MH:	M-806-012	DS MH:	M-806-011
		Total Length Surveyed (ft):	6.2

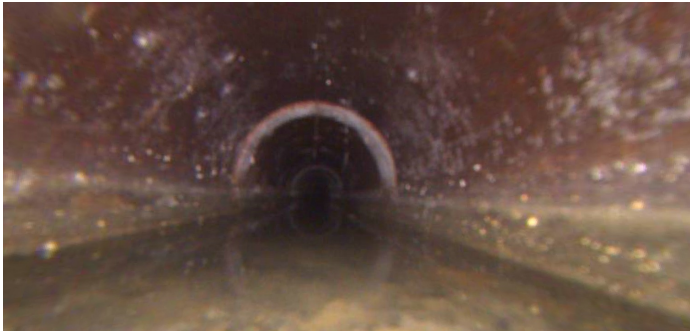
Code: AMH

Description: Manhole

Distance (ft): .0

Remarks: M-806-012

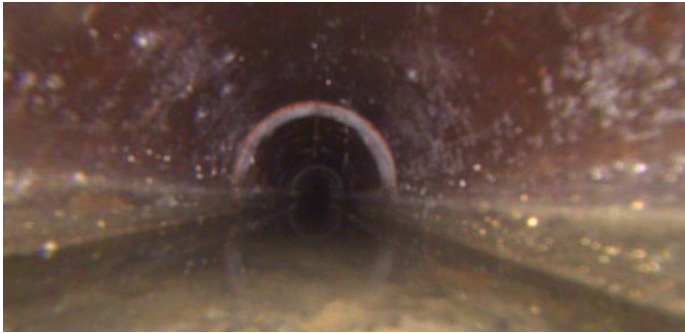
Code:	MWL
Description:	Water Level

Distance (ft):	.0
Structural Grade:	0
O&M Grade:	0
Clock Start/From:	
Clock To:	
1st Value:	
2nd Value:	
Value Percent:	30.000
Continuous Index:	
Within 8" of Joint:	NO
Remarks:

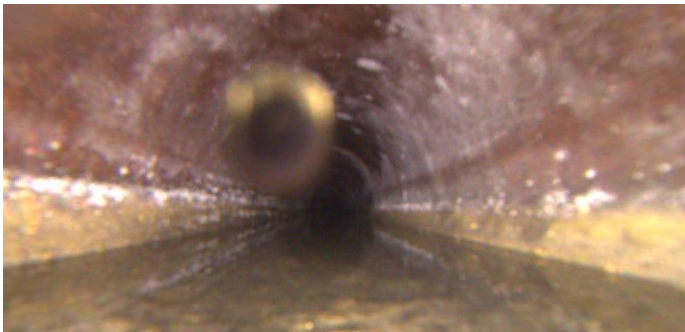
Code:	MSA
Description:	Abandoned Survey

Distance (ft):	6.2
Structural Grade:	0
O&M Grade:	0
Clock Start/From:	
Clock To:	
1st Value:	
2nd Value:	
Value Percent:	
Continuous Index:	
Within 8" of Joint:	NO
Remarks:	debris under water
