Profile/Photo Observation Report

Date:	02/27/2022	Weather:		Coding:	PACP 7.0
Pipe Length (ft):		Owner:	City of Hobart	Pre Clean:	Heavy Cleaning
P.O.#:	YES502259	Surveyor:	S. Bucklin	PSR:	P-806-025-024
Customer:	City of Hobart, IN (Red	Clean Date:	02/22/2022	Shape:	C

Street:	South Main Street	Flow Control:	Not Controlled
City:	Hobart, IN	Year Renewed:	
Location:	Local rural streets with light traffic, t	Tape/Media #:	
Purpose:	Routine Assessment	Dia/Height:	8"
Use:	Sanitary Sewage Pipe	Material:	VCP
Drain Area:		Lining:	None
Category:	NA		
Comment:			
Location Details:		Direction of Survey:	Upstream
US MH:	M-806-024	DS MH:	M-806-025
		Total Length Surveyed (ft):	168.1

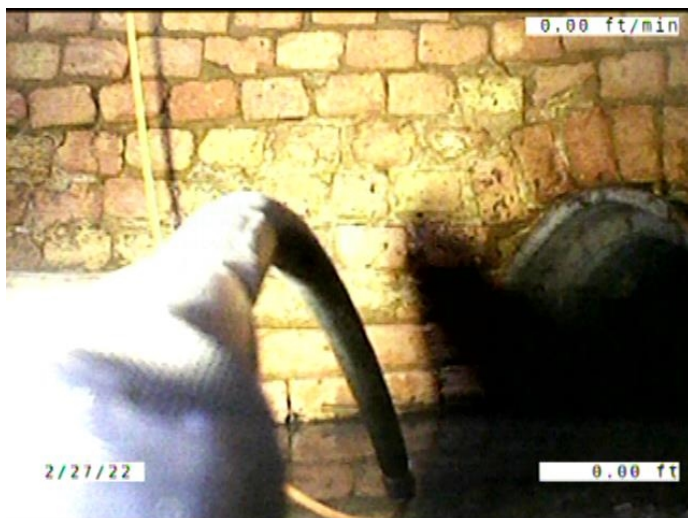
Code: **AMH**
 Description: **Manhole**

Distance (ft): **.0**
 Structural Grade: **0**
 O&M Grade: **0**
 Clock Start/From:
 Clock To:
 1st Value:
 2nd Value:
 Value Percent:
 Continuous Index:
 Within 8" of Joint: **NO**
 Remarks: **M-806-025**

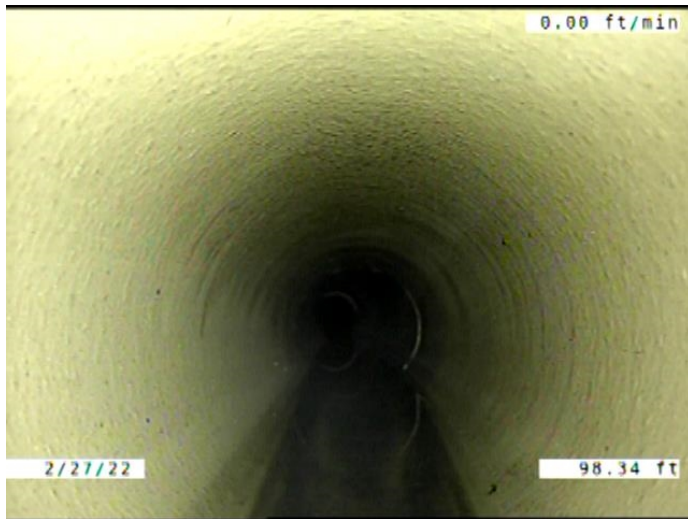
Code: **MWLS**
Description: **Miscellaneous Water Level Sag**

Distance (ft): **98.3**
Structural Grade: **2**
O&M Grade: **0**
Clock Start/From:
Clock To:
1st Value:
2nd Value:
Value Percent: **5.000**
Continuous Index: **S02**
Within 8" of Joint: **NO**
Remarks:

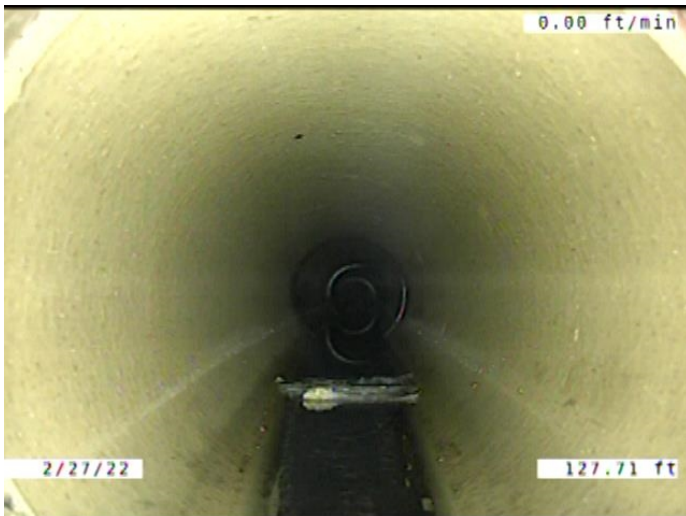
Code: **MWLS**
Description: **Miscellaneous Water Level Sag**

Distance (ft): **127.7**
Structural Grade: **2**
O&M Grade: **0**
Clock Start/From:
Clock To:
1st Value:
2nd Value:
Value Percent: **15.000**
Continuous Index: **S03**
Within 8" of Joint: **NO**
Remarks:
