Profile/Photo Observation Report

Street:	E 8TH ST	Flow Control:	Not Controlled
City:	Hobart, IN	Year Renewed:	
Location:	Light Highway	Tape/Media #:	
Purpose:	Maintenance Related	Dia/Height:	8"
Use:	Sanitary	Material:	PVC
Drain Area:	NA	Lining:	Cured in Place
Category:	NA		
Comment:	flow incorrect

Location Details:		Direction of Survey:	Downstream
US MH:	M-806-027	DS MH:	M-806-028
		Total Length Surveyed (ft):	203.8

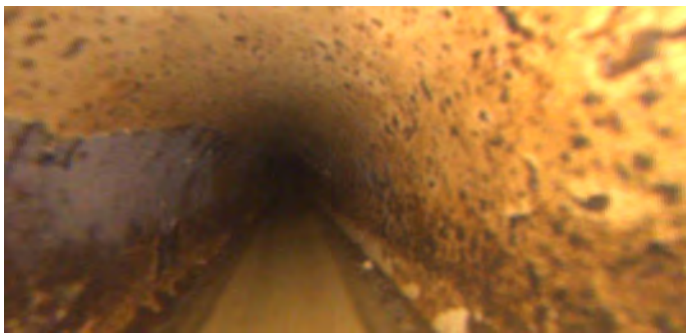
Code: **AMH**
Description: **Manhole**

Distance (ft): **.0**
Structural Grade: **0**
O&M Grade: **0**
Clock Start/From:
Clock To:
1st Value:
2nd Value:
Value Percent:
Continuous Index:
Within 8" of Joint: **NO**
Remarks: **M-806-027**

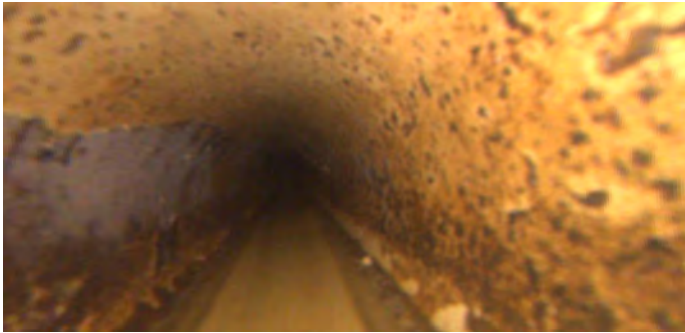
Code:	MWL
Description:	Water Level

Distance (ft):	.0
Structural Grade:	0
O&M Grade:	0
Clock Start/From:	
Clock To:	
1st Value:	
2nd Value:	
Value Percent:	5.000
Continuous Index:	
Within 8" of Joint:	NO
Remarks:

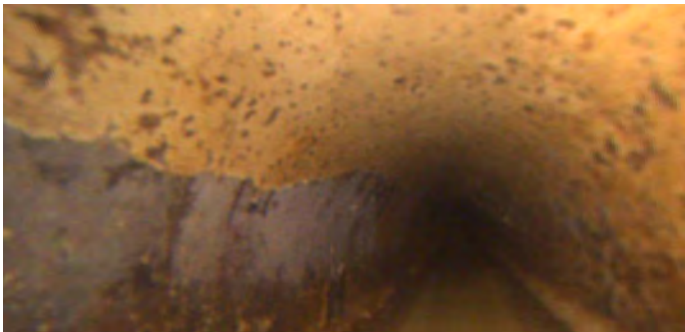
Code:	CL
Description:	Crack Longitudinal

Distance (ft):	.0
Structural Grade:	2
O&M Grade:	0
Clock Start/From:	10
Clock To:	
1st Value:	
2nd Value:	
Value Percent:	
Continuous Index:	
Within 8" of Joint:	
Remarks:

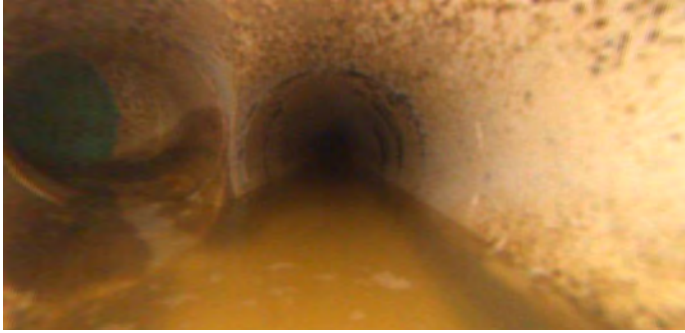
Code: **TF**
Description: **Tap Factory**

Distance (ft): **41.3**
Structural Grade: **0**
O&M Grade: **0**
Clock Start/From: **9**
Clock To:
1st Value: **4.000**
2nd Value:
Value Percent:
Continuous Index:
Within 8" of Joint: **YES**
Remarks:

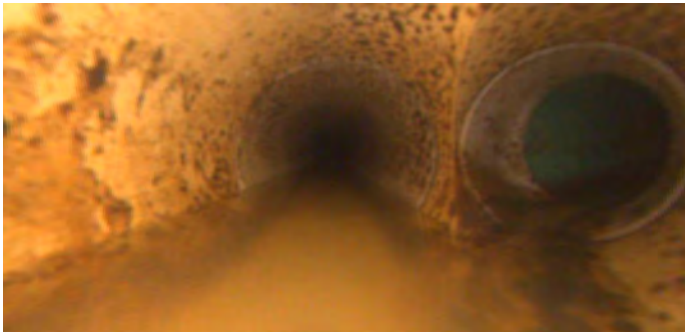
Code: **TF**
Description: **Tap Factory**

Distance (ft): **80.8**
Structural Grade: **0**
O&M Grade: **0**
Clock Start/From: **3**
Clock To:
1st Value: **4.000**
2nd Value:
Value Percent:
Continuous Index:
Within 8" of Joint: **YES**
Remarks:

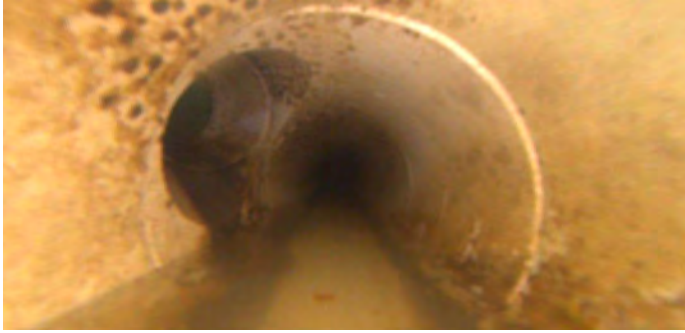
Code: **TF**
Description: **Tap Factory**

Distance (ft): **95.7**
Structural Grade: **0**
O&M Grade: **0**
Clock Start/From: **10**
Clock To:
1st Value: **4.000**
2nd Value:
Value Percent:
Continuous Index:
Within 8" of Joint: **YES**
Remarks:

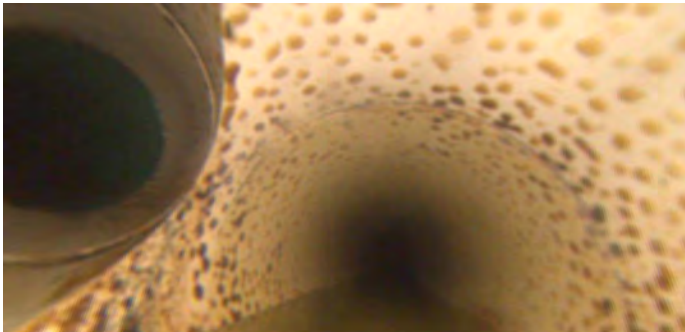
Code: **TF**
Description: **Tap Factory**

Distance (ft): **187.1**
Structural Grade: **0**
O&M Grade: **0**
Clock Start/From: **10**
Clock To:
1st Value: **4.000**
2nd Value:
Value Percent:
Continuous Index:
Within 8" of Joint: **YES**
Remarks:

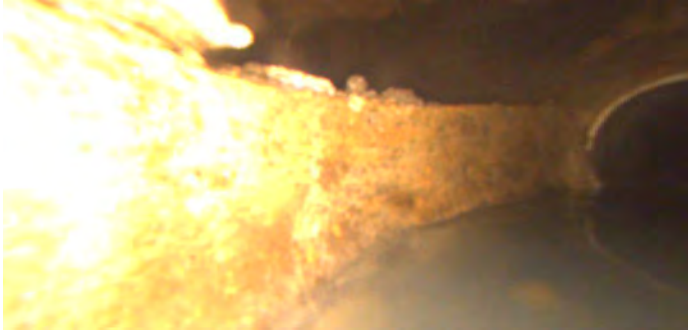
Code:	AMH
Description:	Manhole
Distance (ft):	203.8
Structural Grade:	0
O&M Grade:	0
Clock Start/From:	
Clock To:	
1st Value:	
2nd Value:	
Value Percent:	
Continuous Index:	
Within 8" of Joint:	NO
Remarks:	M-806-028
