## Profile/Photo Observation Report

Street:	<b>E 8TH ST &amp; 9TH CT</b>	Flow Control:	<b>Not Controlled</b>
City:	<b>Hobart, IN</b>	Year Renewed:	
Location:	<b>Sidewalk</b>	Tape/Media #:	
Purpose:	<b>Maintenance Related</b>	Dia/Height:	<b>8"</b>
Use:	<b>Sanitary</b>	Material:	<b>PVC</b>
Drain Area:	<b>NA</b>	Lining:	<b>Cured in Place</b>
Category:	<b>NA</b>		
Comment:

Location Details:		Direction of Survey:	<b>Downstream</b>
US MH:	<b>M-806-029</b>	DS MH:	<b>M-806-028</b>
		Total Length Surveyed (ft):	<b>382.2</b>

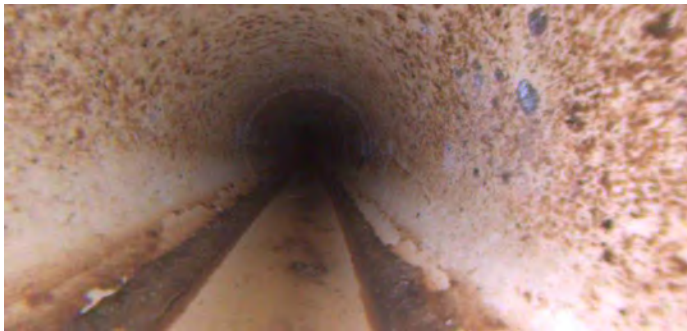
Code: AMH

Description: Manhole

Distance (ft): .0

Remarks: M-806-029

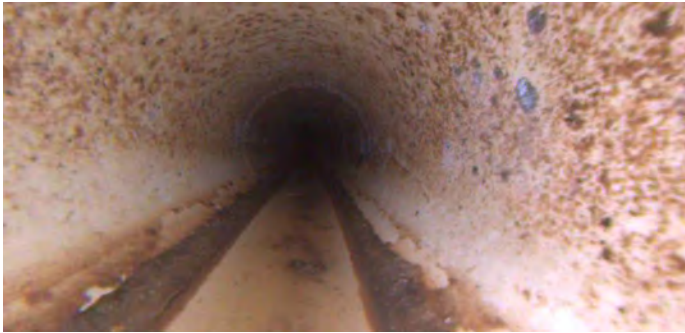
Code:	<b>MWL</b>
Description:	<b>Water Level</b>

Distance (ft):	<b>.0</b>
Structural Grade:	<b>0</b>
O&M Grade:	<b>0</b>
Clock Start/From:	
Clock To:	
1st Value:	
2nd Value:	
Value Percent:	<b>5.000</b>
Continuous Index:	
Within 8" of Joint:	<b>NO</b>
Remarks:

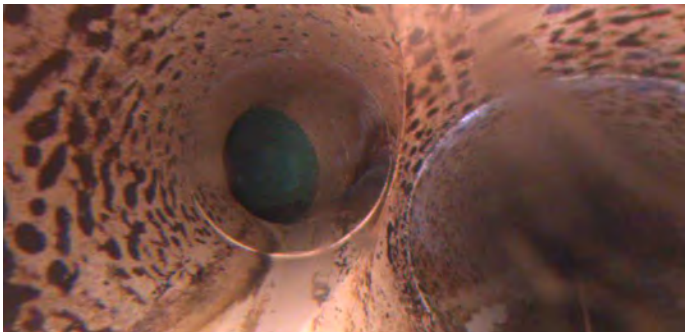
Code:	<b>TF</b>
Description:	<b>Tap Factory</b>

Distance (ft):	<b>53.9</b>
Structural Grade:	<b>0</b>
O&M Grade:	<b>0</b>
Clock Start/From:	<b>3</b>
Clock To:	
1st Value:	<b>4.000</b>
2nd Value:	
Value Percent:	
Continuous Index:	
Within 8" of Joint:	
Remarks:

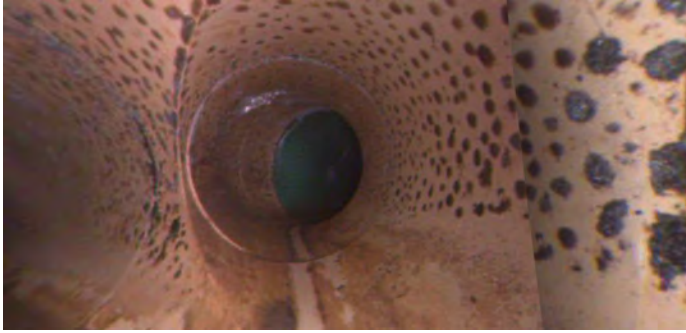
Code: **TF**  
Description: **Tap Factory**

Distance (ft): **92.5**  
Structural Grade: **0**  
O&M Grade: **0**  
Clock Start/From: **9**  
Clock To:  
1st Value: **4.000**  
2nd Value:  
Value Percent:  
Continuous Index:  
Within 8" of Joint: **NO**  
Remarks:

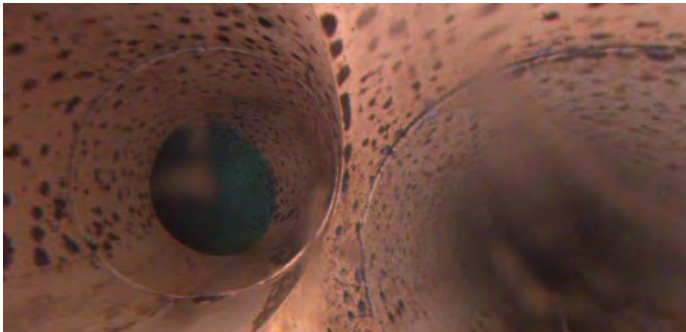
Code: **TF**  
Description: **Tap Factory**

Distance (ft): **131.3**  
Structural Grade: **0**  
O&M Grade: **0**  
Clock Start/From: **3**  
Clock To:  
1st Value: **4.000**  
2nd Value:  
Value Percent:  
Continuous Index:  
Within 8" of Joint:  
Remarks:

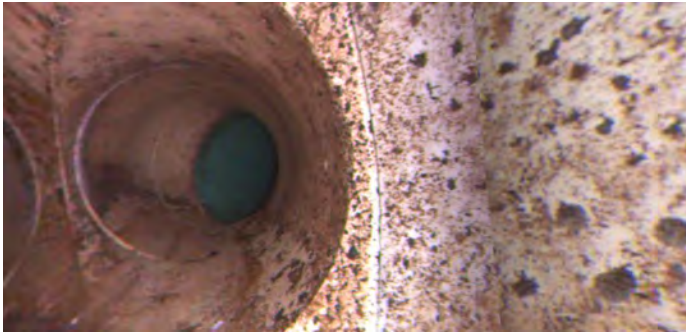
Code: **TF**  
Description: **Tap Factory**

Distance (ft): **221.8**  
Structural Grade: **0**  
O&M Grade: **0**  
Clock Start/From: **9**  
Clock To:  
1st Value: **4.000**  
2nd Value:  
Value Percent:  
Continuous Index:  
Within 8" of Joint:  
Remarks:

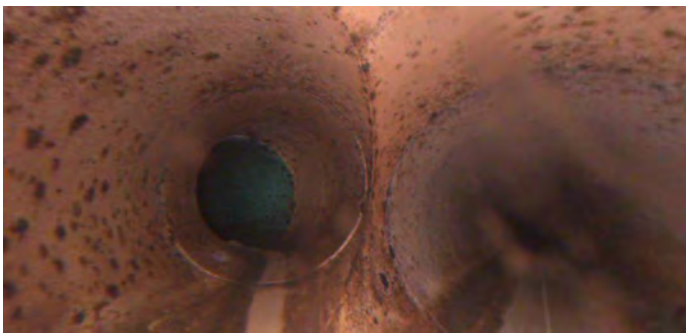
Code: **TFA**  
Description: **Tap Factory Active**

Distance (ft): **226.9**  
Structural Grade: **0**  
O&M Grade: **0**  
Clock Start/From: **3**  
Clock To:  
1st Value: **4.000**  
2nd Value:  
Value Percent:  
Continuous Index:  
Within 8" of Joint:  
Remarks:

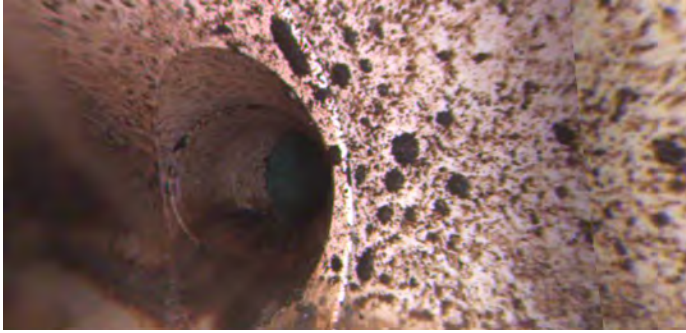
Code: **TF**  
Description: **Tap Factory**

Distance (ft): **299.6**  
Structural Grade: **0**  
O&M Grade: **0**  
Clock Start/From: **9**  
Clock To:  
1st Value: **4.000**  
2nd Value:  
Value Percent:  
Continuous Index:  
Within 8" of Joint:  
Remarks:

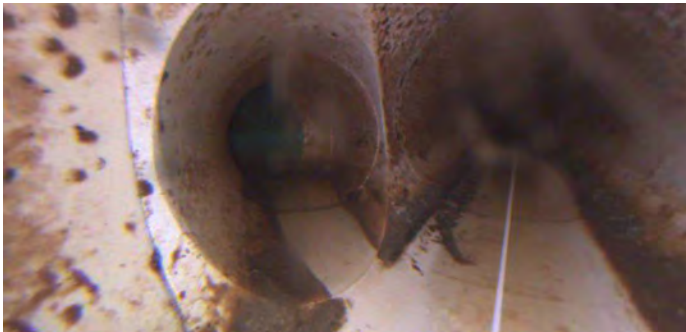
Code: **TFA**  
Description: **Tap Factory Active**

Distance (ft): **319.9**  
Structural Grade: **0**  
O&M Grade: **0**  
Clock Start/From: **3**  
Clock To:  
1st Value: **4.000**  
2nd Value:  
Value Percent:  
Continuous Index:  
Within 8" of Joint:  
Remarks:

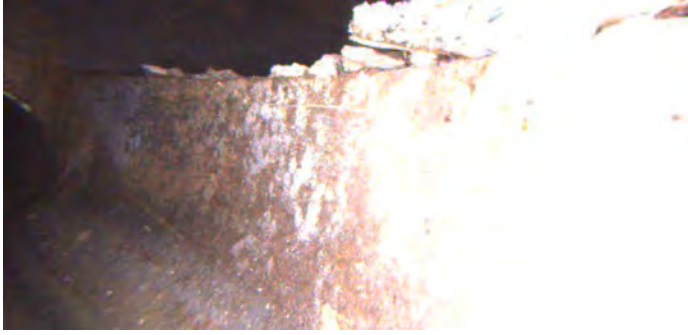
Code:	AMH
Description:	Manhole
Distance (ft):	382.2
Structural Grade:	0
O&M Grade:	0
Clock Start/From:	
Clock To:	
1st Value:	
2nd Value:	
Value Percent:	
Continuous Index:	
Within 8" of Joint:	NO
Remarks:	M-806-028
