Profile/Photo Observation Report

Date:	04/12/2018	Weather:		Coding:	PACP 6.0
Pipe Length (ft):	390.5	Owner:	NA	Pre Clean:	Not Known
P.O.#:		Surveyor:	Jen Costello	PSR:	P-806-028-029
Customer:		Clean Date:	01/01/1900	Shape:	C

Street:	Capitol	Flow Control:	Not Controlled
City:	Hobart, IN	Year Renewed:	
Location:	Sidewalk	Tape/Media #:	
Purpose:	Maintenance Related	Dia/Height:	8"
Use:	Sanitary	Material:	PVC
Drain Area:	NA	Lining:	Cured in Place
Category:	NA		
Comment:

Location Details:		Direction of Survey:	Downstream
US MH:	M-806-029	DS MH:	M-806-028
		Total Length Surveyed (ft):	382.2

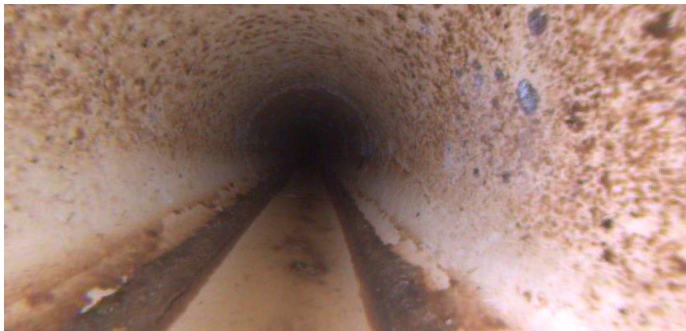
Code: **AMH**
Description: **Manhole**

Distance (ft): **.0**
Structural Grade: **0**
O&M Grade: **0**
Clock Start/From:
Clock To:
1st Value:
2nd Value:
Value Percent:
Continuous Index:
Within 8" of Joint: **NO**
Remarks: **M-806-029**

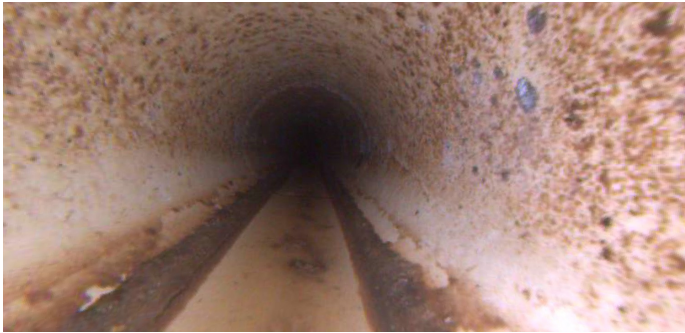
Code:	MWL
Description:	Water Level

Distance (ft):	.0
Structural Grade:	0
O&M Grade:	0
Clock Start/From:	
Clock To:	
1st Value:	
2nd Value:	
Value Percent:	5.000
Continuous Index:	
Within 8" of Joint:	NO
Remarks:

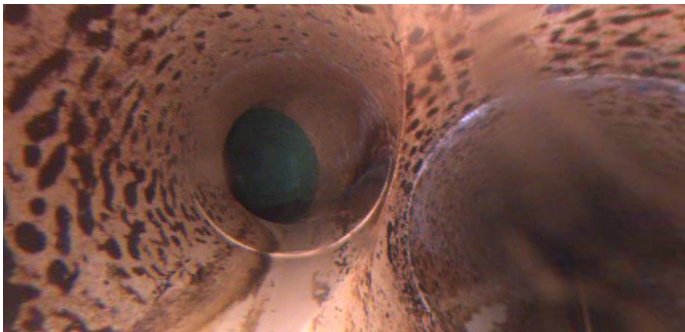
Code:	TF
Description:	Tap Factory

Distance (ft):	53.9
Structural Grade:	0
O&M Grade:	0
Clock Start/From:	3
Clock To:	
1st Value:	4.000
2nd Value:	
Value Percent:	
Continuous Index:	
Within 8" of Joint:	
Remarks:

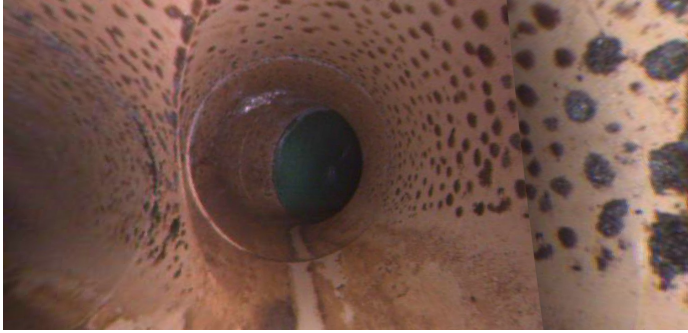
Code: **TF**
Description: **Tap Factory**

Distance (ft): **92.5**
Structural Grade: **0**
O&M Grade: **0**
Clock Start/From: **9**
Clock To:
1st Value: **4.000**
2nd Value:
Value Percent:
Continuous Index:
Within 8" of Joint: **NO**
Remarks:

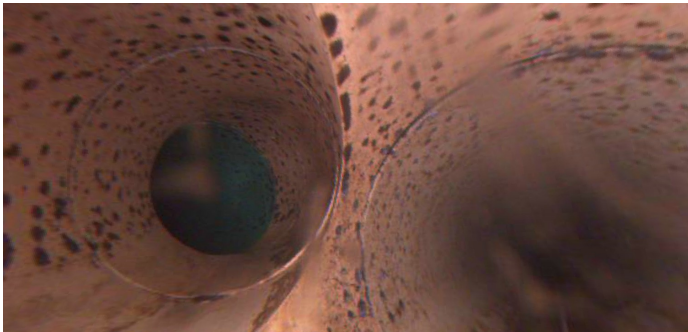
Code: **TF**
Description: **Tap Factory**

Distance (ft): **131.3**
Structural Grade: **0**
O&M Grade: **0**
Clock Start/From: **3**
Clock To:
1st Value: **4.000**
2nd Value:
Value Percent:
Continuous Index:
Within 8" of Joint:
Remarks:

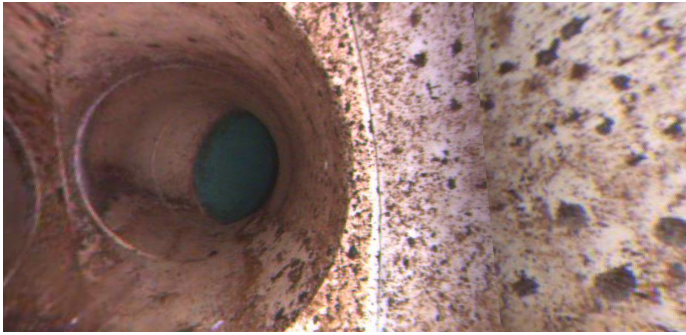
Code: **TF**
Description: **Tap Factory**

Distance (ft): **221.8**
Structural Grade: **0**
O&M Grade: **0**
Clock Start/From: **9**
Clock To:
1st Value: **4.000**
2nd Value:
Value Percent:
Continuous Index:
Within 8" of Joint:
Remarks:

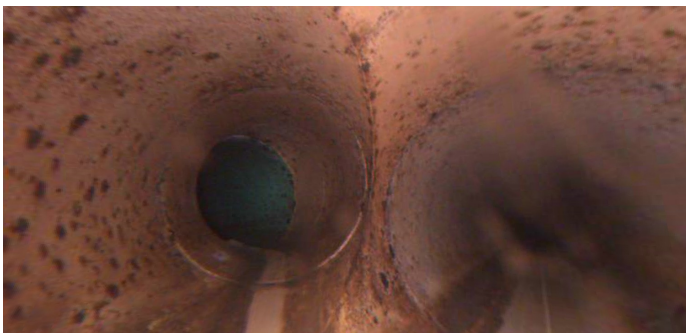
Code: **TFA**
Description: **Tap Factory Active**

Distance (ft): **226.9**
Structural Grade: **0**
O&M Grade: **0**
Clock Start/From: **3**
Clock To:
1st Value: **4.000**
2nd Value:
Value Percent:
Continuous Index:
Within 8" of Joint:
Remarks:

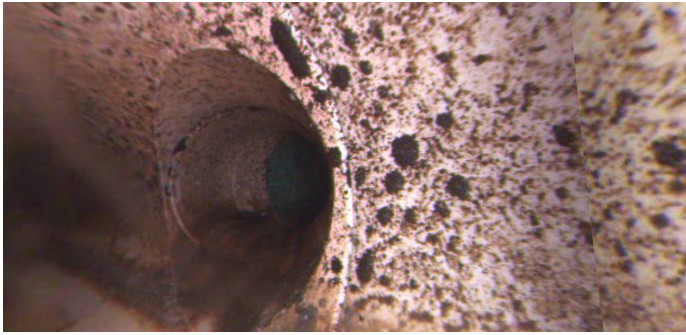
Code: **TF**
Description: **Tap Factory**

Distance (ft): **299.6**
Structural Grade: **0**
O&M Grade: **0**
Clock Start/From: **9**
Clock To:
1st Value: **4.000**
2nd Value:
Value Percent:
Continuous Index:
Within 8" of Joint:
Remarks:

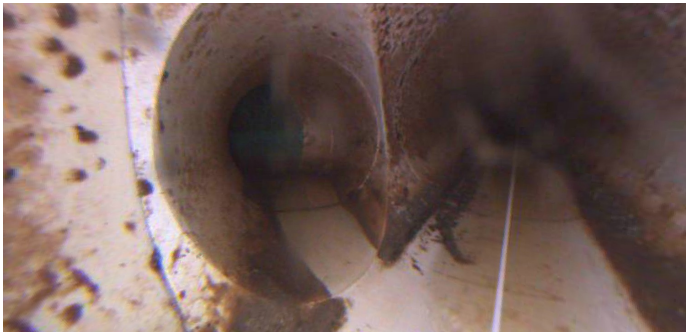
Code: **TFA**
Description: **Tap Factory Active**

Distance (ft): **319.9**
Structural Grade: **0**
O&M Grade: **0**
Clock Start/From: **3**
Clock To:
1st Value: **4.000**
2nd Value:
Value Percent:
Continuous Index:
Within 8" of Joint:
Remarks:

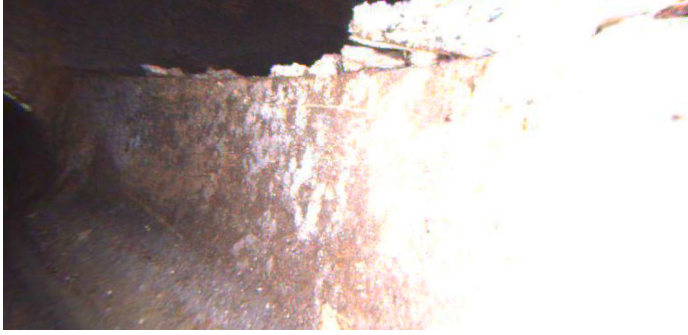
Code:	AMH
Description:	Manhole
Distance (ft):	382.2
Structural Grade:	0
O&M Grade:	0
Clock Start/From:	
Clock To:	
1st Value:	
2nd Value:	
Value Percent:	
Continuous Index:	
Within 8" of Joint:	NO
Remarks:	M-806-028
