Profile/Photo Observation Report

Street:	STARBOARD CT	Flow Control:	Not Controlled
City:	Hobart, IN	Year Renewed:	
Location:	Sidewalk	Tape/Media #:	
Purpose:	Maintenance Related	Dia/Height:	8"
Use:	Sanitary	Material:	PVC
Drain Area:	NA	Lining:	Cured in Place
Category:	NA		
Comment:	flow incorrect.

Location Details:		Direction of Survey:	Upstream
US MH:	M-806-035	DS MH:	M-806-034
		Total Length Surveyed (ft):	254.0

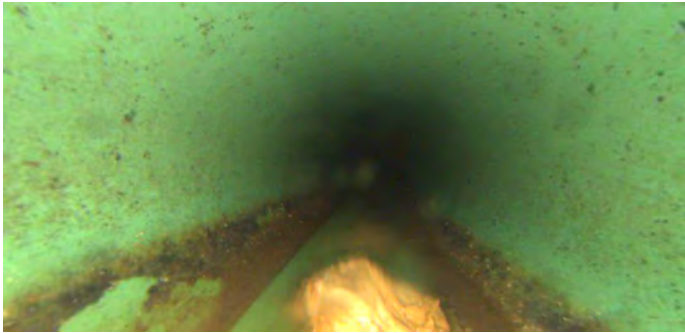
Code:	MWL
Description:	Water Level

Distance (ft):	.0
Structural Grade:	0
O&M Grade:	0
Clock Start/From:	
Clock To:	
1st Value:	
2nd Value:	
Value Percent:	5.000
Continuous Index:	
Within 8" of Joint:	NO
Remarks:

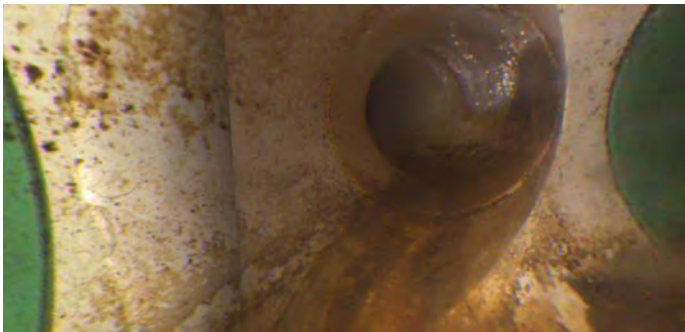
Code:	TFA
Description:	Tap Factory Active

Distance (ft):	29.1
Structural Grade:	0
O&M Grade:	0
Clock Start/From:	3
Clock To:	
1st Value:	4.000
2nd Value:	
Value Percent:	
Continuous Index:	
Within 8" of Joint:	
Remarks:

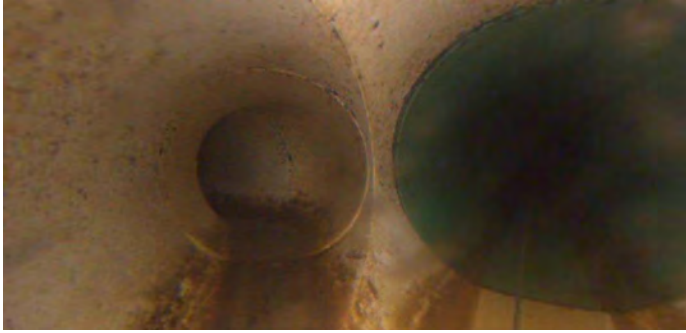
Code: **TFA**
Description: **Tap Factory Active**

Distance (ft): **105.2**
Structural Grade: **0**
O&M Grade: **0**
Clock Start/From: **3**
Clock To:
1st Value: **4.000**
2nd Value:
Value Percent:
Continuous Index:
Within 8" of Joint:
Remarks:

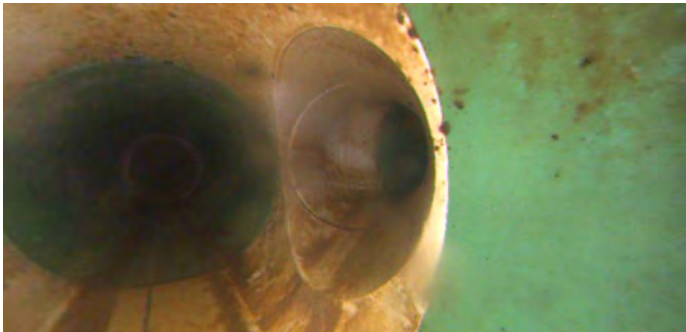
Code: **TF**
Description: **Tap Factory**

Distance (ft): **108.9**
Structural Grade: **0**
O&M Grade: **0**
Clock Start/From: **9**
Clock To:
1st Value: **4.000**
2nd Value:
Value Percent:
Continuous Index:
Within 8" of Joint:
Remarks:

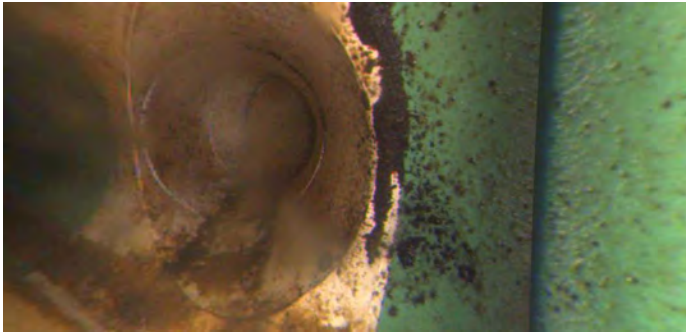
Code: **TF**
Description: **Tap Factory**

Distance (ft): **194.8**
Structural Grade: **0**
O&M Grade: **0**
Clock Start/From: **9**
Clock To:
1st Value: **4.000**
2nd Value:
Value Percent:
Continuous Index:
Within 8" of Joint:
Remarks:

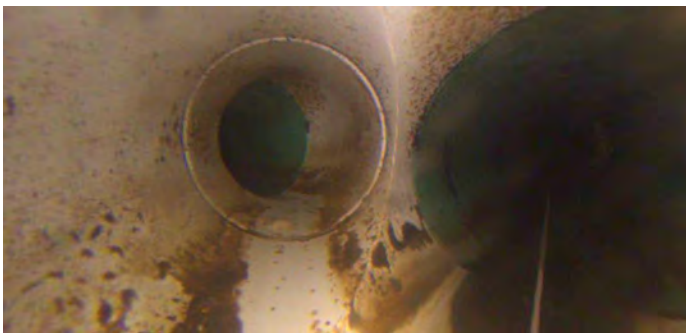
Code: **TF**
Description: **Tap Factory**

Distance (ft): **198.1**
Structural Grade: **0**
O&M Grade: **0**
Clock Start/From: **3**
Clock To:
1st Value: **4.000**
2nd Value:
Value Percent:
Continuous Index:
Within 8" of Joint:
Remarks:

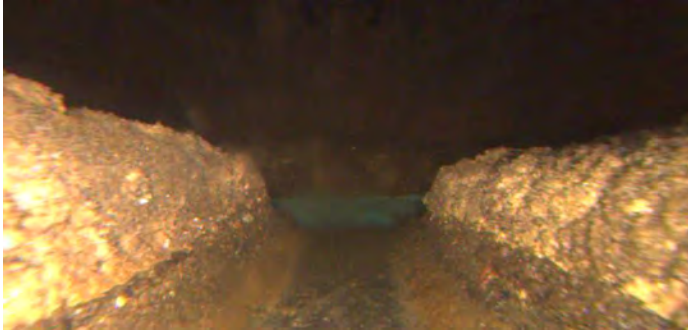
Code:	AMH
Description:	Manhole
Distance (ft):	253.9
Structural Grade:	0
O&M Grade:	0
Clock Start/From:	
Clock To:	
1st Value:	
2nd Value:	
Value Percent:	
Continuous Index:	
Within 8" of Joint:	NO
Remarks:	M-806-035
