## Profile/Photo Observation Report

Street:	<b>East 10th Street</b>	Flow Control:	<b>Not Controlled</b>
City:	<b>Hobart, IN</b>	Year Renewed:	
Location:	<b>Sidewalk</b>	Tape/Media #:	<b>DEP254</b>
Purpose:	<b>Routine Assessment</b>	Dia/Height:	<b>15"</b>
Use:	<b>Sanitary</b>	Material:	<b>PVC</b>
Drain Area:		Lining:	
Category:	<b>NA</b>		
Comment:	<b>YES501824 Submittal 2</b>		
Location Details:		Direction of Survey:	<b>Upstream</b>
US MH:	<b>M-806-035</b>	DS MH:	<b>M-806-064</b>
		Total Length Surveyed (ft):	<b>199.9</b>

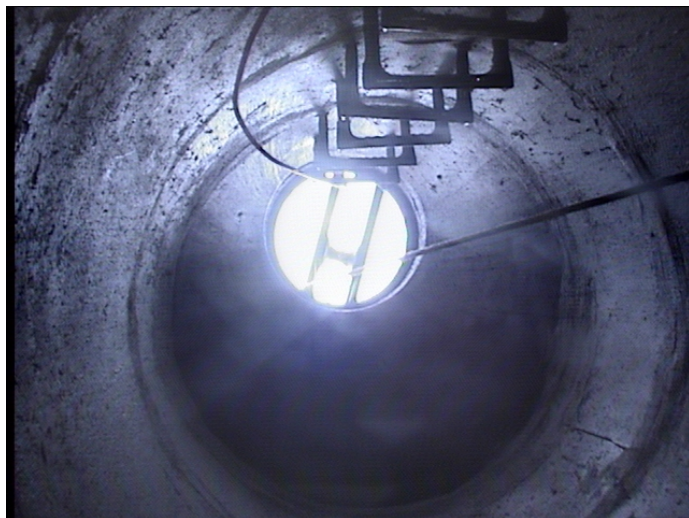
Code: **AMH**  
 Description: **Manhole**

Distance (ft): **.0**  
 Structural Grade: **0**  
 O&M Grade: **0**  
 Clock Start/From:  
 Clock To:  
 1st Value:  
 2nd Value:  
 Value Percent:  
 Continuous Index:  
 Within 8" of Joint: **NO**  
 Remarks: **M-806-064**

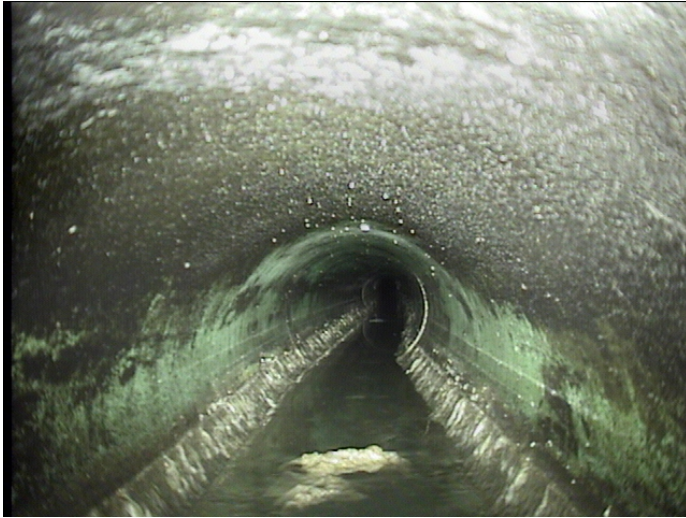
Code: **MWL**  
Description: **Water Level**

Distance (ft): **.0**  
Structural Grade: **0**  
O&M Grade: **0**  
Clock Start/From:  
Clock To:  
1st Value:  
2nd Value:  
Value Percent: **10.000**  
Continuous Index:  
Within 8" of Joint: **NO**  
Remarks:

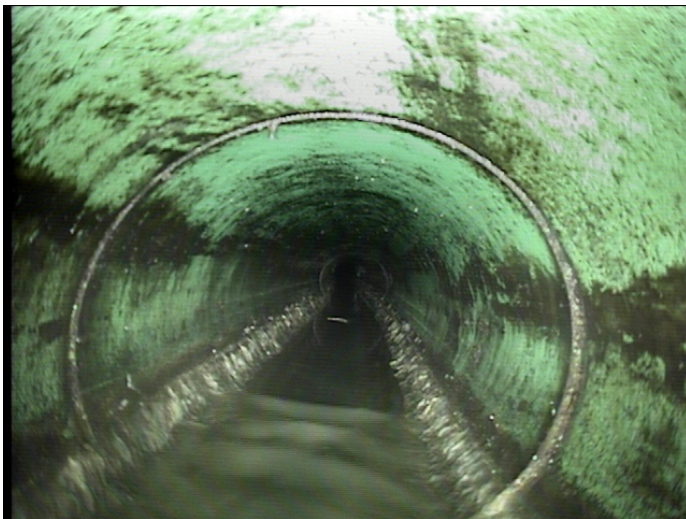
Code: **DSF**  
Description: **Deposits Settled Fine**

Distance (ft): **.0**  
Structural Grade: **0**  
O&M Grade: **2**  
Clock Start/From: **5**  
Clock To: **7**  
1st Value:  
2nd Value:  
Value Percent: **5.000**  
Continuous Index: **S01**  
Within 8" of Joint: **NO**  
Remarks:

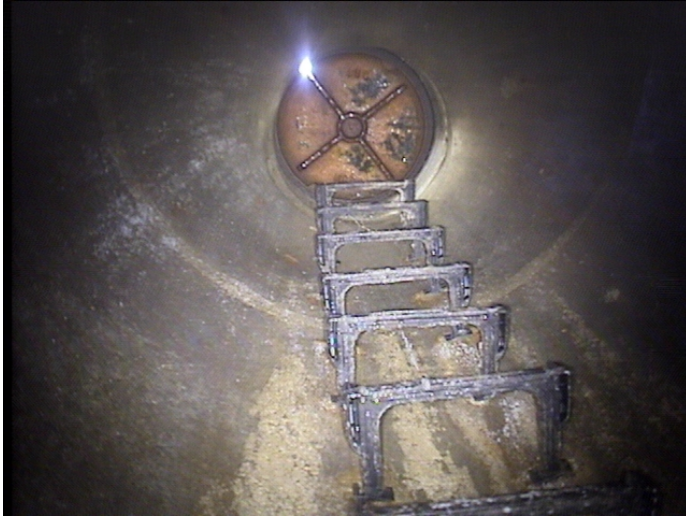
Code: **AMH**  
Description: **Manhole**

Distance (ft): **199.9**  
Structural Grade: **0**  
O&M Grade: **0**  
Clock Start/From:  
Clock To:  
1st Value:  
2nd Value:  
Value Percent:  
Continuous Index:  
Within 8" of Joint: **NO**  
Remarks: **M-806-035**

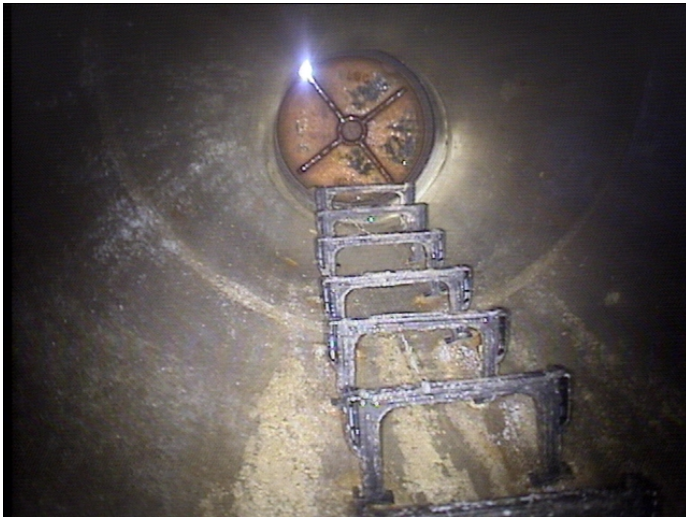
Code: **DSF**  
Description: **Deposits Settled Fine**

Distance (ft): **199.9**  
Structural Grade: **0**  
O&M Grade: **2**  
Clock Start/From: **5**  
Clock To: **7**  
1st Value:  
2nd Value:  
Value Percent: **5.000**  
Continuous Index: **F01**  
Within 8" of Joint: **NO**  
Remarks:
