Profile/Photo Observation Report

Date:	04/14/2018	Weather:		Coding:	PACP 6.0
Pipe Length (ft):		Owner:	City of Hobart	Pre Clean:	Not Known
P.O.#:	253	Surveyor:	B. Helbling	PSR:	P-806-036-028
Customer:	City of Hobart	Clean Date:		Shape:	C

Street:	East 10th Street	Flow Control:	Not Controlled
City:	Hobart, IN	Year Renewed:	
Location:	Sidewalk	Tape/Media #:	DEP253
Purpose:	Routine Assessment	Dia/Height:	15"
Use:	Sanitary	Material:	PVC
Drain Area:		Lining:	
Category:	NA		
Comment:	YES501824 Submittal 2		
Location Details:		Direction of Survey:	Downstream
US MH:	M-806-036	DS MH:	M-706-028
		Total Length Surveyed (ft):	265.2

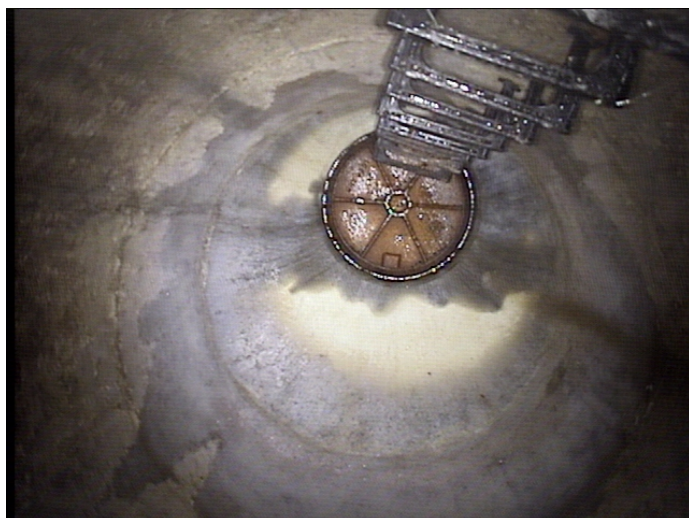
Code: **AMH**
Description: **Manhole**

Distance (ft): **.0**
Structural Grade: **0**
O&M Grade: **0**
Clock Start/From:
Clock To:
1st Value:
2nd Value:
Value Percent:
Continuous Index:
Within 8" of Joint: **NO**
Remarks: **M-806-036**

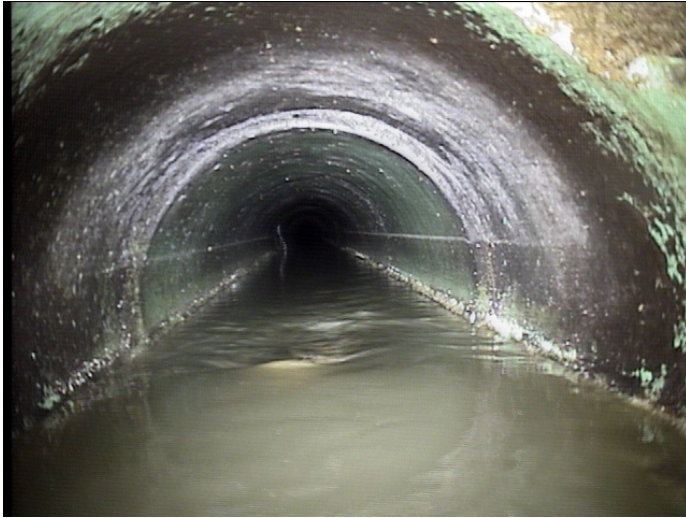
Code: **MWL**
Description: **Water Level**

Distance (ft): **.0**
Structural Grade: **0**
O&M Grade: **0**
Clock Start/From:
Clock To:
1st Value:
2nd Value:
Value Percent: **25.000**
Continuous Index:
Within 8" of Joint: **NO**
Remarks:

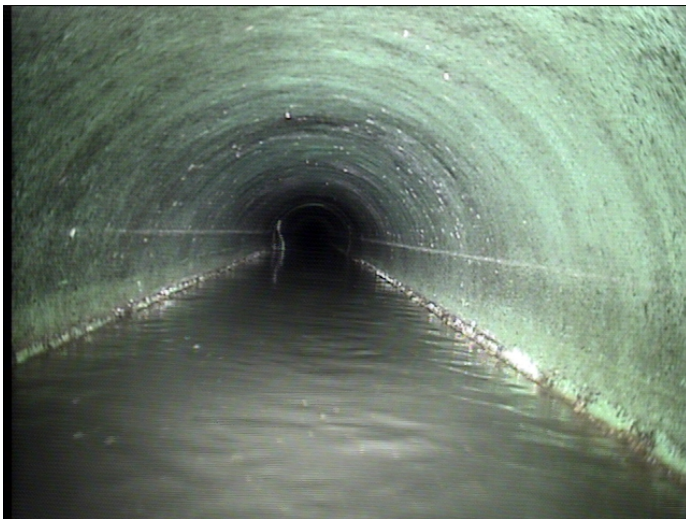
Code: **DSF**
Description: **Deposits Settled Fine**

Distance (ft): **2.9**
Structural Grade: **0**
O&M Grade: **3**
Clock Start/From: **4**
Clock To: **8**
1st Value:
2nd Value:
Value Percent: **15.000**
Continuous Index: **S01**
Within 8" of Joint: **NO**
Remarks:

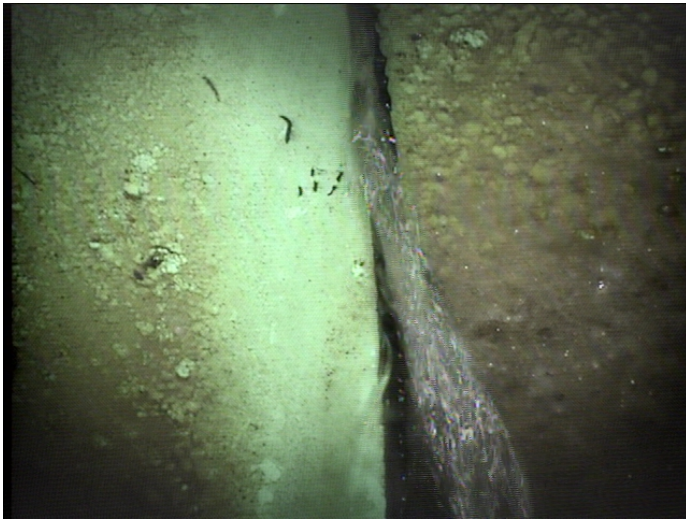
Code: **IG**
Description: **Infil Gusher**

Distance (ft): **15.7**
Structural Grade: **0**
O&M Grade: **5**
Clock Start/From: **9**
Clock To:
1st Value:
2nd Value:
Value Percent:
Continuous Index:
Within 8" of Joint: **YES**
Remarks:

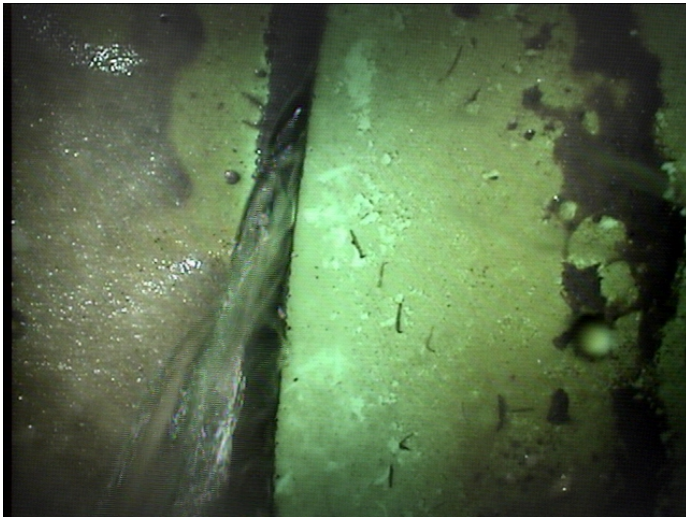
Code: **IG**
Description: **Infil Gusher**

Distance (ft): **42.0**
Structural Grade: **0**
O&M Grade: **5**
Clock Start/From: **3**
Clock To:
1st Value:
2nd Value:
Value Percent:
Continuous Index:
Within 8" of Joint: **YES**
Remarks:

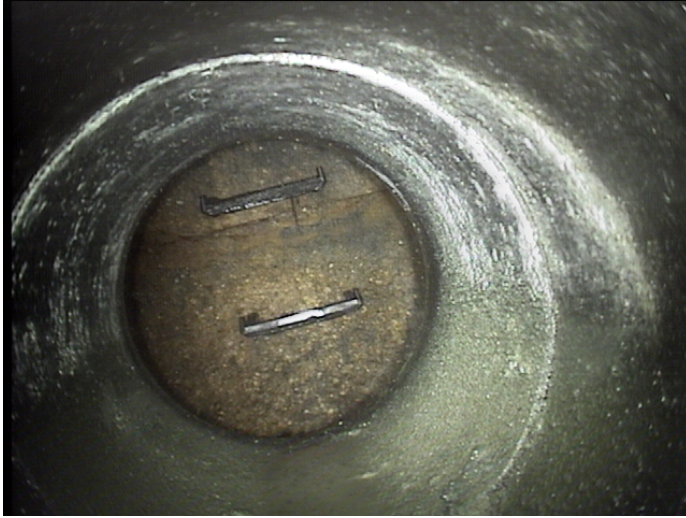
Code: **AMH**
Description: **Manhole**

Distance (ft): **264.8**
Structural Grade: **0**
O&M Grade: **0**
Clock Start/From:
Clock To:
1st Value:
2nd Value:
Value Percent:
Continuous Index:
Within 8" of Joint: **NO**
Remarks: **M-706-028**

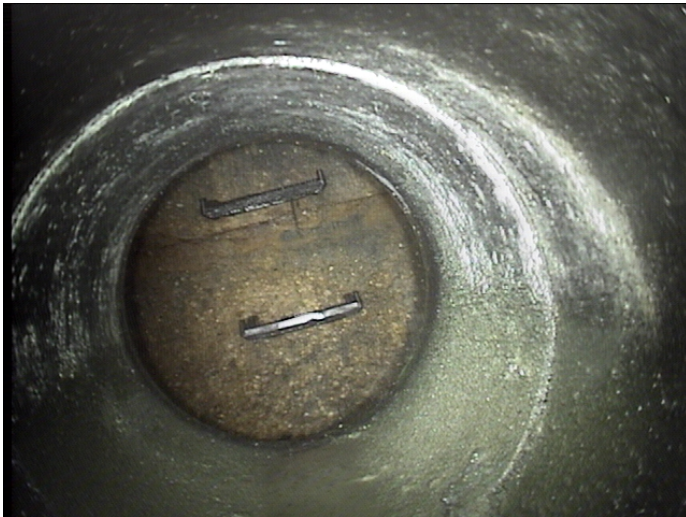
Code: **DSF**
Description: **Deposits Settled Fine**

Distance (ft): **264.8**
Structural Grade: **0**
O&M Grade: **3**
Clock Start/From: **4**
Clock To: **8**
1st Value:
2nd Value:
Value Percent: **15.000**
Continuous Index: **F01**
Within 8" of Joint: **NO**
Remarks:
