## Profile/Photo Observation Report

Date:	<b>04/13/2018</b>	Weather:		Coding:	<b>PACP 6.0</b>
Pipe Length (ft):	<b>314.2</b>	Owner:	<b>NA</b>	Pre Clean:	<b>Not Known</b>
P.O.#:		Surveyor:	<b>Jen Costello</b>	PSR:	<b>P-806-037-036</b>
Customer:		Clean Date:	<b>01/01/1900</b>	Shape:	<b>C</b>

Street:	<b>E 10TH ST &amp; PORT CIR</b>	Flow Control:	<b>Not Controlled</b>
City:	<b>Hobart, IN</b>	Year Renewed:	
Location:	<b>Ditch</b>	Tape/Media #:	
Purpose:	<b>Maintenance Related</b>	Dia/Height:	<b>8"</b>
Use:	<b>Sanitary</b>	Material:	<b>PVC</b>
Drain Area:	<b>NA</b>	Lining:	<b>Cured in Place</b>
Category:	<b>NA</b>		
Comment:	<b>flow incorrect.</b>

Location Details:		Direction of Survey:	<b>Upstream</b>
US MH:	<b>M-806-036</b>	DS MH:	<b>M-806-037</b>
		Total Length Surveyed (ft):	<b>307.5</b>

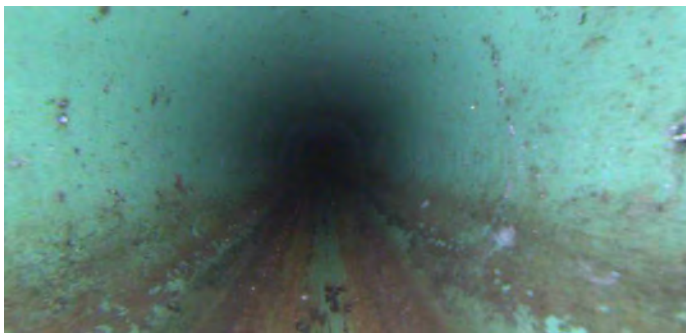
Code: **AMH**  
Description: **Manhole**

Distance (ft): **.0**  
Structural Grade: **0**  
O&M Grade: **0**  
Clock Start/From:  
Clock To:  
1st Value:  
2nd Value:  
Value Percent:  
Continuous Index:  
Within 8" of Joint: **NO**  
Remarks: **M-806-037**

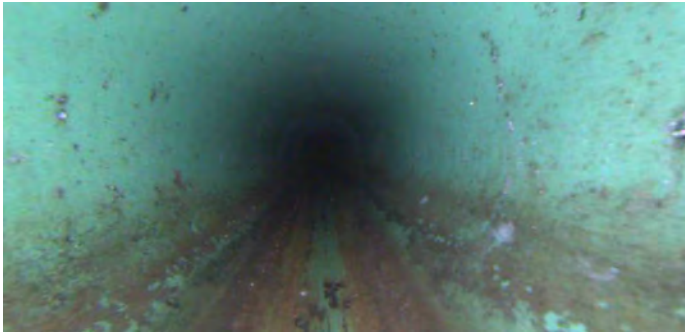
Code:	<b>MWL</b>
Description:	<b>Water Level</b>

Distance (ft):	<b>.0</b>
Structural Grade:	<b>0</b>
O&M Grade:	<b>0</b>
Clock Start/From:	
Clock To:	
1st Value:	
2nd Value:	
Value Percent:	<b>5.000</b>
Continuous Index:	
Within 8" of Joint:	<b>NO</b>
Remarks:

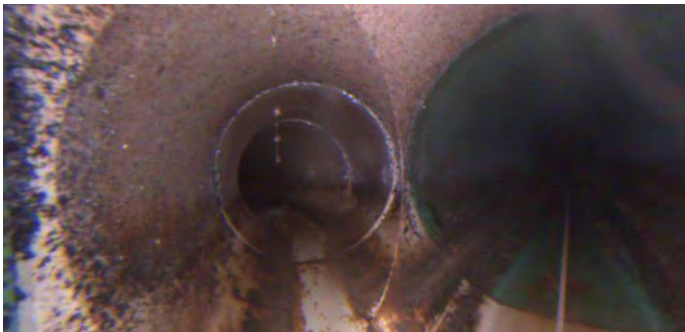
Code:	<b>TF</b>
Description:	<b>Tap Factory</b>

Distance (ft):	<b>26.8</b>
Structural Grade:	<b>0</b>
O&M Grade:	<b>0</b>
Clock Start/From:	<b>3</b>
Clock To:	
1st Value:	<b>4.000</b>
2nd Value:	
Value Percent:	
Continuous Index:	
Within 8" of Joint:	
Remarks:

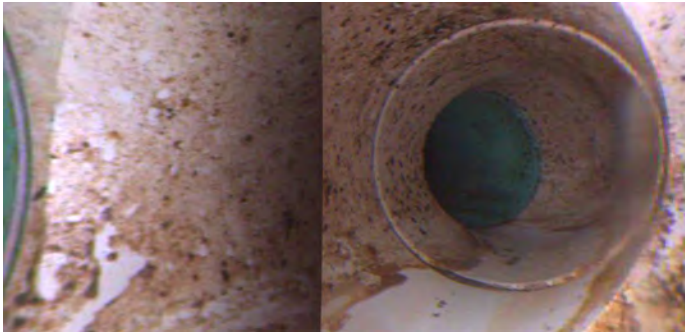
Code: **TF**  
Description: **Tap Factory**

Distance (ft): **85.2**  
Structural Grade: **0**  
O&M Grade: **0**  
Clock Start/From: **3**  
Clock To:  
1st Value: **4.000**  
2nd Value:  
Value Percent:  
Continuous Index:  
Within 8" of Joint:  
Remarks:

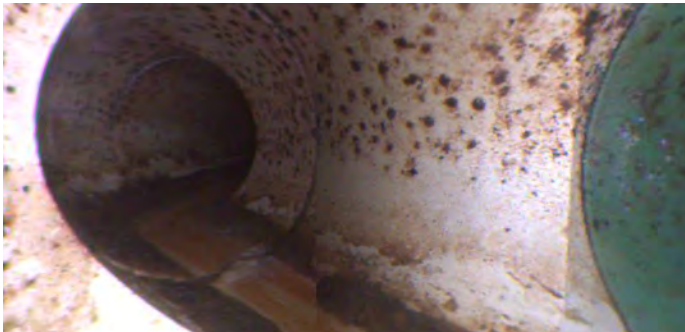
Code: **TF**  
Description: **Tap Factory**

Distance (ft): **90.5**  
Structural Grade: **0**  
O&M Grade: **0**  
Clock Start/From: **9**  
Clock To:  
1st Value: **4.000**  
2nd Value:  
Value Percent:  
Continuous Index:  
Within 8" of Joint:  
Remarks:

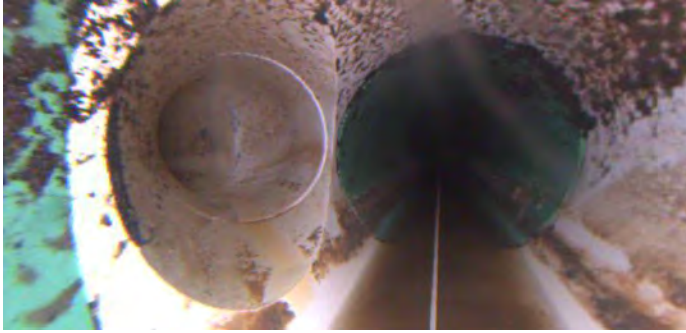
Code: **TF**  
Description: **Tap Factory**

Distance (ft): **158.8**  
Structural Grade: **0**  
O&M Grade: **0**  
Clock Start/From: **3**  
Clock To:  
1st Value: **4.000**  
2nd Value:  
Value Percent:  
Continuous Index:  
Within 8" of Joint:  
Remarks:

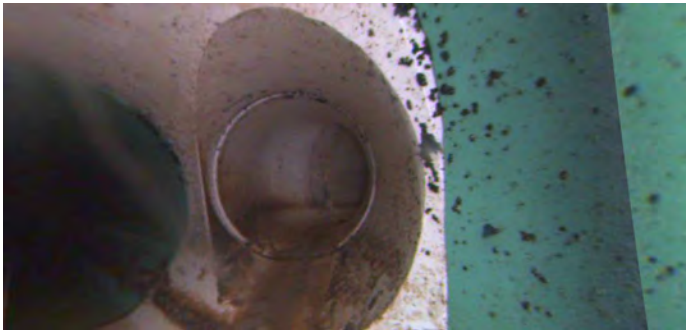
Code: **TF**  
Description: **Tap Factory**

Distance (ft): **163.6**  
Structural Grade: **0**  
O&M Grade: **0**  
Clock Start/From: **9**  
Clock To:  
1st Value: **4.000**  
2nd Value:  
Value Percent:  
Continuous Index:  
Within 8" of Joint: **NO**  
Remarks:

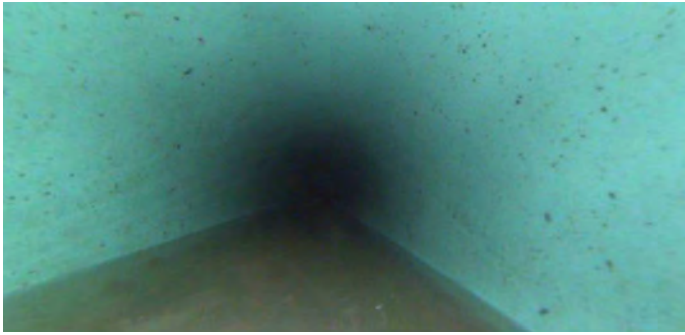
Code: **MWL**  
Description: **Water Level**

Distance (ft): **208.5**  
Structural Grade: **0**  
O&M Grade: **0**  
Clock Start/From:  
Clock To:  
1st Value:  
2nd Value:  
Value Percent: **30.000**  
Continuous Index:  
Within 8" of Joint: **NO**  
Remarks:

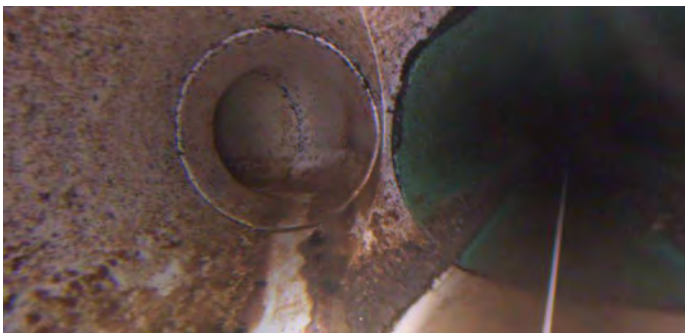
Code: **TF**  
Description: **Tap Factory**

Distance (ft): **250.4**  
Structural Grade: **0**  
O&M Grade: **0**  
Clock Start/From: **3**  
Clock To:  
1st Value: **4.000**  
2nd Value:  
Value Percent:  
Continuous Index:  
Within 8" of Joint:  
Remarks:

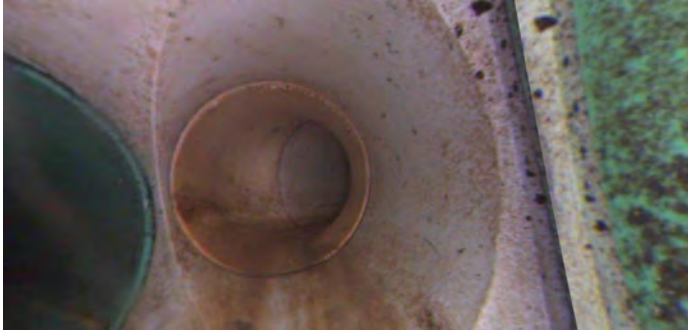
Code: **TF**  
Description: **Tap Factory**

Distance (ft): **255.6**  
Structural Grade: **0**  
O&M Grade: **0**  
Clock Start/From: **9**  
Clock To:  
1st Value: **4.000**  
2nd Value:  
Value Percent:  
Continuous Index:  
Within 8" of Joint:  
Remarks:

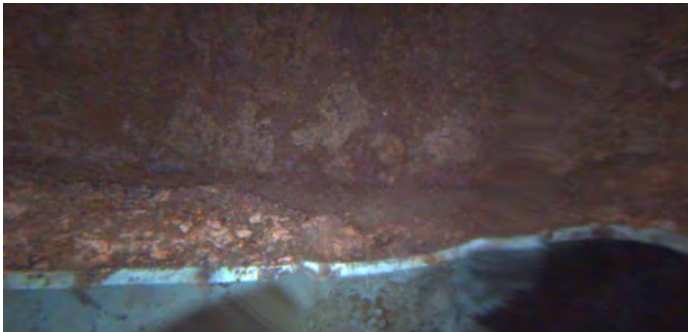
Code: **AMH**  
Description: **Manhole**

Distance (ft): **307.5**  
Structural Grade: **0**  
O&M Grade: **0**  
Clock Start/From:  
Clock To:  
1st Value:  
2nd Value:  
Value Percent:  
Continuous Index:  
Within 8" of Joint: **NO**  
Remarks: **M-806-036**
