Profile/Photo Observation Report

Street:	Capitol	Flow Control:	Not Controlled
City:	Hobart, IN	Year Renewed:	
Location:	Ditch	Tape/Media #:	
Purpose:	Maintenance Related	Dia/Height:	8"
Use:	Sanitary	Material:	PVC
Drain Area:	NA	Lining:	Cured in Place
Category:	NA		
Comment:	flow incorrect.

Location Details:		Direction of Survey:	Upstream
US MH:	M-806-036	DS MH:	M-806-037
		Total Length Surveyed (ft):	307.5

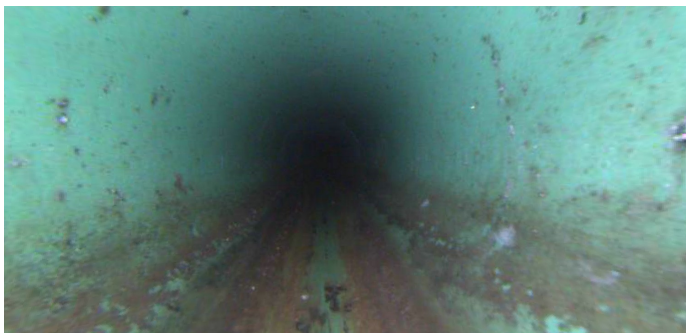
Code: **AMH**
Description: **Manhole**

Distance (ft): **.0**
Structural Grade: **0**
O&M Grade: **0**
Clock Start/From:
Clock To:
1st Value:
2nd Value:
Value Percent:
Continuous Index:
Within 8" of Joint: **NO**
Remarks: **M-806-037**

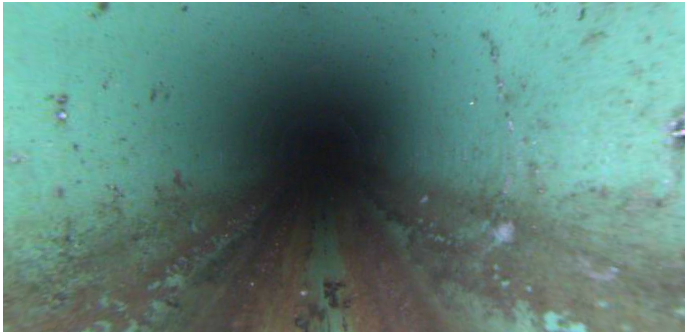
Code:	MWL
Description:	Water Level

Distance (ft):	.0
Structural Grade:	0
O&M Grade:	0
Clock Start/From:	
Clock To:	
1st Value:	
2nd Value:	
Value Percent:	5.000
Continuous Index:	
Within 8" of Joint:	NO
Remarks:

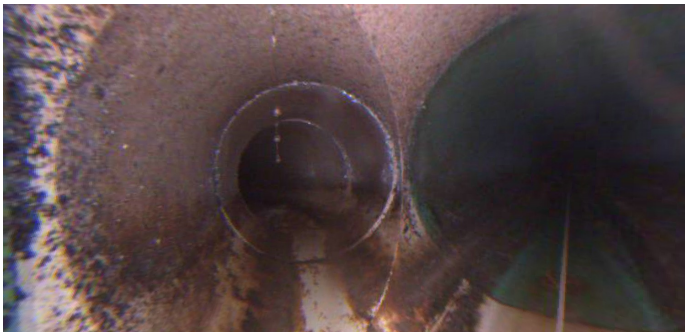
Code:	TF
Description:	Tap Factory

Distance (ft):	26.8
Structural Grade:	0
O&M Grade:	0
Clock Start/From:	3
Clock To:	
1st Value:	4.000
2nd Value:	
Value Percent:	
Continuous Index:	
Within 8" of Joint:	
Remarks:

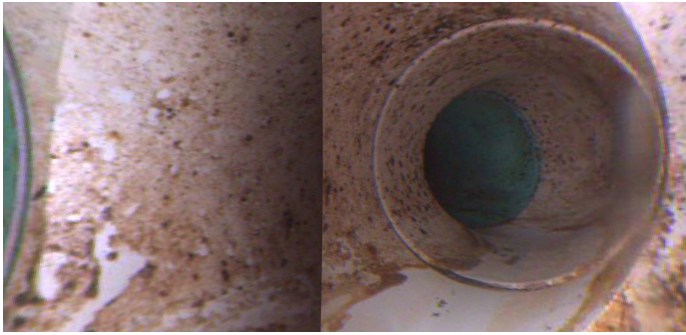
Code: **TF**
Description: **Tap Factory**

Distance (ft): **85.2**
Structural Grade: **0**
O&M Grade: **0**
Clock Start/From: **3**
Clock To:
1st Value: **4.000**
2nd Value:
Value Percent:
Continuous Index:
Within 8" of Joint:
Remarks:

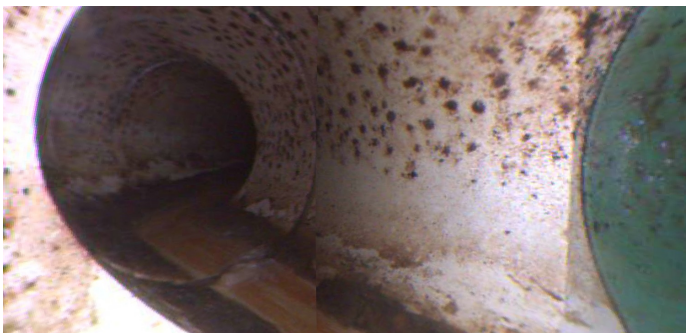
Code: **TF**
Description: **Tap Factory**

Distance (ft): **90.5**
Structural Grade: **0**
O&M Grade: **0**
Clock Start/From: **9**
Clock To:
1st Value: **4.000**
2nd Value:
Value Percent:
Continuous Index:
Within 8" of Joint:
Remarks:

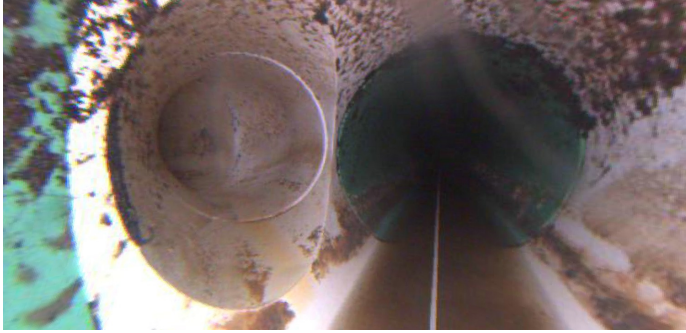
Code: **TF**
Description: **Tap Factory**

Distance (ft): **158.8**
Structural Grade: **0**
O&M Grade: **0**
Clock Start/From: **3**
Clock To:
1st Value: **4.000**
2nd Value:
Value Percent:
Continuous Index:
Within 8" of Joint:
Remarks:

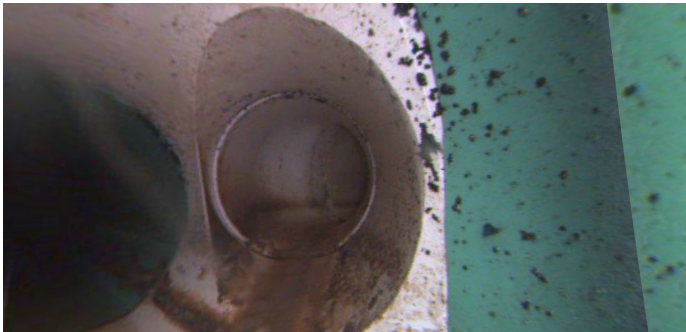
Code: **TF**
Description: **Tap Factory**

Distance (ft): **163.6**
Structural Grade: **0**
O&M Grade: **0**
Clock Start/From: **9**
Clock To:
1st Value: **4.000**
2nd Value:
Value Percent:
Continuous Index:
Within 8" of Joint: **NO**
Remarks:

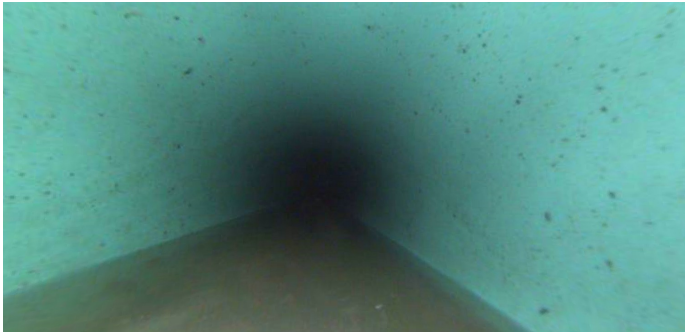
Code: **MWL**
Description: **Water Level**

Distance (ft): **208.5**
Structural Grade: **0**
O&M Grade: **0**
Clock Start/From:
Clock To:
1st Value:
2nd Value:
Value Percent: **30.000**
Continuous Index:
Within 8" of Joint: **NO**
Remarks:

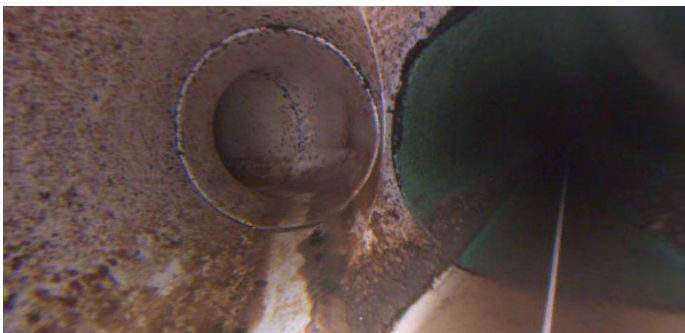
Code: **TF**
Description: **Tap Factory**

Distance (ft): **250.4**
Structural Grade: **0**
O&M Grade: **0**
Clock Start/From: **3**
Clock To:
1st Value: **4.000**
2nd Value:
Value Percent:
Continuous Index:
Within 8" of Joint:
Remarks:

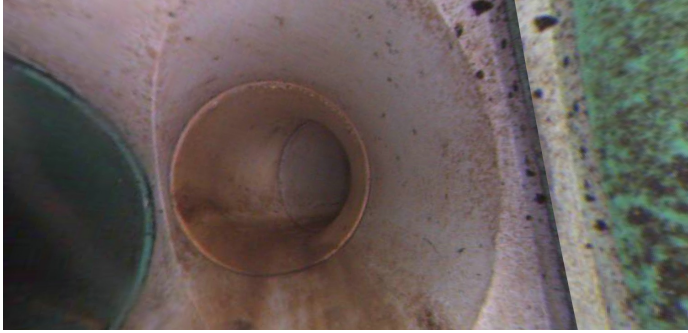
Code: **TF**
Description: **Tap Factory**

Distance (ft): **255.6**
Structural Grade: **0**
O&M Grade: **0**
Clock Start/From: **9**
Clock To:
1st Value: **4.000**
2nd Value:
Value Percent:
Continuous Index:
Within 8" of Joint:
Remarks:

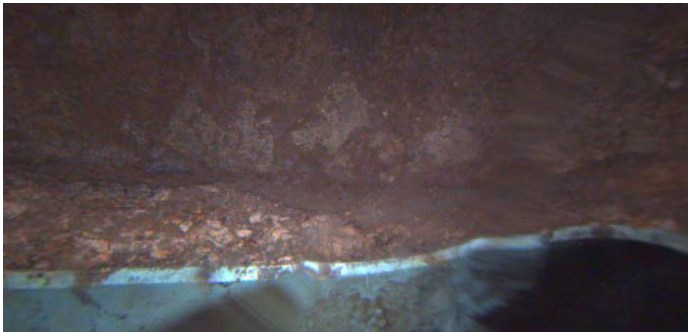
Code: **AMH**
Description: **Manhole**

Distance (ft): **307.5**
Structural Grade: **0**
O&M Grade: **0**
Clock Start/From:
Clock To:
1st Value:
2nd Value:
Value Percent:
Continuous Index:
Within 8" of Joint: **NO**
Remarks: **M-806-036**
