Profile/Photo Observation Report

Date:	04/14/2018	Weather:		Coding:	PACP 6.0
Pipe Length (ft):	135.5	Owner:	NA	Pre Clean:	Not Known
P.O.#:		Surveyor:	Jen Costello	PSR:	P-806-043-041
Customer:		Clean Date:	01/01/1900	Shape:	C

Location Details:		Direction of Survey:	Downstream
US MH:	M-806-041	DS MH:	M-806-043
		Total Length Surveyed (ft):	131.5

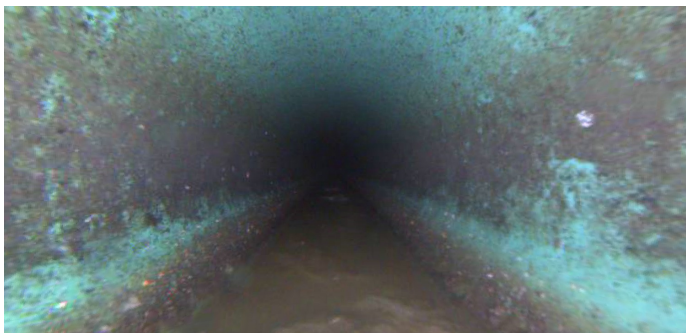
Code: **AMH**
Description: **Manhole**

Distance (ft): **.0**
Structural Grade: **0**
O&M Grade: **0**
Clock Start/From:
Clock To:
1st Value:
2nd Value:
Value Percent:
Continuous Index:
Within 8" of Joint: **NO**
Remarks: **M-806-041**

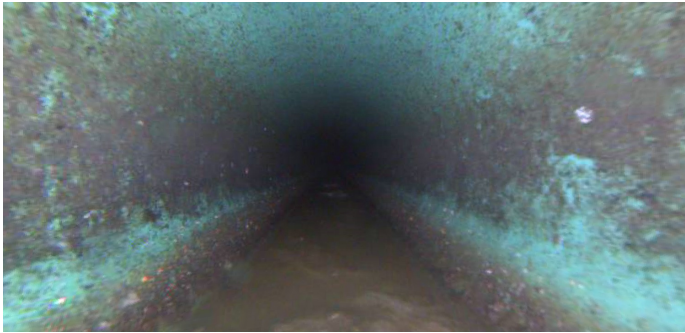
Code:	MWL
Description:	Water Level

Distance (ft):	.0
Structural Grade:	0
O&M Grade:	0
Clock Start/From:	
Clock To:	
1st Value:	
2nd Value:	
Value Percent:	5.000
Continuous Index:	
Within 8" of Joint:	NO
Remarks:

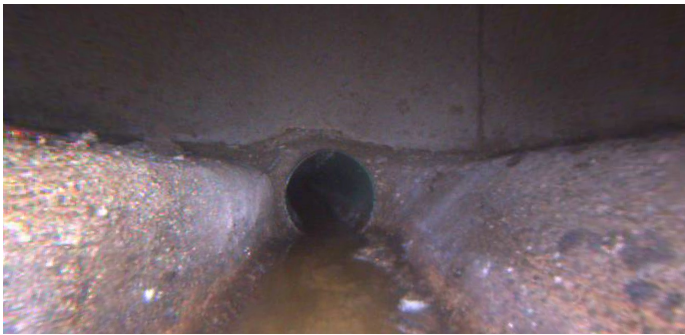
Code:	AMH
Description:	Manhole

Distance (ft):	131.5
Structural Grade:	0
O&M Grade:	0
Clock Start/From:	
Clock To:	
1st Value:	
2nd Value:	
Value Percent:	
Continuous Index:	
Within 8" of Joint:	NO
Remarks:	M-806-043
