Profile/Photo Observation Report

Date:	10/23/2021	Weather:		Coding:	PACP 6.0
Pipe Length (ft):		Owner:	Hobart, IN	Pre Clean:	Not Known
P.O.#:	982_1	Surveyor:	M. Pielacha	PSR:	M-806-042A_M-608-042
Customer:	Hobart, IN	Clean Date:		Shape:	C

Location Details:		Direction of Survey:	Upstream
US MH:	M-806-042A	DS MH:	M-608-042
		Total Length Surveyed (ft):	122.2

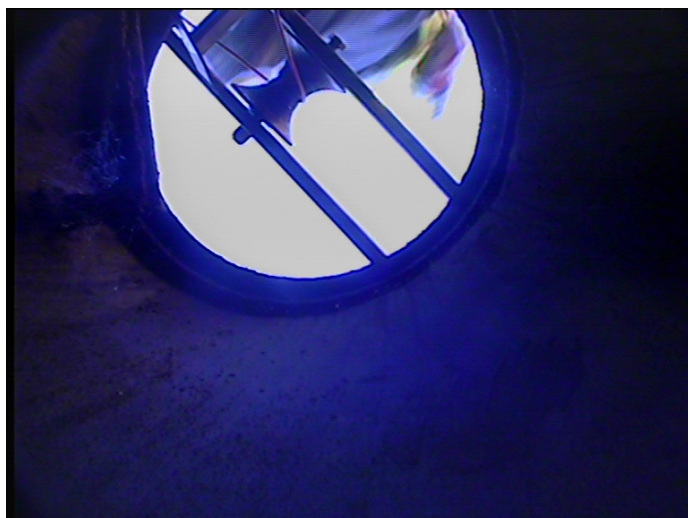
Code: **AMH**
Description: **Manhole**

Distance (ft): **.0**
Structural Grade: **0**
O&M Grade: **0**
Clock Start/From:
Clock To:
1st Value:
2nd Value:
Value Percent:
Continuous Index:
Within 8" of Joint: **NO**
Remarks: **M-608-042**

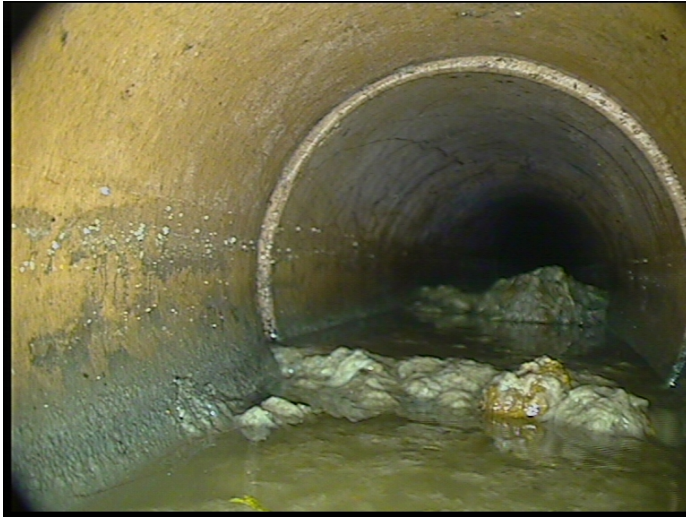
Code: **MWL**
Description: **Water Level**

Distance (ft): **.0**
Structural Grade: **0**
O&M Grade: **0**
Clock Start/From:
Clock To:
1st Value:
2nd Value:
Value Percent: **10.000**
Continuous Index:
Within 8" of Joint: **NO**
Remarks:

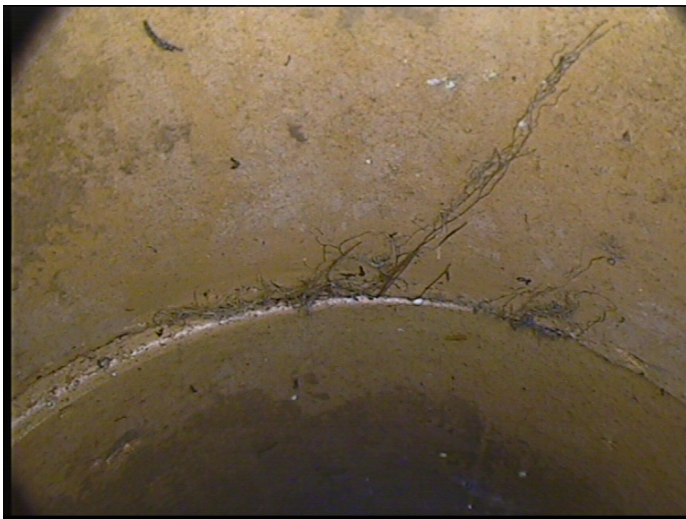
Code: **RFJ**
Description: **Roots Fine Joint**

Distance (ft): **51.6**
Structural Grade: **0**
O&M Grade: **1**
Clock Start/From: **12**
Clock To: **3**
1st Value:
2nd Value:
Value Percent:
Continuous Index:
Within 8" of Joint: **YES**
Remarks:

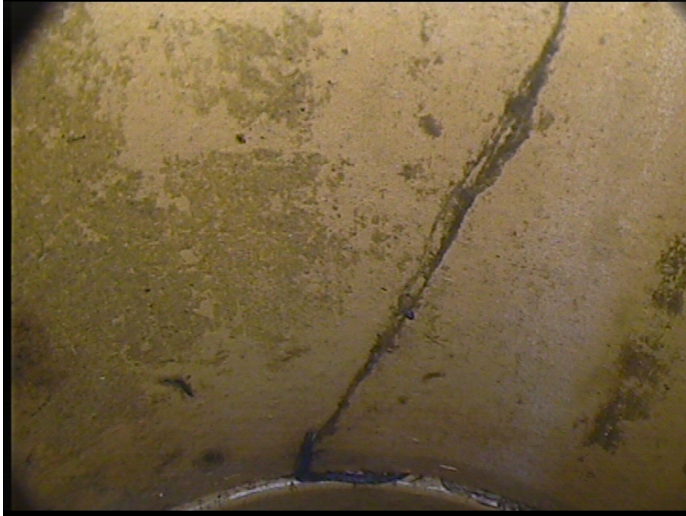
Code: **RFJ**
Description: **Roots Fine Joint**

Distance (ft): **96.3**
Structural Grade: **0**
O&M Grade: **1**
Clock Start/From: **3**
Clock To:
1st Value:
2nd Value:
Value Percent:
Continuous Index:
Within 8" of Joint: **YES**
Remarks:

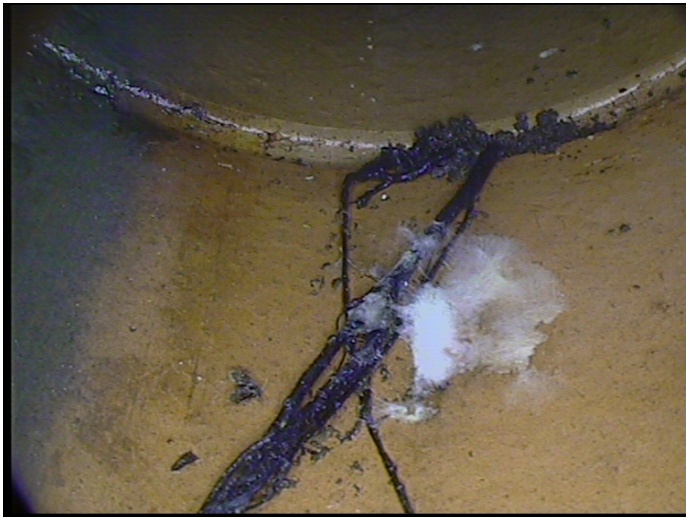
Code: **RFJ**
Description: **Roots Fine Joint**

Distance (ft): **106.6**
Structural Grade: **0**
O&M Grade: **1**
Clock Start/From: **4**
Clock To:
1st Value:
2nd Value:
Value Percent:
Continuous Index:
Within 8" of Joint: **YES**
Remarks:

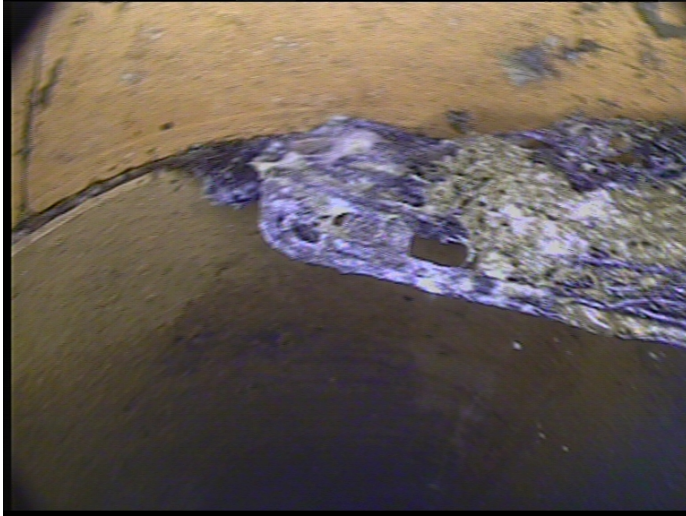
Code:	RMJ
Description:	Roots Medium Joint
Distance (ft):	111.6
Structural Grade:	0
O&M Grade:	3
Clock Start/From:	12
Clock To:	5
1st Value:	
2nd Value:	
Value Percent:	10.000
Continuous Index:	
Within 8" of Joint:	YES
Remarks:

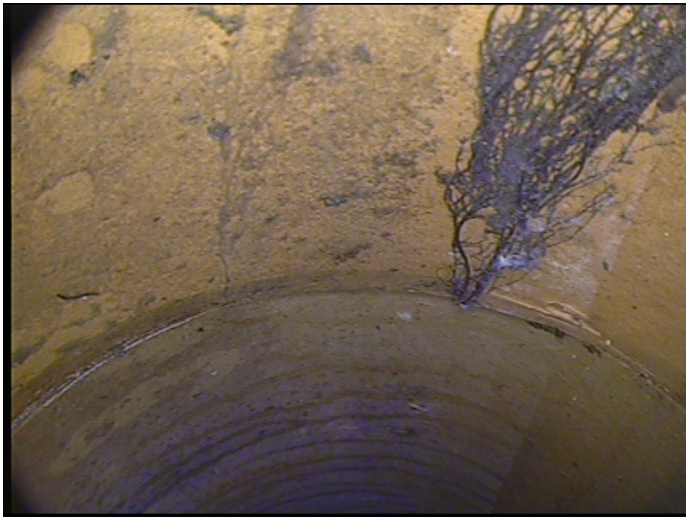
Code:	RFJ
Description:	Roots Fine Joint
Distance (ft):	116.3
Structural Grade:	0
O&M Grade:	1
Clock Start/From:	9
Clock To:	3
1st Value:	
2nd Value:	
Value Percent:	
Continuous Index:	
Within 8" of Joint:	YES
Remarks:

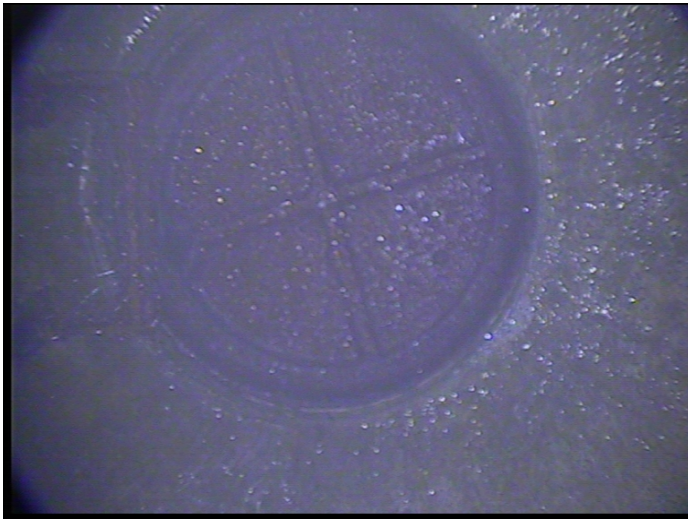
Code:	AMH
Description:	Manhole
Distance (ft):	122.1
Structural Grade:	0
O&M Grade:	0
Clock Start/From:	
Clock To:	
1st Value:	
2nd Value:	
Value Percent:	
Continuous Index:	
Within 8" of Joint:	NO
Remarks:	M-806-042A
