Profile/Photo Observation Report

Date:	10/20/2021	Weather:		Coding:	PACP 6.0
Pipe Length (ft):		Owner:	Hobart, IN	Pre Clean:	Not Known
P.O.#:	902_1	Surveyor:	M. Pielacha	PSR:	P-806-UNK2-049
Customer:	Hobart, IN	Clean Date:		Shape:	C

Street:	6th Street	Flow Control:	
City:	Hobart, IN	Year Renewed:	
Location:	Light Highway	Tape/Media #:	902
Purpose:	Routine Assessment	Dia/Height:	12"
Use:	Sanitary	Material:	PVC
Drain Area:		Lining:

US MH: **M-806-49** DS MH: **M-806-49** Total Length Surveyed (ft): **178.6**

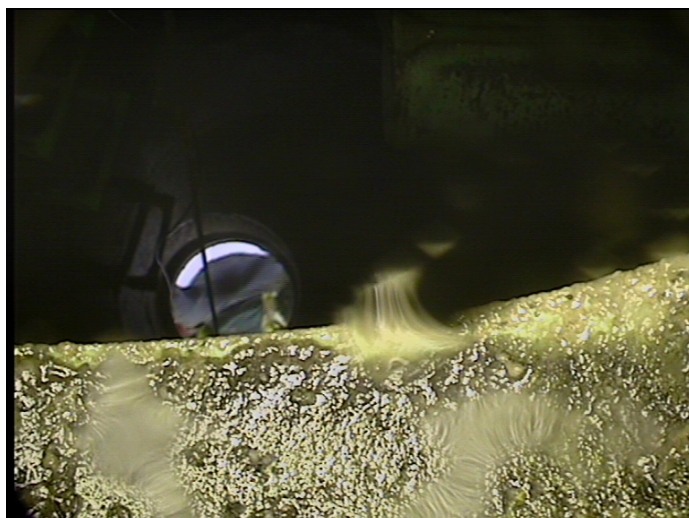
Code: **AMH**
Description: **Manhole**

Distance (ft): **.0**
Structural Grade: **0**
O&M Grade: **0**
Clock Start/From:
Clock To:
1st Value:
2nd Value:
Value Percent:
Continuous Index:
Within 8" of Joint: **NO**
Remarks: **M-806-49**

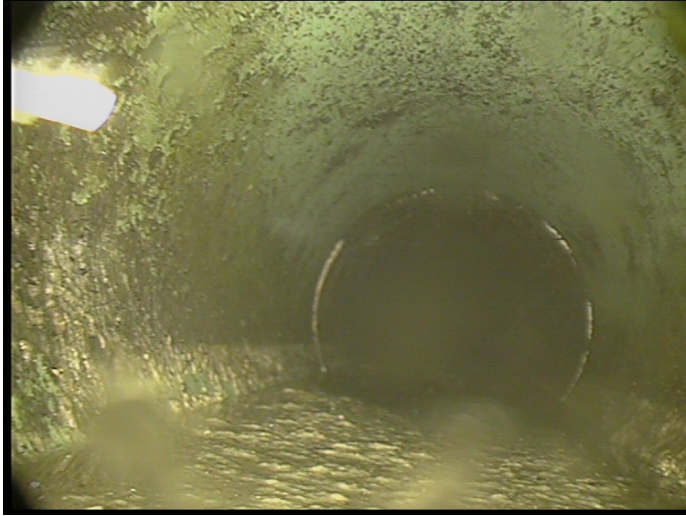
Code: **MWL**
Description: **Water Level**

Distance (ft): **.0**
Structural Grade: **0**
O&M Grade: **0**
Clock Start/From:
Clock To:
1st Value:
2nd Value:
Value Percent: **10.000**
Continuous Index:
Within 8" of Joint: **NO**
Remarks:

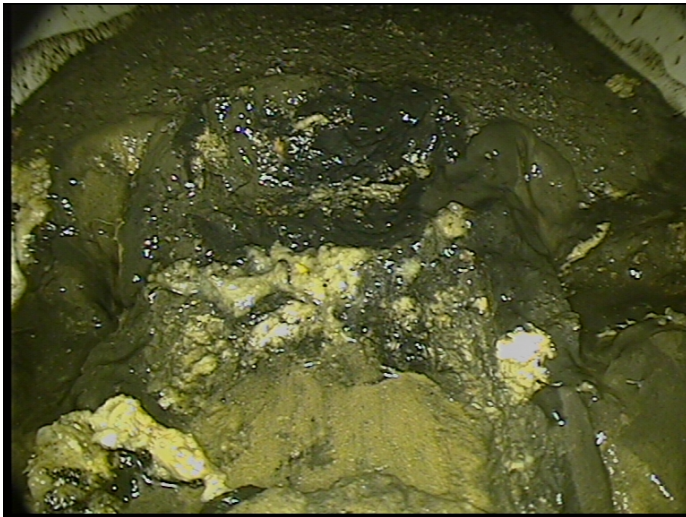
Code: **DSF**
Description: **Deposits Settled Fine**

Distance (ft): **62.2**
Structural Grade: **0**
O&M Grade: **3**
Clock Start/From: **4**
Clock To: **8**
1st Value:
2nd Value:
Value Percent: **15.000**
Continuous Index: **S01**
Within 8" of Joint: **YES**
Remarks:

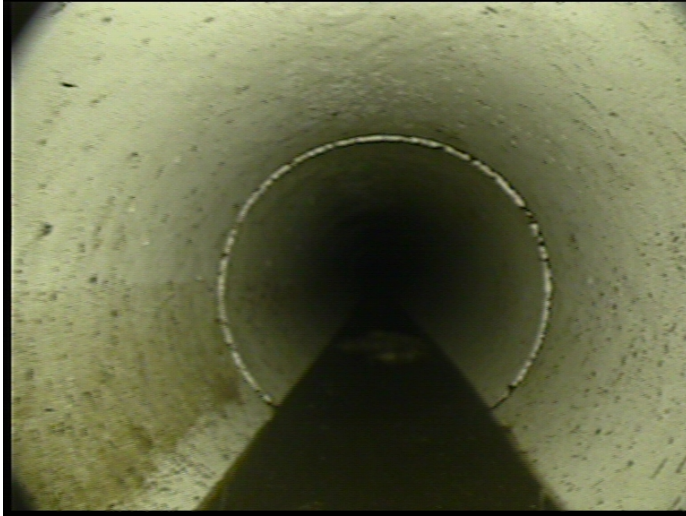
Code: **DSF**
Description: **Deposits Settled Fine**

Distance (ft): **113.8**
Structural Grade: **0**
O&M Grade: **3**
Clock Start/From: **4**
Clock To: **8**
1st Value:
2nd Value:
Value Percent: **15.000**
Continuous Index: **F01**
Within 8" of Joint: **NO**
Remarks:

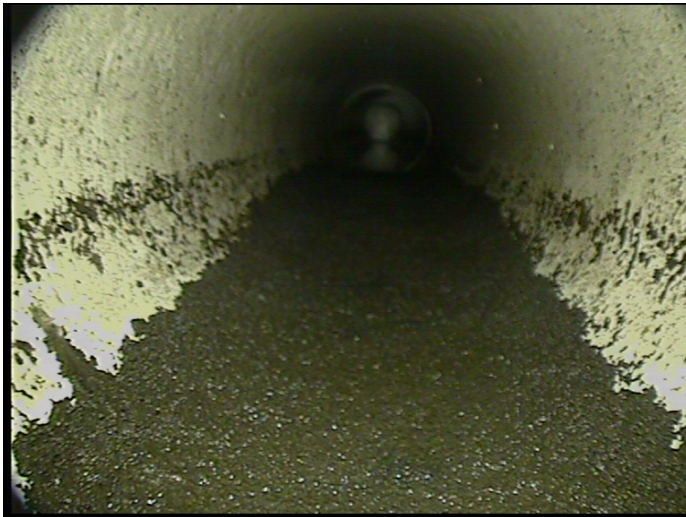
Code: **DSF**
Description: **Deposits Settled Fine**

Distance (ft): **159.0**
Structural Grade: **0**
O&M Grade: **2**
Clock Start/From: **4**
Clock To: **8**
1st Value:
2nd Value:
Value Percent: **10.000**
Continuous Index: **S02**
Within 8" of Joint: **YES**
Remarks:

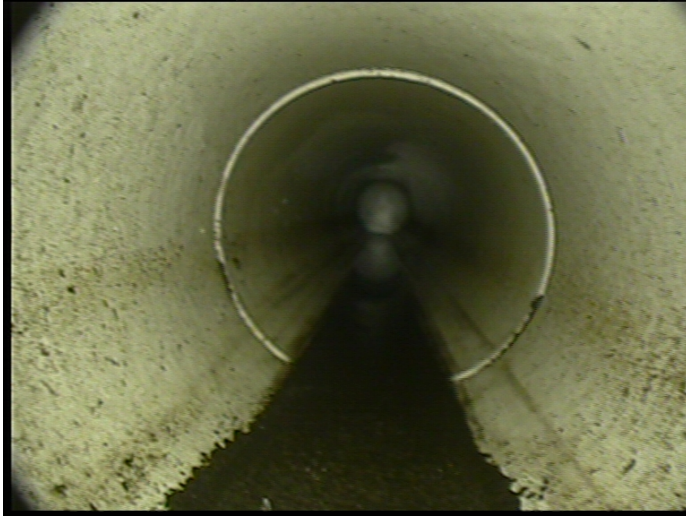
Code: **DSF**
Description: **Deposits Settled Fine**

Distance (ft): **165.2**
Structural Grade: **0**
O&M Grade: **2**
Clock Start/From: **4**
Clock To: **8**
1st Value:
2nd Value:
Value Percent: **10.000**
Continuous Index: **F02**
Within 8" of Joint: **NO**
Remarks:

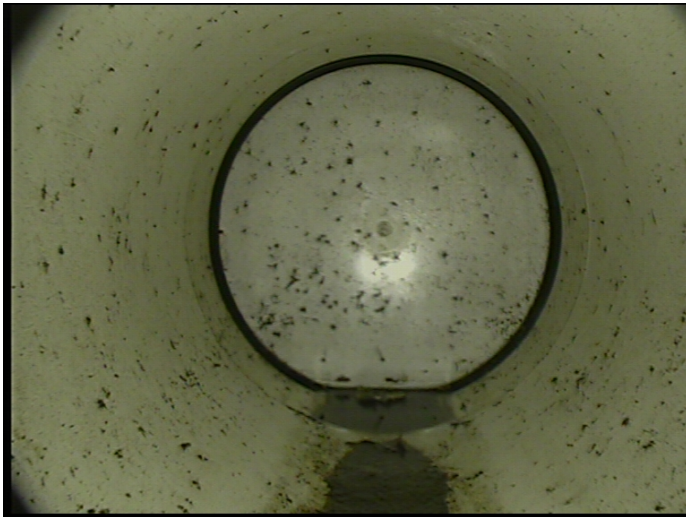
Code: **MGO**
Description: **General Observation**

Distance (ft): **178.6**
Structural Grade: **0**
O&M Grade: **0**
Clock Start/From:
Clock To:
1st Value:
2nd Value:
Value Percent:
Continuous Index:
Within 8" of Joint: **NO**
Remarks: **end of line**

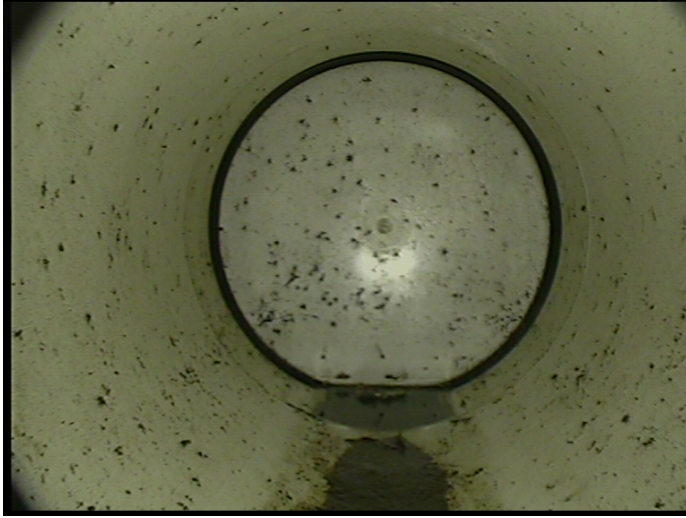
Code:	AMH
Description:	Manhole
Distance (ft):	178.6
Structural Grade:	0
O&M Grade:	0
Clock Start/From:	
Clock To:	
1st Value:	
2nd Value:	
Value Percent:	
Continuous Index:	
Within 8" of Joint:	NO
Remarks:	M-806-49
