Profile/Photo Observation Report

Date:	05/07/2018	Weather:		Coding:	PACP 6.0
Pipe Length (ft):		Owner:	City of Hobart	Pre Clean:	No Pre-Cleaning
P.O.#:	613	Surveyor:	M. Pielacha	PSR:	P-806-065-049
Customer:	City of Hobart	Clean Date:		Shape:	C

Street:	Gilbert Road	Flow Control:	Not Controlled
City:	Hobart, IN	Year Renewed:	
Location:	Light Highway	Tape/Media #:	DEP 613
Purpose:	Routine Assessment	Dia/Height:	6"
Use:	Sanitary	Material:	PVC
Drain Area:		Lining:	
Category:	NA		
Comment:	5-21-2018		
Location Details:		Direction of Survey:	Downstream
US MH:	M-806-049	DS MH:	M-806-065
		Total Length Surveyed (ft):	295.3

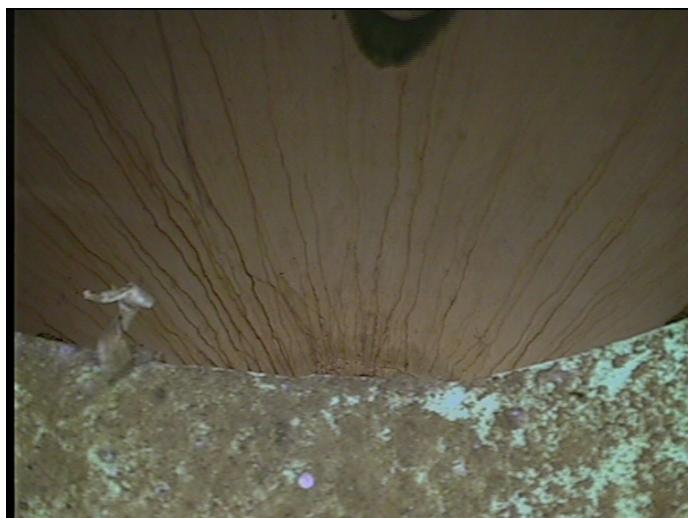
Code: **AMH**
Description: **Manhole**

Distance (ft): **.0**
Structural Grade: **0**
O&M Grade: **0**
Clock Start/From:
Clock To:
1st Value:
2nd Value:
Value Percent:
Continuous Index:
Within 8" of Joint: **NO**
Remarks: **M-806-065**

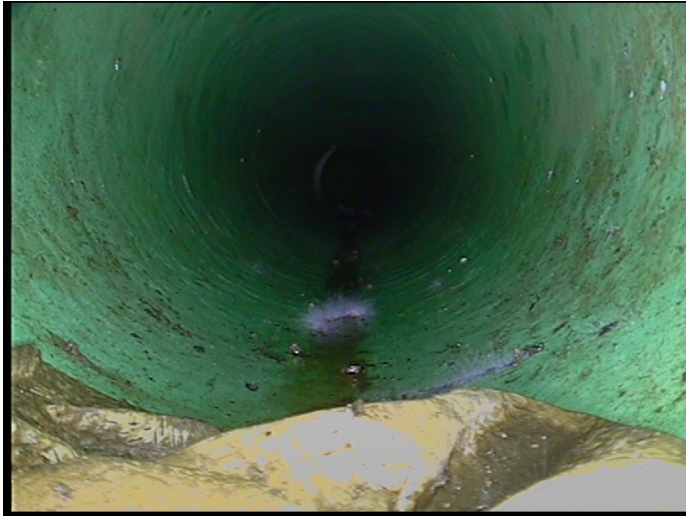
Code: **MWL**
Description: **Water Level**

Distance (ft): **.0**
Structural Grade: **0**
O&M Grade: **0**
Clock Start/From:
Clock To:
1st Value:
2nd Value:
Value Percent: **0.000**
Continuous Index:
Within 8" of Joint: **NO**
Remarks:

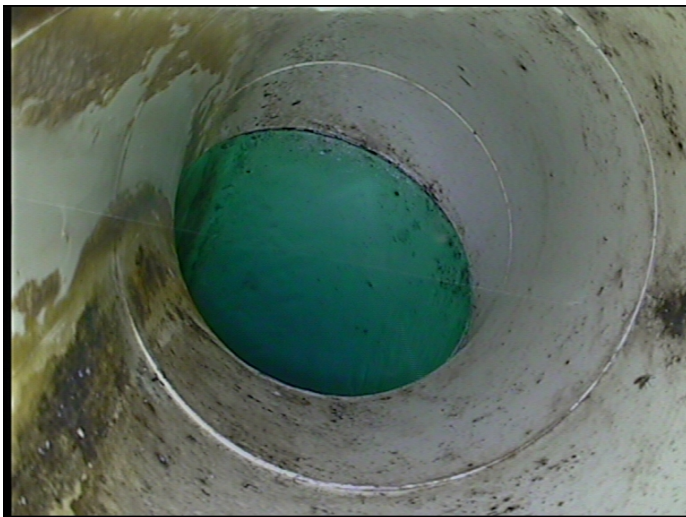
Code: **TF**
Description: **Tap Factory**

Distance (ft): **5.3**
Structural Grade: **0**
O&M Grade: **0**
Clock Start/From: **10**
Clock To:
1st Value: **4.000**
2nd Value:
Value Percent:
Continuous Index:
Within 8" of Joint: **NO**
Remarks:

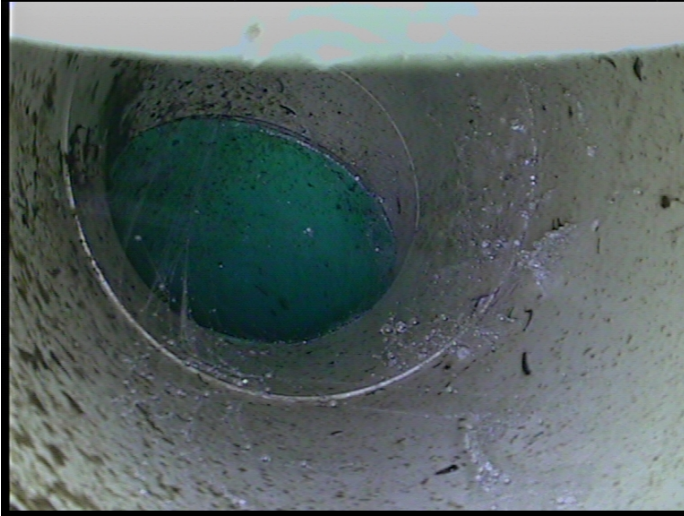
Code: **TF**
Description: **Tap Factory**

Distance (ft): **56.0**
Structural Grade: **0**
O&M Grade: **0**
Clock Start/From: **10**
Clock To:
1st Value: **4.000**
2nd Value:
Value Percent:
Continuous Index:
Within 8" of Joint: **NO**
Remarks:

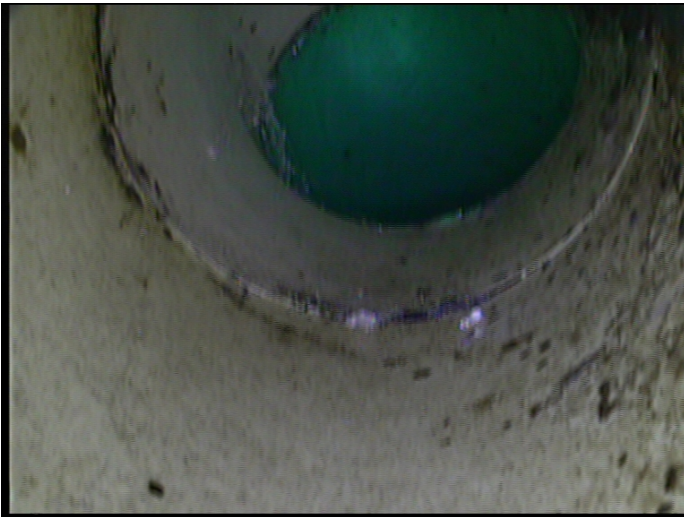
Code: **TF**
Description: **Tap Factory**

Distance (ft): **81.0**
Structural Grade: **0**
O&M Grade: **0**
Clock Start/From: **2**
Clock To:
1st Value: **4.000**
2nd Value:
Value Percent:
Continuous Index:
Within 8" of Joint: **NO**
Remarks:

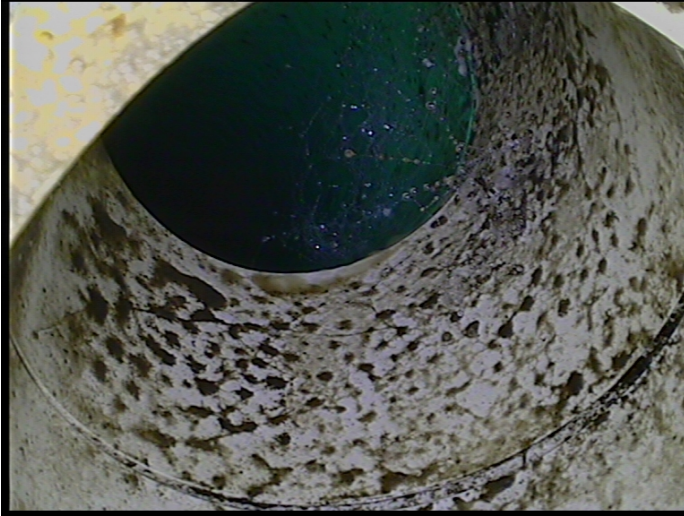
Code: **TF**
Description: **Tap Factory**

Distance (ft): **141.3**
Structural Grade: **0**
O&M Grade: **0**
Clock Start/From: **10**
Clock To:
1st Value: **4.000**
2nd Value:
Value Percent:
Continuous Index:
Within 8" of Joint: **NO**
Remarks:

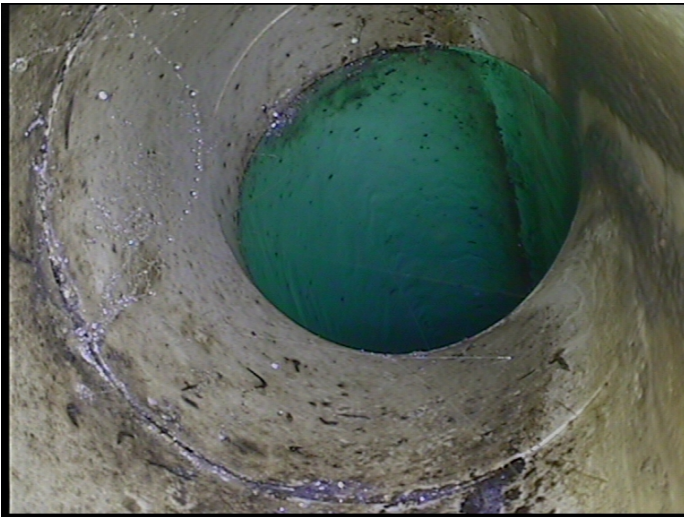
Code: **TF**
Description: **Tap Factory**

Distance (ft): **160.0**
Structural Grade: **0**
O&M Grade: **0**
Clock Start/From: **3**
Clock To:
1st Value: **6.000**
2nd Value:
Value Percent:
Continuous Index:
Within 8" of Joint: **NO**
Remarks:

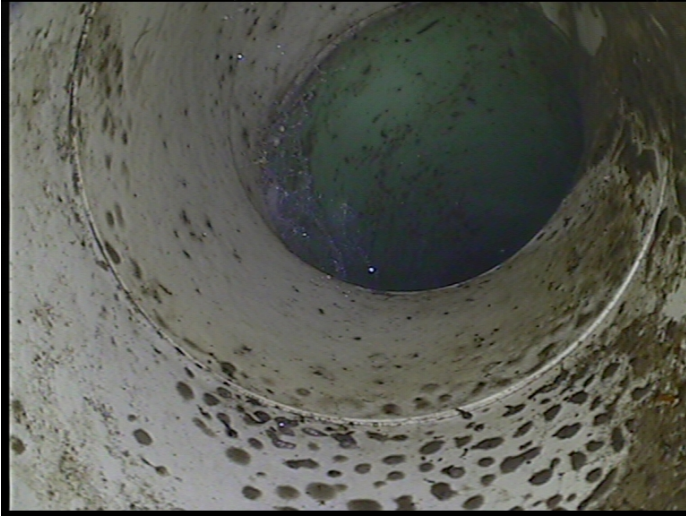
Code:	TF
Description:	Tap Factory
Distance (ft):	247.1
Structural Grade:	0
O&M Grade:	0
Clock Start/From:	2
Clock To:	
1st Value:	4.000
2nd Value:	
Value Percent:	
Continuous Index:	
Within 8" of Joint:	NO
Remarks:

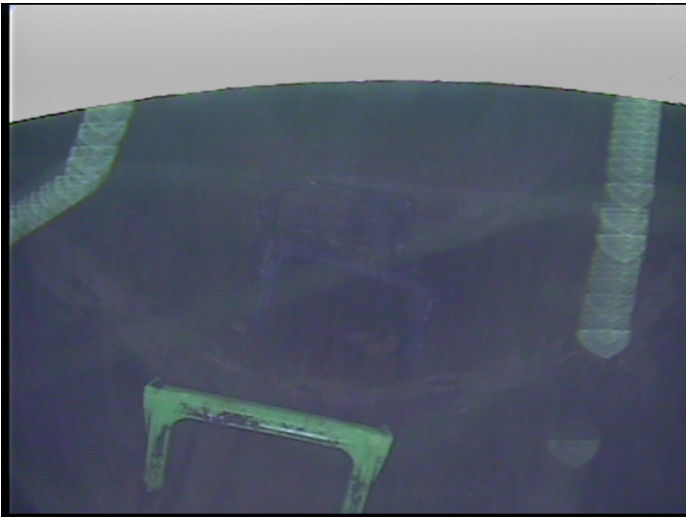
Code:	AMH
Description:	Manhole
Distance (ft):	295.3
Structural Grade:	0
O&M Grade:	0
Clock Start/From:	
Clock To:	
1st Value:	
2nd Value:	
Value Percent:	
Continuous Index:	
Within 8" of Joint:	NO
Remarks:	M-806-049
