## Profile/Photo Observation Report

Street:	<b>DEER CROSS TRL &amp; FAWN CT</b>	Flow Control:	<b>Not Controlled</b>
City:	<b>Hobart, IN</b>	Year Renewed:	
Location:	<b>Yard</b>	Tape/Media #:	
Purpose:	<b>Maintenance Related</b>	Dia/Height:	<b>8"</b>
Use:	<b>Sanitary</b>	Material:	<b>PVC</b>
Drain Area:	<b>NA</b>	Lining:	<b>Cured in Place</b>
Category:	<b>NA</b>		
Comment:	<b>flow incorrect.</b>

Location Details:		Direction of Survey:	<b>Downstream</b>
US MH:	<b>M-806-052</b>	DS MH:	<b>M-806-051</b>
		Total Length Surveyed (ft):	<b>107.2</b>

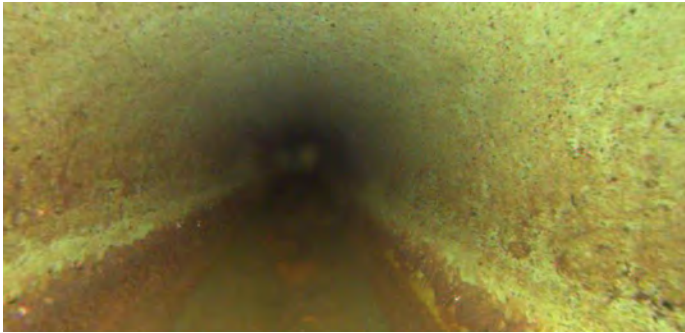
Code:	<b>MWL</b>
Description:	<b>Water Level</b>

Distance (ft):	<b>.0</b>
Structural Grade:	<b>0</b>
O&M Grade:	<b>0</b>
Clock Start/From:	
Clock To:	
1st Value:	
2nd Value:	
Value Percent:	<b>5.000</b>
Continuous Index:	
Within 8" of Joint:	<b>NO</b>
Remarks:

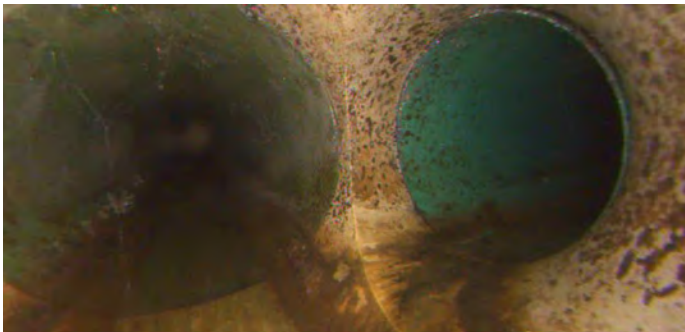
Code:	<b>TFA</b>
Description:	<b>Tap Factory Active</b>

Distance (ft):	<b>51.1</b>
Structural Grade:	<b>0</b>
O&M Grade:	<b>0</b>
Clock Start/From:	<b>3</b>
Clock To:	
1st Value:	<b>4.000</b>
2nd Value:	
Value Percent:	
Continuous Index:	
Within 8" of Joint:	
Remarks:

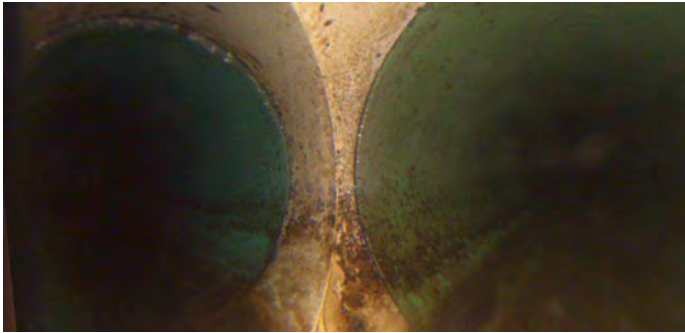
Code: **TFA**  
Description: **Tap Factory Active**

Distance (ft): **94.8**  
Structural Grade: **0**  
O&M Grade: **0**  
Clock Start/From: **9**  
Clock To:  
1st Value: **4.000**  
2nd Value:  
Value Percent:  
Continuous Index:  
Within 8" of Joint:  
Remarks:

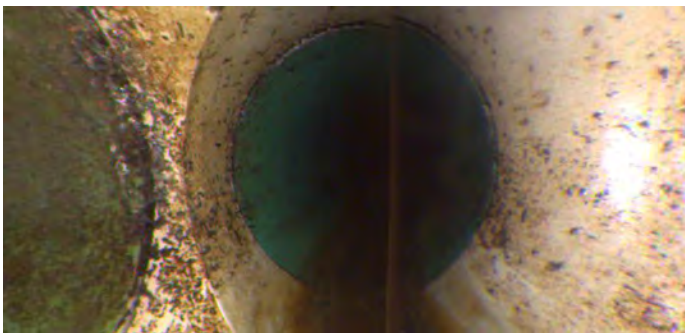
Code: **TF**  
Description: **Tap Factory**

Distance (ft): **100.6**  
Structural Grade: **0**  
O&M Grade: **0**  
Clock Start/From: **3**  
Clock To:  
1st Value: **4.000**  
2nd Value:  
Value Percent:  
Continuous Index:  
Within 8" of Joint:  
Remarks:

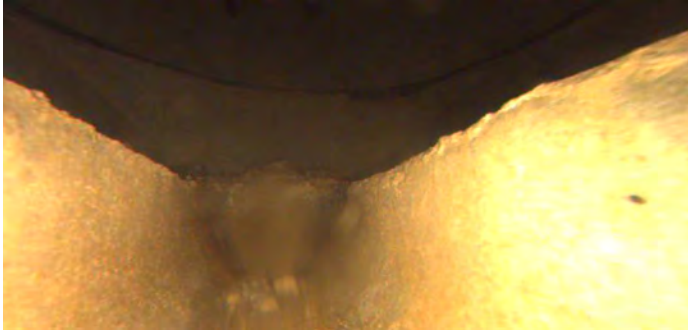
Code:	<b>AMH</b>
Description:	<b>Manhole</b>
Distance (ft):	<b>107.2</b>
Structural Grade:	<b>0</b>
O&M Grade:	<b>0</b>
Clock Start/From:	
Clock To:	
1st Value:	
2nd Value:	
Value Percent:	
Continuous Index:	
Within 8" of Joint:	<b>NO</b>
Remarks:	<b>M-806-051</b>
