Profile/Ph	oto Observatio	n Report				RedZon
Date:	04/12/2018	Weather:			Coding:	PACP 6.0
Pipe Length (ft): 116.4	Owner:	NA		Pre Clean:	Not Known
P.O.#:		Surveyor:	Jen Costell	C	PSR:	P-806-056-057
Customer:		Clean Date	: 01/01/190	ט	Shape:	с
Street:	DEER CROSS TRL		Flow Control	:	Not Controlled	
City:	Hobart, IN		Year Renewe	ed:		
Location:	Sidewalk		Tape/Media	#:		
Purpose:	Maintenance Rela	ated	Dia/Height:		8"	
Use:	Sanitary		Material:		PVC	
Drain Area:	NA		Lining:		Cured in Place	
Category:	NA					
Comment:	mh confirmed.					
Location Detail	ls:		Direction of	Survey:	Upstream	
US MH:	M-806-056	DS MH:	M-806-057	To	tal Length Surveyed (ft):	113.3
0&M Index:	2.00	O&M Quick	:	2100	O&M Rating:	2.00
Structural Index:	0.00	Structural C	uick:	0000	Structural Rating:	0.00
Overall Index:	2.00	Overall Qui	ck:	2100	Overall Rating:	2.00

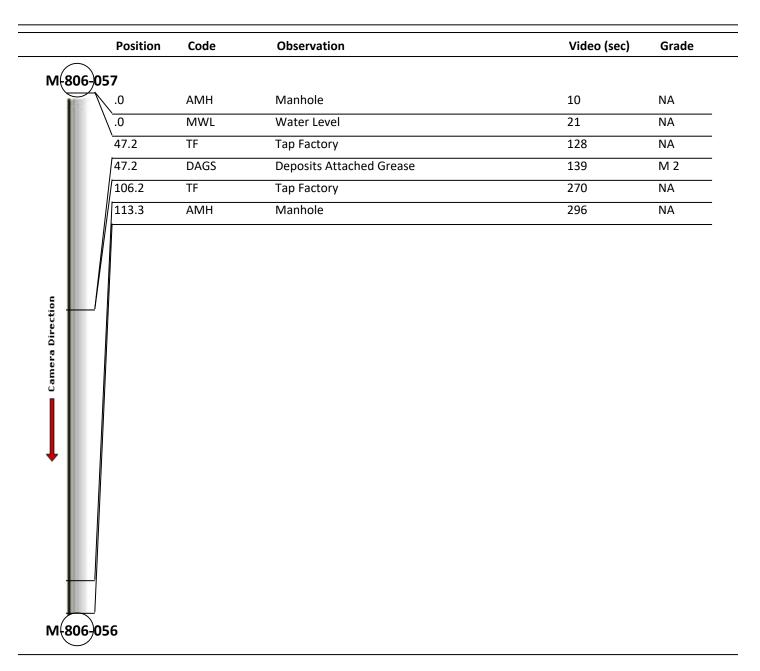
Code:	АМН
Description:	Manhole
Distance (ft):	.0
Structural Grade:	0
O&M Grade:	0
Clock Start/From:	
Clock To:	
1st Value:	
2nd Value:	
Value Percent:	
Continuous Index:	
Within 8" of Joint:	NO
Remarks:	M-806-057
