Profile/Photo Observation Report

Street:	DEER CROSS TRL	Flow Control:	Not Controlled
City:	Hobart, IN	Year Renewed:	
Location:	Sidewalk	Tape/Media #:	
Purpose:	Maintenance Related	Dia/Height:	8"
Use:	Sanitary	Material:	PVC
Drain Area:	NA	Lining:	Cured in Place
Category:	NA		
Comment:

Location Details:		Direction of Survey:	Downstream
US MH:	M-806-057	DS MH:	M-806-055
		Total Length Surveyed (ft):	77.2

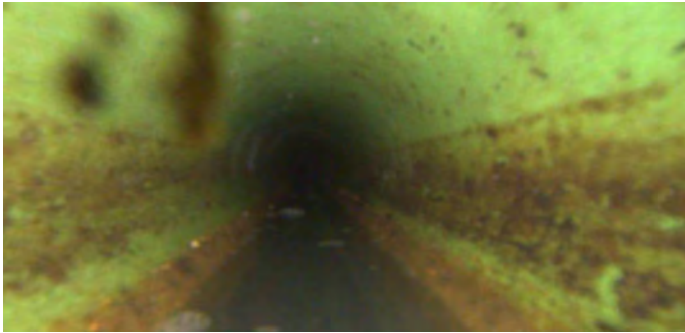
Code:	MWL
Description:	Water Level

Distance (ft):	.0
Structural Grade:	0
O&M Grade:	0
Clock Start/From:	
Clock To:	
1st Value:	
2nd Value:	
Value Percent:	5.000
Continuous Index:	
Within 8" of Joint:	NO
Remarks:

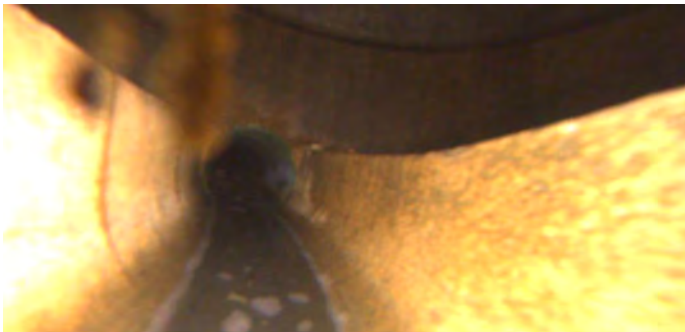
Code:	AMH
Description:	Manhole

Distance (ft):	77.2
Structural Grade:	0
O&M Grade:	0
Clock Start/From:	
Clock To:	
1st Value:	
2nd Value:	
Value Percent:	
Continuous Index:	
Within 8" of Joint:	NO
Remarks:	M-806-055
