Profile/Photo Observation Report

Street:	DEER CROSS TRL	Flow Control:	Not Controlled
City:	Hobart, IN	Year Renewed:	
Location:	Sidewalk	Tape/Media #:	
Purpose:	Maintenance Related	Dia/Height:	8"
Use:	Sanitary	Material:	PVC
Drain Area:	NA	Lining:	Cured in Place
Category:	NA		
Comment:

Location Details:		Direction of Survey:	Downstream
US MH:	M-806-057	DS MH:	M-806-058
		Total Length Surveyed (ft):	188.2

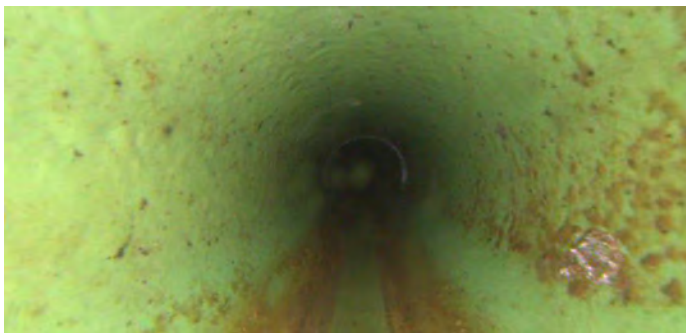
Code: **AMH**
Description: **Manhole**

Distance (ft): **.0**
Structural Grade: **0**
O&M Grade: **0**
Clock Start/From:
Clock To:
1st Value:
2nd Value:
Value Percent:
Continuous Index:
Within 8" of Joint: **NO**
Remarks: **M-806-057**

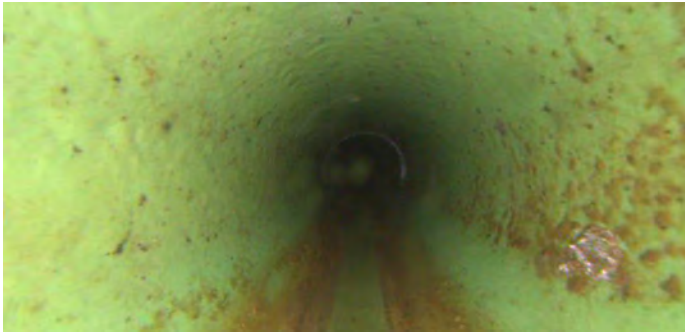
Code:	MWL
Description:	Water Level

Distance (ft):	.0
Structural Grade:	0
O&M Grade:	0
Clock Start/From:	
Clock To:	
1st Value:	
2nd Value:	
Value Percent:	5.000
Continuous Index:	
Within 8" of Joint:	NO
Remarks:

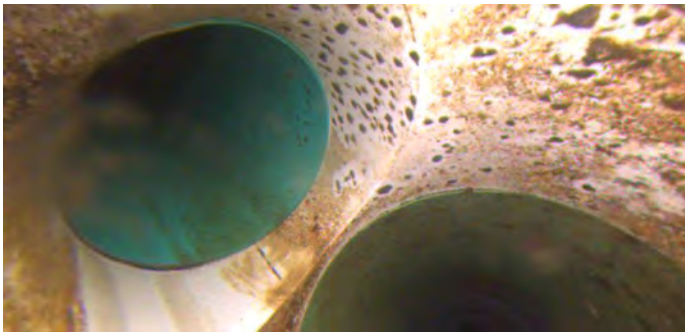
Code:	TF
Description:	Tap Factory

Distance (ft):	16.3
Structural Grade:	0
O&M Grade:	0
Clock Start/From:	1
Clock To:	
1st Value:	4.000
2nd Value:	
Value Percent:	
Continuous Index:	
Within 8" of Joint:	
Remarks:

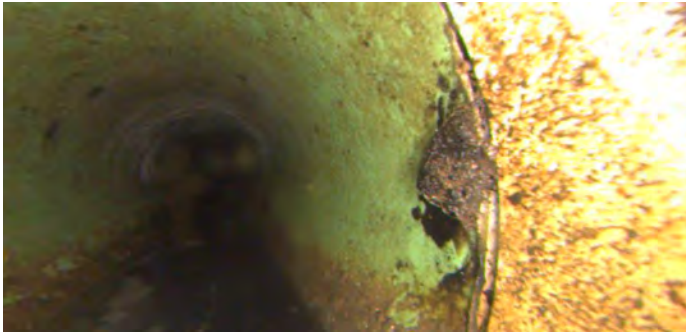
Code: **RFJ**
Description: **Roots Fine Joint**

Distance (ft): **16.3**
Structural Grade: **0**
O&M Grade: **1**
Clock Start/From: **3**
Clock To:
1st Value:
2nd Value:
Value Percent:
Continuous Index:
Within 8" of Joint: **YES**
Remarks:

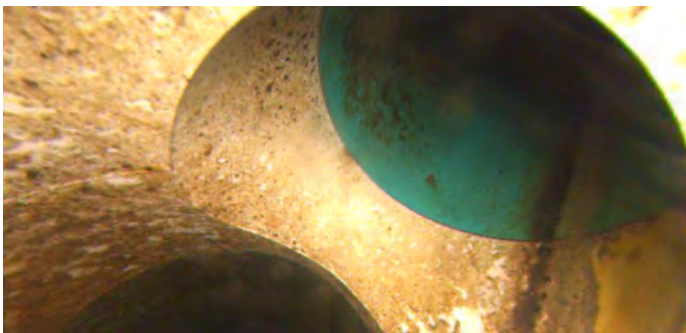
Code: **TF**
Description: **Tap Factory**

Distance (ft): **157.3**
Structural Grade: **0**
O&M Grade: **0**
Clock Start/From: **2**
Clock To:
1st Value: **4.000**
2nd Value:
Value Percent:
Continuous Index:
Within 8" of Joint:
Remarks:

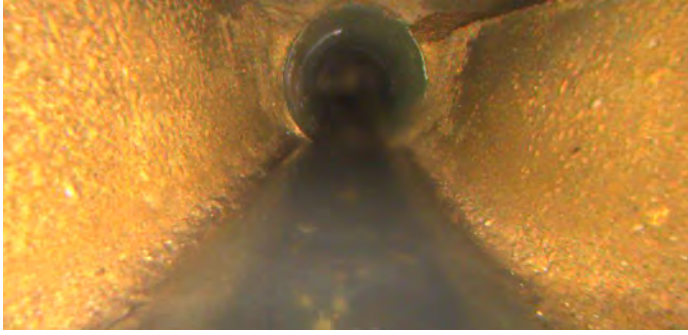
Code:	AMH
Description:	Manhole
Distance (ft):	188.2
Structural Grade:	0
O&M Grade:	0
Clock Start/From:	
Clock To:	
1st Value:	
2nd Value:	
Value Percent:	
Continuous Index:	
Within 8" of Joint:	NO
Remarks:	M-806-058
