Profile/Photo Observation Report

Date:	04/12/2018	Weather:		Coding:	PACP 6.0
Pipe Length (ft):	191.2	Owner:	NA	Pre Clean:	Not Known
P.O.#:		Surveyor:	Jen Costello	PSR:	P-806-057-058
Customer:		Clean Date:	01/01/1900	Shape:	C

Street:	Capitol	Flow Control:	Not Controlled
City:	Hobart, IN	Year Renewed:	
Location:	Sidewalk	Tape/Media #:	
Purpose:	Maintenance Related	Dia/Height:	8"
Use:	Sanitary	Material:	PVC
Drain Area:	NA	Lining:	Cured in Place
Category:	NA		
Comment:

Location Details:		Direction of Survey:	Downstream
US MH:	M-806-057	DS MH:	M-806-058
		Total Length Surveyed (ft):	188.2

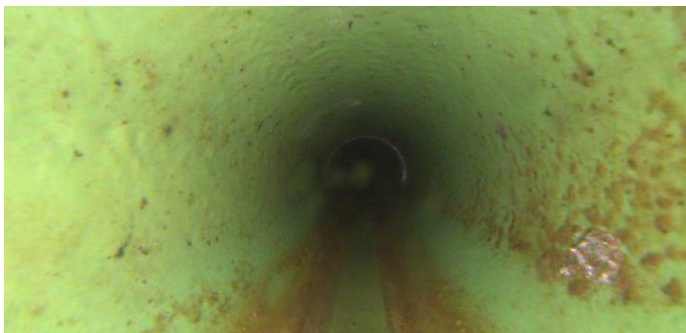
Code: **AMH**
Description: **Manhole**

Distance (ft): **.0**
Structural Grade: **0**
O&M Grade: **0**
Clock Start/From:
Clock To:
1st Value:
2nd Value:
Value Percent:
Continuous Index:
Within 8" of Joint: **NO**
Remarks: **M-806-057**

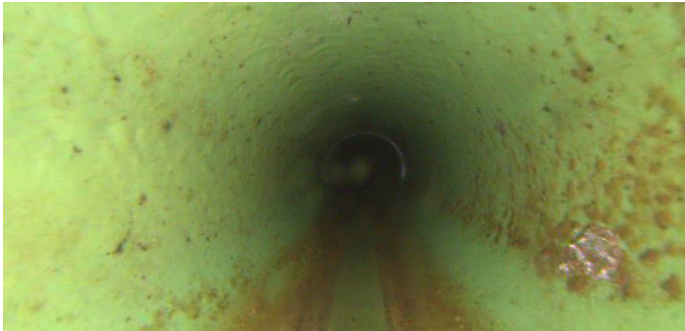
Code:	MWL
Description:	Water Level

Distance (ft):	.0
Structural Grade:	0
O&M Grade:	0
Clock Start/From:	
Clock To:	
1st Value:	
2nd Value:	
Value Percent:	5.000
Continuous Index:	
Within 8" of Joint:	NO
Remarks:

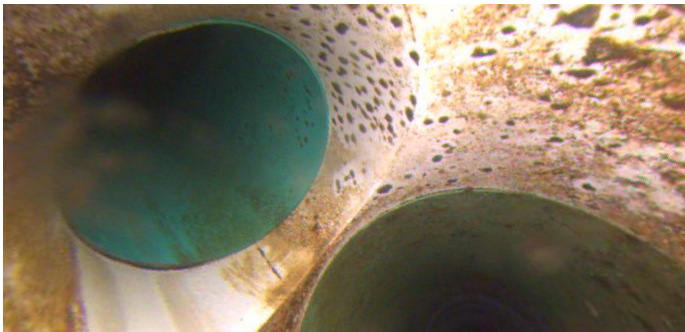
Code:	TF
Description:	Tap Factory

Distance (ft):	16.3
Structural Grade:	0
O&M Grade:	0
Clock Start/From:	1
Clock To:	
1st Value:	4.000
2nd Value:	
Value Percent:	
Continuous Index:	
Within 8" of Joint:	
Remarks:

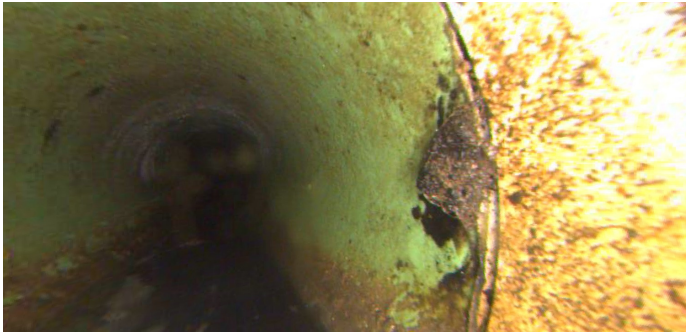
Code: **RFJ**
Description: **Roots Fine Joint**

Distance (ft): **16.3**
Structural Grade: **0**
O&M Grade: **1**
Clock Start/From: **3**
Clock To:
1st Value:
2nd Value:
Value Percent:
Continuous Index:
Within 8" of Joint: **YES**
Remarks:

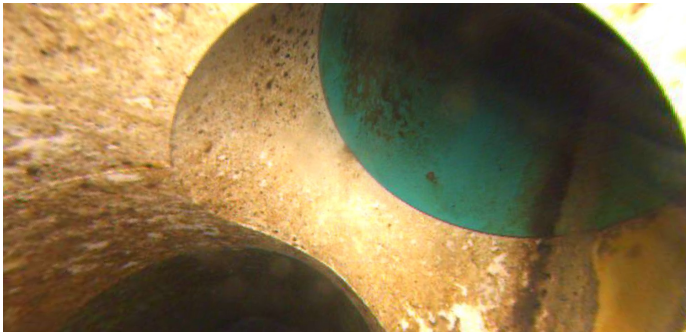
Code: **TF**
Description: **Tap Factory**

Distance (ft): **157.3**
Structural Grade: **0**
O&M Grade: **0**
Clock Start/From: **2**
Clock To:
1st Value: **4.000**
2nd Value:
Value Percent:
Continuous Index:
Within 8" of Joint:
Remarks:

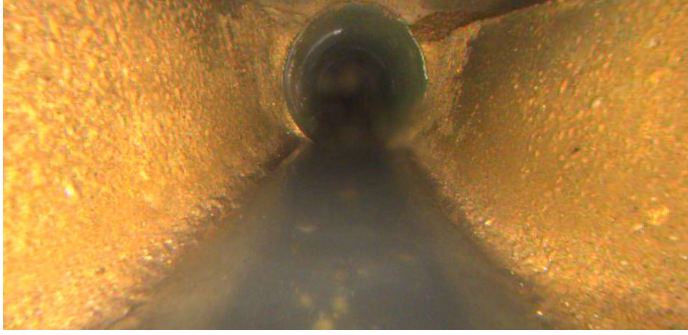
Code:	AMH
Description:	Manhole
Distance (ft):	188.2
Structural Grade:	0
O&M Grade:	0
Clock Start/From:	
Clock To:	
1st Value:	
2nd Value:	
Value Percent:	
Continuous Index:	
Within 8" of Joint:	NO
Remarks:	M-806-058
