Profile/Photo Observation Report

Date:	04/14/2018	Weather:		Coding:	PACP 6.0
Pipe Length (ft):		Owner:	City of Hobart	Pre Clean:	Not Known
P.O.#:	254	Surveyor:	B. Helbling	PSR:	P-806-062-035
Customer:	City of Hobart	Clean Date:		Shape:	C

Street:	East 10th Street	Flow Control:	Not Controlled
City:	Hobart, IN	Year Renewed:	
Location:	Sidewalk	Tape/Media #:	DEP254
Purpose:	Routine Assessment	Dia/Height:	15"
Use:	Sanitary	Material:	PVC
Drain Area:		Lining:	
Category:	NA		
Comment:	YES501824 Submittal 2		
Location Details:		Direction of Survey:	Upstream
US MH:	M-806-062	DS MH:	M-806-035
		Total Length Surveyed (ft):	145.8

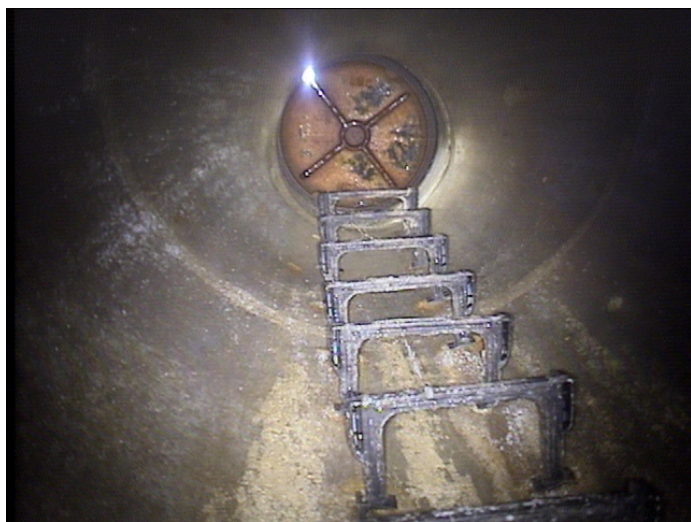
Code: **AMH**
Description: **Manhole**

Distance (ft): **.0**
Structural Grade: **0**
O&M Grade: **0**
Clock Start/From:
Clock To:
1st Value:
2nd Value:
Value Percent:
Continuous Index:
Within 8" of Joint: **NO**
Remarks: **M-806-035**

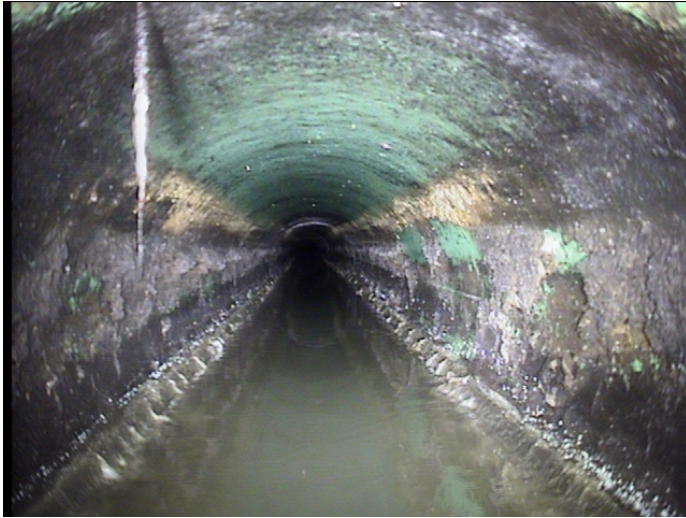
Code: **MWL**
Description: **Water Level**

Distance (ft): **.0**
Structural Grade: **0**
O&M Grade: **0**
Clock Start/From:
Clock To:
1st Value:
2nd Value:
Value Percent: **10.000**
Continuous Index:
Within 8" of Joint: **NO**
Remarks:

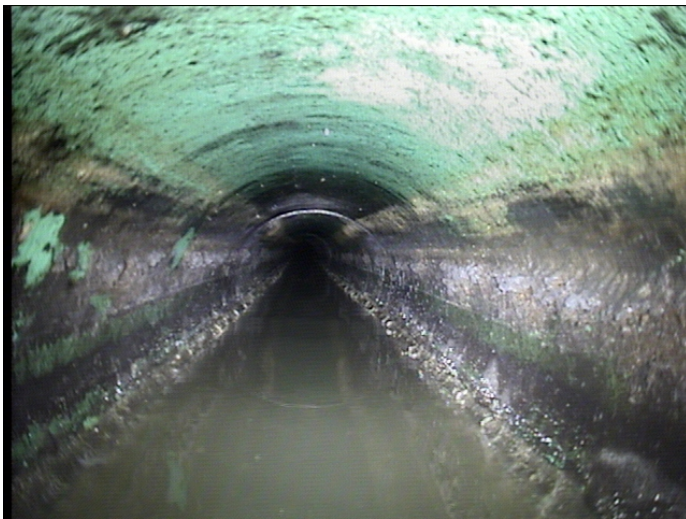
Code: **DSF**
Description: **Deposits Settled Fine**

Distance (ft): **4.9**
Structural Grade: **0**
O&M Grade: **2**
Clock Start/From: **5**
Clock To: **7**
1st Value:
2nd Value:
Value Percent: **5.000**
Continuous Index: **S01**
Within 8" of Joint: **NO**
Remarks:

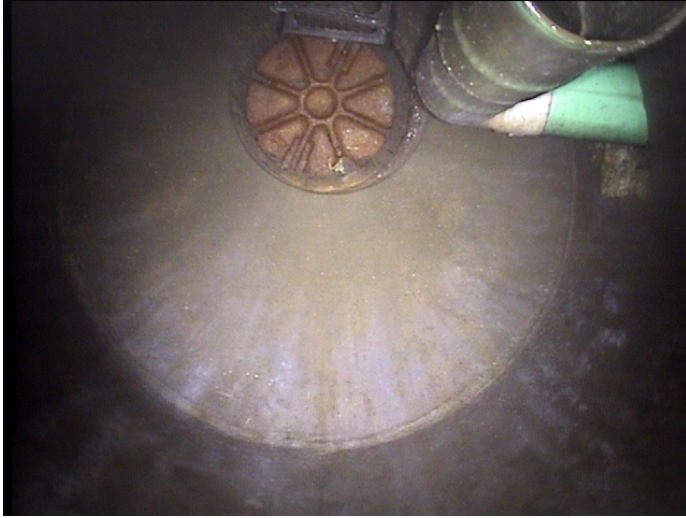
Code: **DSF**
Description: **Deposits Settled Fine**

Distance (ft): **145.8**
Structural Grade: **0**
O&M Grade: **2**
Clock Start/From: **5**
Clock To: **7**
1st Value:
2nd Value:
Value Percent: **5.000**
Continuous Index: **F01**
Within 8" of Joint: **NO**
Remarks:

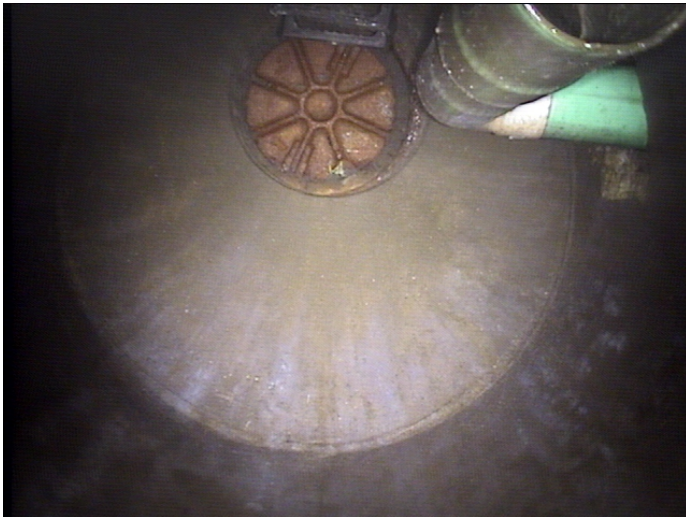
Code: **AMH**
Description: **Manhole**

Distance (ft): **145.8**
Structural Grade: **0**
O&M Grade: **0**
Clock Start/From:
Clock To:
1st Value:
2nd Value:
Value Percent:
Continuous Index:
Within 8" of Joint: **NO**
Remarks: **M-806-062**
