## Profile/Photo Observation Report

Street:	<b>East 10th Street</b>	Flow Control:	<b>Not Controlled</b>
City:	<b>Hobart, IN</b>	Year Renewed:	
Location:	<b>Sidewalk</b>	Tape/Media #:	<b>DEP253</b>
Purpose:	<b>Routine Assessment</b>	Dia/Height:	<b>15"</b>
Use:	<b>Sanitary</b>	Material:	<b>PVC</b>
Drain Area:		Lining:	
Category:	<b>NA</b>		
Comment:	<b>YES501824 Submittal 2</b>		
Location Details:		Direction of Survey:	<b>Downstream</b>
US MH:	<b>M-806-064</b>	DS MH:	<b>M-806-036</b>
		Total Length Surveyed (ft):	<b>94.4</b>

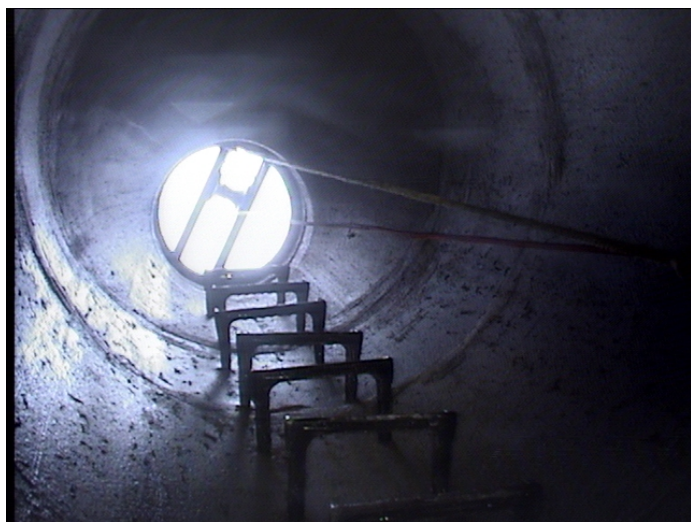
Code: **AMH**  
 Description: **Manhole**

Distance (ft): **.0**  
 Structural Grade: **0**  
 O&M Grade: **0**  
 Clock Start/From:  
 Clock To:  
 1st Value:  
 2nd Value:  
 Value Percent:  
 Continuous Index:  
 Within 8" of Joint: **NO**  
 Remarks: **M-806-064**

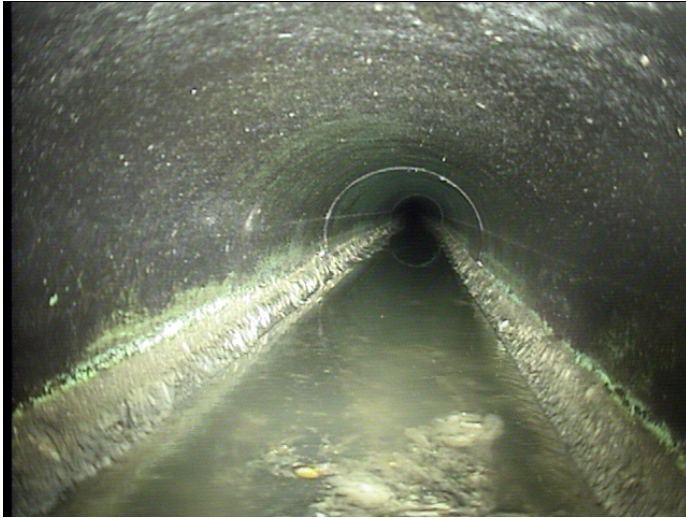
Code: **MWL**  
Description: **Water Level**

Distance (ft): **.0**  
Structural Grade: **0**  
O&M Grade: **0**  
Clock Start/From:  
Clock To:  
1st Value:  
2nd Value:  
Value Percent: **15.000**  
Continuous Index:  
Within 8" of Joint: **NO**  
Remarks:

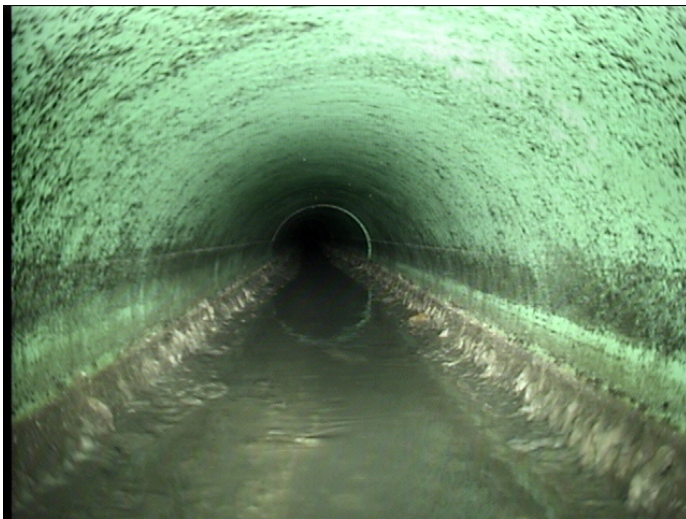
Code: **DSF**  
Description: **Deposits Settled Fine**

Distance (ft): **8.0**  
Structural Grade: **0**  
O&M Grade: **3**  
Clock Start/From: **5**  
Clock To: **7**  
1st Value:  
2nd Value:  
Value Percent: **20.000**  
Continuous Index: **S01**  
Within 8" of Joint: **NO**  
Remarks:

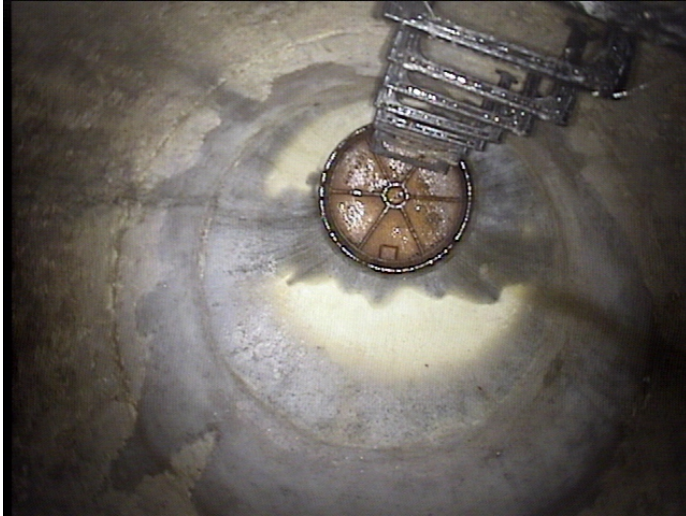
Code: **AMH**  
Description: **Manhole**

Distance (ft): **94.4**  
Structural Grade: **0**  
O&M Grade: **0**  
Clock Start/From:  
Clock To:  
1st Value:  
2nd Value:  
Value Percent:  
Continuous Index:  
Within 8" of Joint: **NO**  
Remarks: **M-806-036**

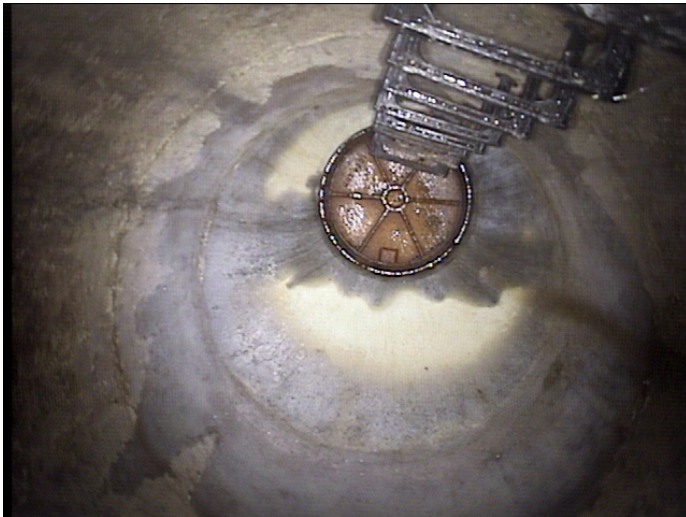
Code: **DSF**  
Description: **Deposits Settled Fine**

Distance (ft): **94.4**  
Structural Grade: **0**  
O&M Grade: **3**  
Clock Start/From: **5**  
Clock To: **7**  
1st Value:  
2nd Value:  
Value Percent: **20.000**  
Continuous Index: **F01**  
Within 8" of Joint: **NO**  
Remarks:
