Profile/Photo Observation Report

Street:	E 12TH ST	Flow Control:	Not Controlled
City:	Hobart, IN	Year Renewed:	
Location:	Light Highway	Tape/Media #:	
Purpose:	Maintenance Related	Dia/Height:	10"
Use:	Sanitary	Material:	PVC
Drain Area:	NA	Lining:	Cured in Place
Category:	NA		
Comment:	Reverse setup. flow incorrect.

Location Details:		Direction of Survey:	Downstream
US MH:	M-807-003	DS MH:	M-807-002
		Total Length Surveyed (ft):	382.5

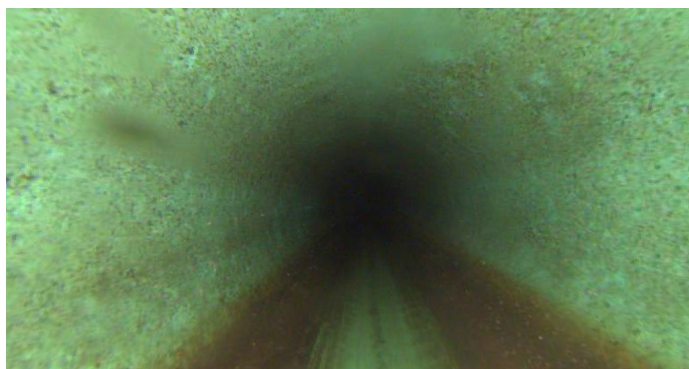
Code: **AMH**
Description: **Manhole**

Distance (ft): **.0**
Structural Grade: **0**
O&M Grade: **0**
Clock Start/From:
Clock To:
1st Value:
2nd Value:
Value Percent:
Continuous Index:
Within 8" of Joint: **NO**
Remarks: **M-807-003**

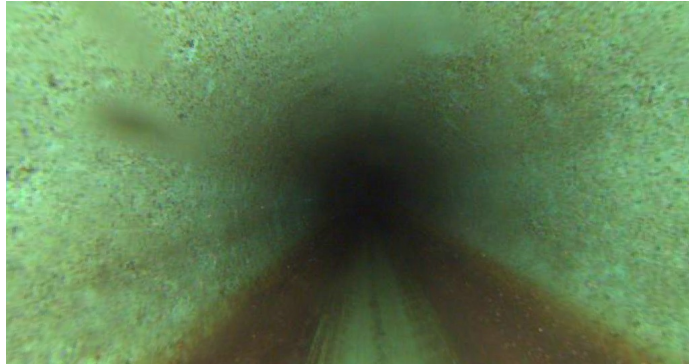
Code: **MWL**
Description: **Water Level**

Distance (ft): **.0**
Structural Grade: **0**
O&M Grade: **0**
Clock Start/From:
Clock To:
1st Value:
2nd Value:
Value Percent: **10.000**
Continuous Index:
Within 8" of Joint: **NO**
Remarks:

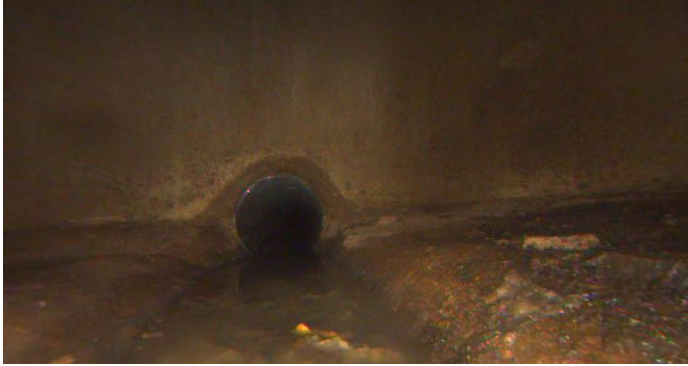
Code:	AMH
Description:	Manhole
Distance (ft):	382.5
Structural Grade:	0
O&M Grade:	0
Clock Start/From:	
Clock To:	
1st Value:	
2nd Value:	
Value Percent:	
Continuous Index:	
Within 8" of Joint:	NO
Remarks:	M-807-002
