## Profile/Photo Observation Report

Street:	<b>Capitol</b>	Flow Control:	<b>Not Controlled</b>
City:	<b>Hobart, IN</b>	Year Renewed:	
Location:	<b>Light Highway</b>	Tape/Media #:	
Purpose:	<b>Maintenance Related</b>	Dia/Height:	<b>10"</b>
Use:	<b>Sanitary</b>	Material:	<b>PVC</b>
Drain Area:	<b>NA</b>	Lining:	<b>Cured in Place</b>
Category:	<b>NA</b>		
Comment:	<b>Reverse setup. flow incorrect.</b>

Location Details:		Direction of Survey:	<b>Downstream</b>
US MH:	<b>M-807-003</b>	DS MH:	<b>M-807-002</b>
		Total Length Surveyed (ft):	<b>382.5</b>

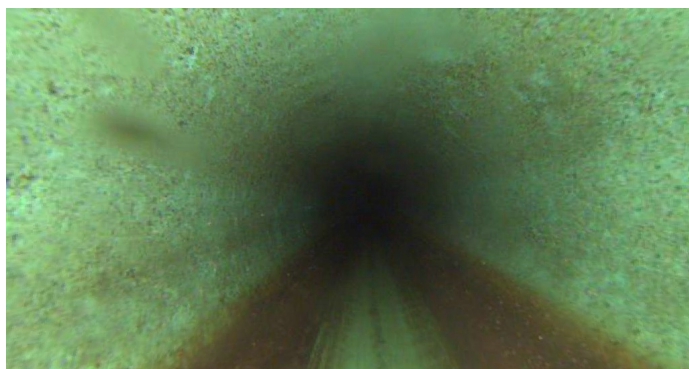
Code: **AMH**  
Description: **Manhole**

Distance (ft): **.0**  
Structural Grade: **0**  
O&M Grade: **0**  
Clock Start/From:  
Clock To:  
1st Value:  
2nd Value:  
Value Percent:  
Continuous Index:  
Within 8" of Joint: **NO**  
Remarks: **M-807-003**

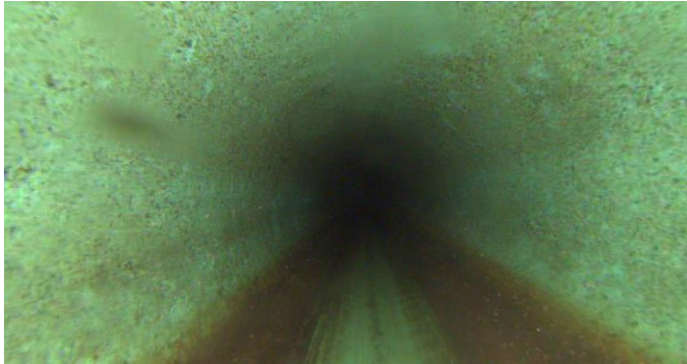
Code: **MWL**  
Description: **Water Level**

Distance (ft): **.0**  
Structural Grade: **0**  
O&M Grade: **0**  
Clock Start/From:  
Clock To:  
1st Value:  
2nd Value:  
Value Percent: **10.000**  
Continuous Index:  
Within 8" of Joint: **NO**  
Remarks:

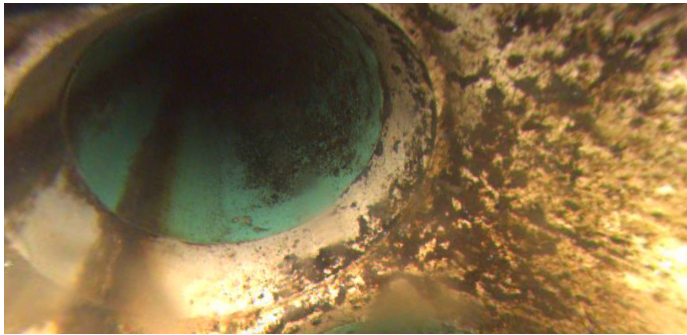
Code: **TF**  
Description: **Tap Factory**

Distance (ft): **15.0**  
Structural Grade: **0**  
O&M Grade: **0**  
Clock Start/From: **11**  
Clock To:  
1st Value: **4.000**  
2nd Value:  
Value Percent:  
Continuous Index:  
Within 8" of Joint:  
Remarks:

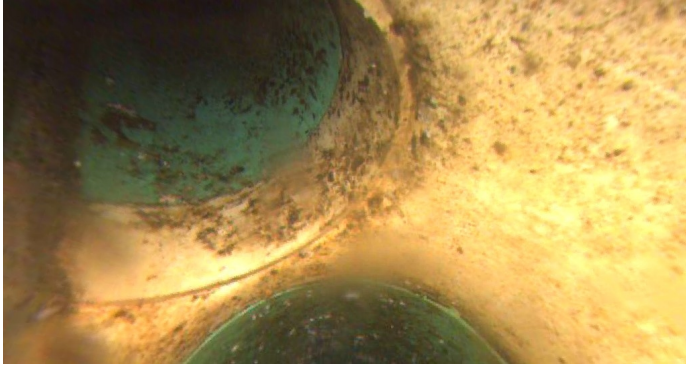
Code: **TF**  
Description: **Tap Factory**

Distance (ft): **52.7**  
Structural Grade: **0**  
O&M Grade: **0**  
Clock Start/From: **10**  
Clock To:  
1st Value: **4.000**  
2nd Value:  
Value Percent:  
Continuous Index:  
Within 8" of Joint:  
Remarks:

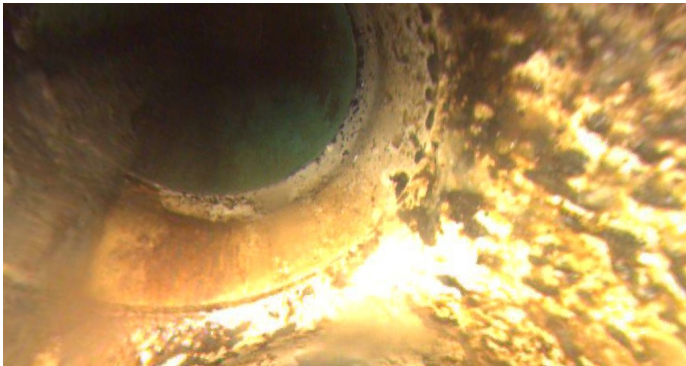
Code: **TF**  
Description: **Tap Factory**

Distance (ft): **187.4**  
Structural Grade: **0**  
O&M Grade: **0**  
Clock Start/From: **11**  
Clock To:  
1st Value: **4.000**  
2nd Value:  
Value Percent:  
Continuous Index:  
Within 8" of Joint:  
Remarks:

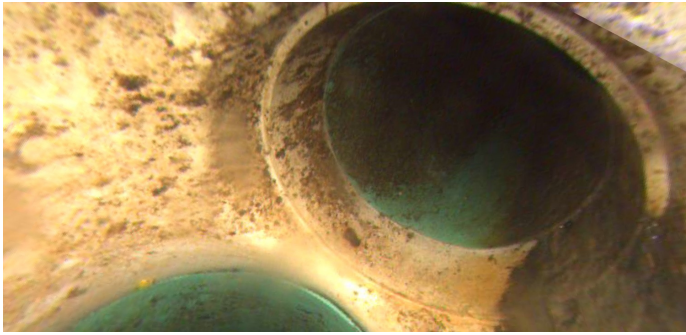
Code: **TF**  
Description: **Tap Factory**

Distance (ft): **207.0**  
Structural Grade: **0**  
O&M Grade: **0**  
Clock Start/From: **1**  
Clock To:  
1st Value: **4.000**  
2nd Value:  
Value Percent:  
Continuous Index:  
Within 8" of Joint:  
Remarks:

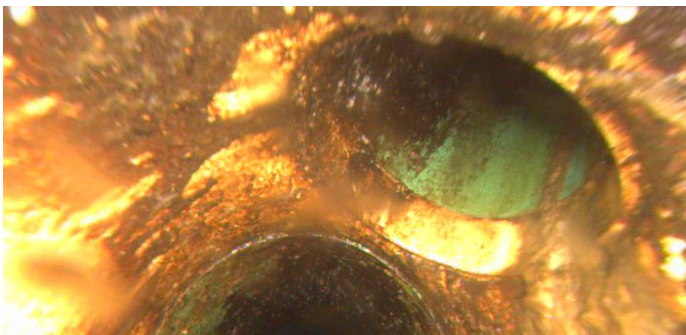
Code: **TF**  
Description: **Tap Factory**

Distance (ft): **276.8**  
Structural Grade: **0**  
O&M Grade: **0**  
Clock Start/From: **1**  
Clock To:  
1st Value: **4.000**  
2nd Value:  
Value Percent:  
Continuous Index:  
Within 8" of Joint:  
Remarks:

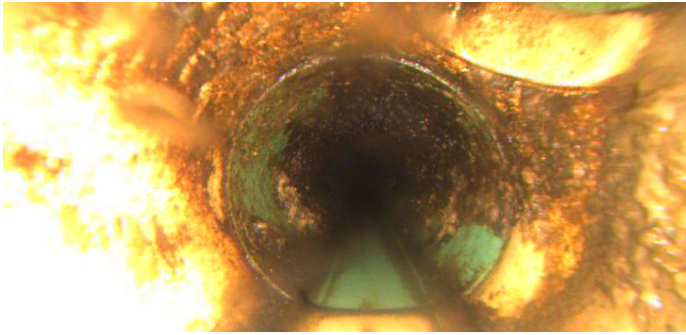
Code: **DAGS**  
Description: **Deposits Attached Grease**

Distance (ft): **276.9**  
Structural Grade: **0**  
O&M Grade: **2**  
Clock Start/From: **8**  
Clock To: **4**  
1st Value:  
2nd Value:  
Value Percent: **5.000**  
Continuous Index:  
Within 8" of Joint: **NO**  
Remarks:

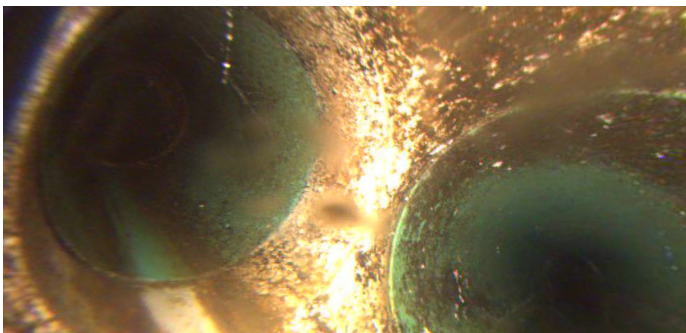
Code: **TF**  
Description: **Tap Factory**

Distance (ft): **360.8**  
Structural Grade: **0**  
O&M Grade: **0**  
Clock Start/From: **10**  
Clock To:  
1st Value: **4.000**  
2nd Value:  
Value Percent:  
Continuous Index:  
Within 8" of Joint:  
Remarks:

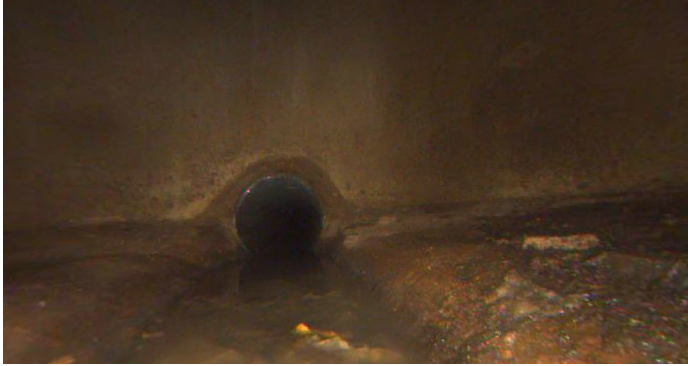
Code:	AMH
Description:	Manhole
Distance (ft):	382.5
Structural Grade:	0
O&M Grade:	0
Clock Start/From:	
Clock To:	
1st Value:	
2nd Value:	
Value Percent:	
Continuous Index:	
Within 8" of Joint:	NO
Remarks:	M-807-002
