Profile/Photo Observation Report

Street:	E 12TH ST	Flow Control:	Not Controlled
City:	Hobart, IN	Year Renewed:	
Location:	Light Highway	Tape/Media #:	
Purpose:	Maintenance Related	Dia/Height:	10"
Use:	Sanitary	Material:	PVC
Drain Area:	NA	Lining:	Cured in Place
Category:	NA		
Comment:	flow incorrect.

Location Details:		Direction of Survey:	Downstream
US MH:	M-807-004	DS MH:	M-807-003
		Total Length Surveyed (ft):	366.2

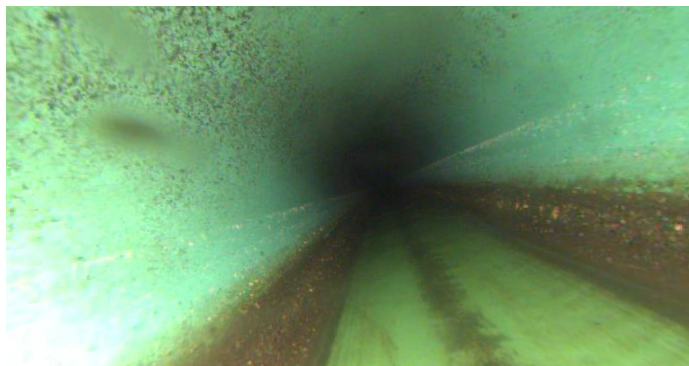
Code: **AMH**
Description: **Manhole**

Distance (ft): **.0**
Structural Grade: **0**
O&M Grade: **0**
Clock Start/From:
Clock To:
1st Value:
2nd Value:
Value Percent:
Continuous Index:
Within 8" of Joint: **NO**
Remarks: **M-807-004**

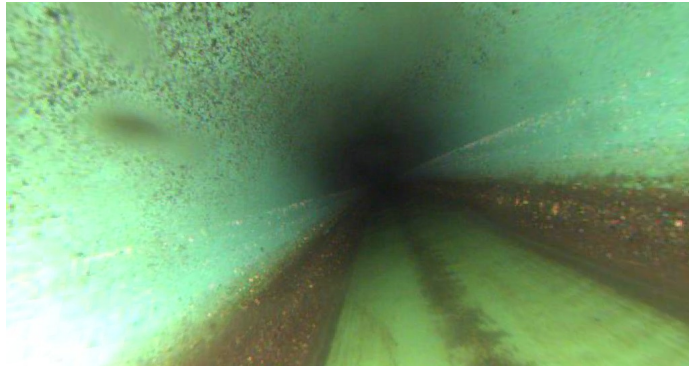
Code: **MWL**
Description: **Water Level**

Distance (ft): **.0**
Structural Grade: **0**
O&M Grade: **0**
Clock Start/From:
Clock To:
1st Value:
2nd Value:
Value Percent: **10.000**
Continuous Index:
Within 8" of Joint: **NO**
Remarks:

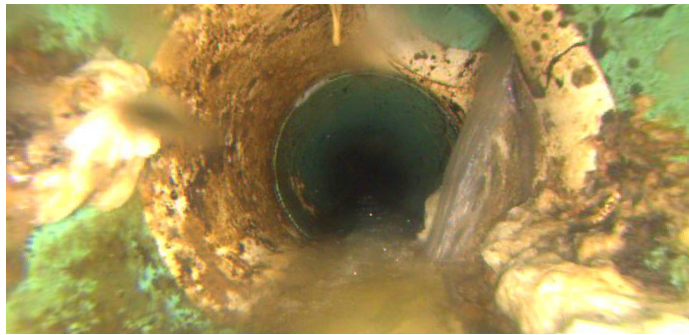
Code: **DAGS**
Description: **Deposits Attached Grease**

Distance (ft): **41.9**
Structural Grade: **0**
O&M Grade: **2**
Clock Start/From: **8**
Clock To: **4**
1st Value:
2nd Value:
Value Percent: **5.000**
Continuous Index:
Within 8" of Joint: **NO**
Remarks:

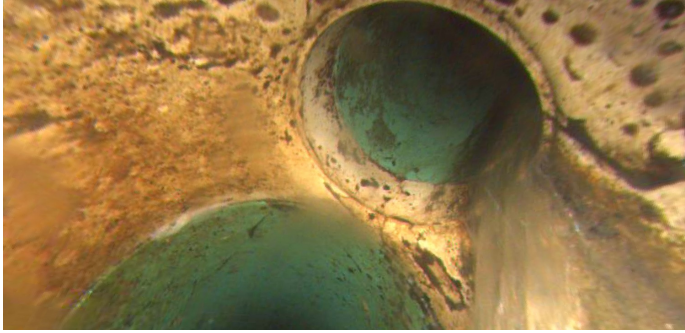
Code: **TFA**
Description: **Tap Factory Active**

Distance (ft): **42.4**
Structural Grade: **0**
O&M Grade: **0**
Clock Start/From: **1**
Clock To:
1st Value: **4.000**
2nd Value:
Value Percent:
Continuous Index:
Within 8" of Joint:
Remarks:

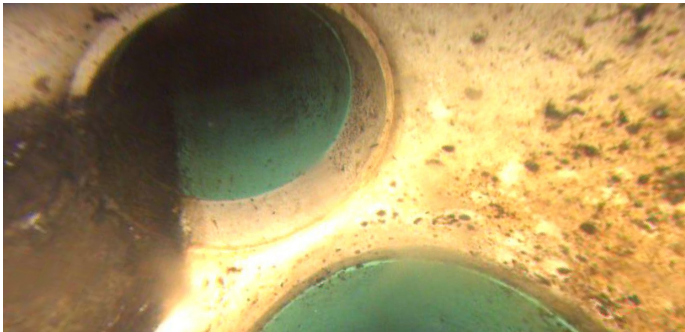
Code: **TFA**
Description: **Tap Factory Active**

Distance (ft): **55.7**
Structural Grade: **0**
O&M Grade: **0**
Clock Start/From: **11**
Clock To:
1st Value: **4.000**
2nd Value:
Value Percent:
Continuous Index:
Within 8" of Joint:
Remarks:

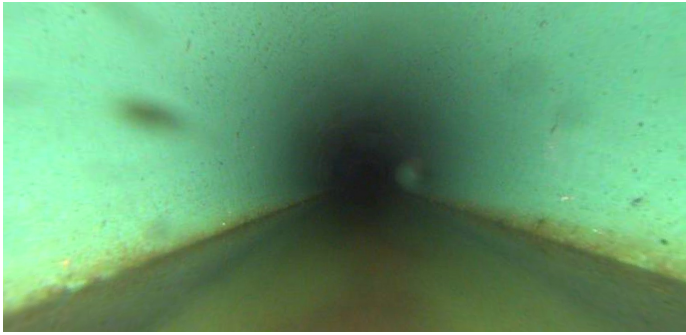
Code: **MWL**
Description: **Water Level**

Distance (ft): **87.2**
Structural Grade: **0**
O&M Grade: **0**
Clock Start/From:
Clock To:
1st Value:
2nd Value:
Value Percent: **30.000**
Continuous Index:
Within 8" of Joint: **NO**
Remarks:

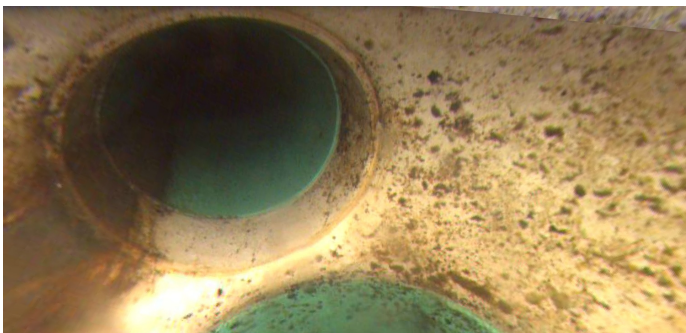
Code: **TF**
Description: **Tap Factory**

Distance (ft): **154.7**
Structural Grade: **0**
O&M Grade: **0**
Clock Start/From: **11**
Clock To:
1st Value: **4.000**
2nd Value:
Value Percent:
Continuous Index:
Within 8" of Joint:
Remarks:

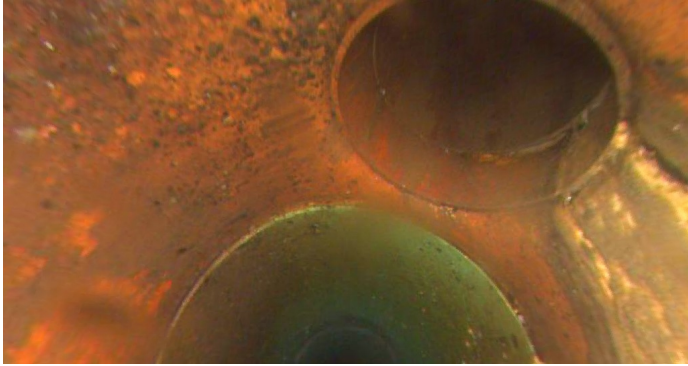
Code: **TF**
Description: **Tap Factory**

Distance (ft): **194.8**
Structural Grade: **0**
O&M Grade: **0**
Clock Start/From: **1**
Clock To:
1st Value: **4.000**
2nd Value:
Value Percent:
Continuous Index:
Within 8" of Joint:
Remarks:

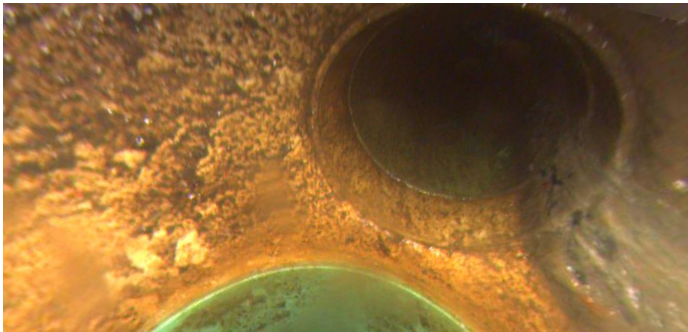
Code: **TF**
Description: **Tap Factory**

Distance (ft): **225.6**
Structural Grade: **0**
O&M Grade: **0**
Clock Start/From: **1**
Clock To:
1st Value: **4.000**
2nd Value:
Value Percent:
Continuous Index:
Within 8" of Joint:
Remarks:

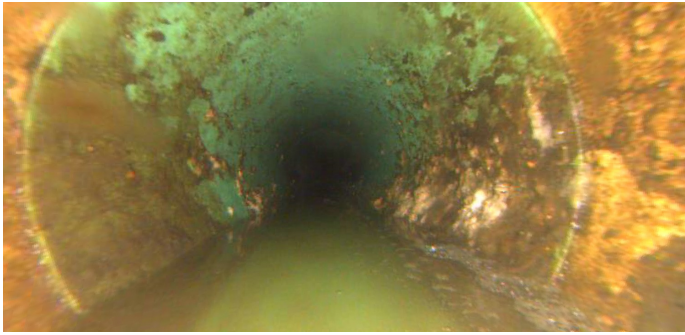
Code: **DAGS**
Description: **Deposits Attached Grease**

Distance (ft): **225.8**
Structural Grade: **0**
O&M Grade: **2**
Clock Start/From: **3**
Clock To: **4**
1st Value:
2nd Value:
Value Percent: **5.000**
Continuous Index:
Within 8" of Joint: **NO**
Remarks:

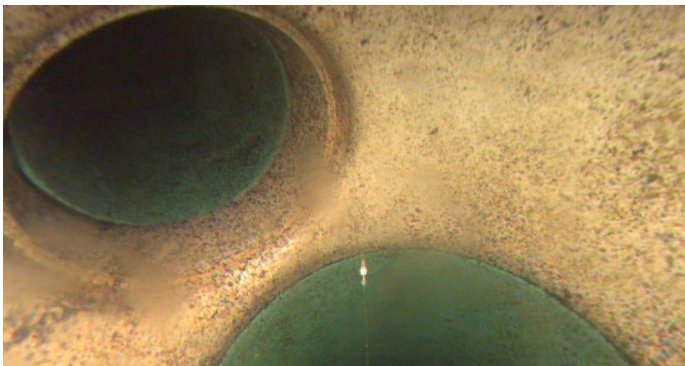
Code: **TF**
Description: **Tap Factory**

Distance (ft): **255.3**
Structural Grade: **0**
O&M Grade: **0**
Clock Start/From: **10**
Clock To:
1st Value: **4.000**
2nd Value:
Value Percent:
Continuous Index:
Within 8" of Joint:
Remarks:

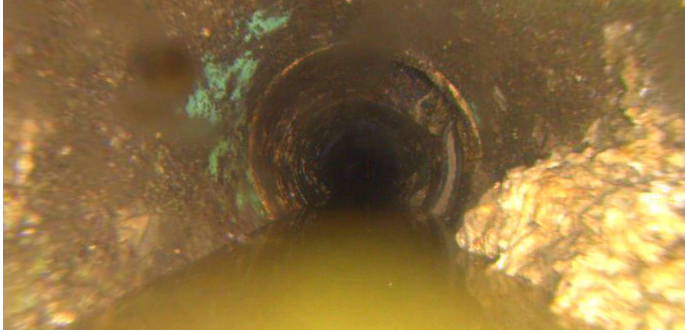
Code: **DAGS**
Description: **Deposits Attached Grease**

Distance (ft): **331.9**
Structural Grade: **0**
O&M Grade: **2**
Clock Start/From: **3**
Clock To: **4**
1st Value:
2nd Value:
Value Percent: **10.000**
Continuous Index:
Within 8" of Joint: **NO**
Remarks:

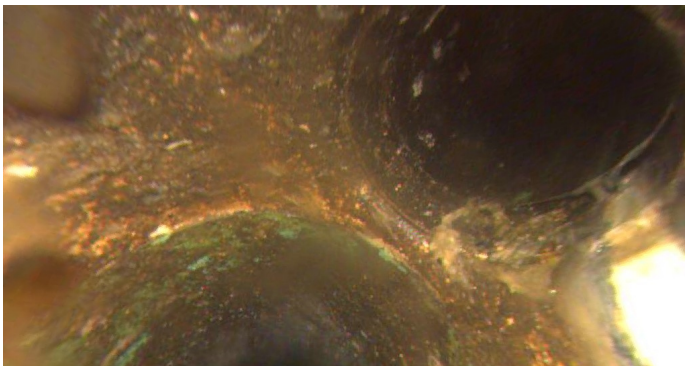
Code: **TF**
Description: **Tap Factory**

Distance (ft): **333.0**
Structural Grade: **0**
O&M Grade: **0**
Clock Start/From: **2**
Clock To:
1st Value: **4.000**
2nd Value:
Value Percent:
Continuous Index:
Within 8" of Joint:
Remarks:

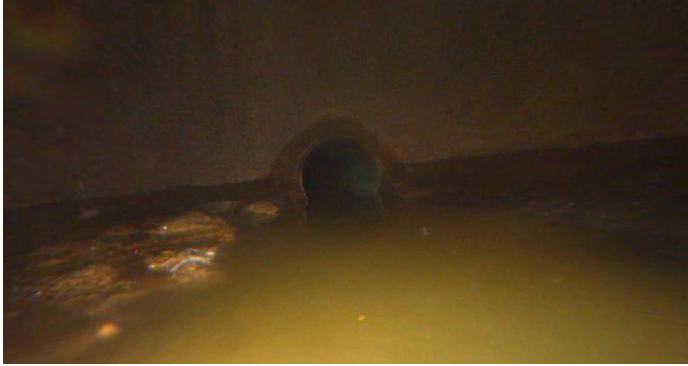
Code:	AMH
Description:	Manhole
Distance (ft):	366.2
Structural Grade:	0
O&M Grade:	0
Clock Start/From:	
Clock To:	
1st Value:	
2nd Value:	
Value Percent:	
Continuous Index:	
Within 8" of Joint:	NO
Remarks:	M-807-003
