Profile/Photo Observation Report

Date:	04/06/2018	Weather:		Coding:	PACP 6.0
Pipe Length (ft):	361.7	Owner:	NA	Pre Clean:	Not Known
P.O.#:		Surveyor:	Jen Costello	PSR:	P-807-005-006
Customer:		Clean Date:	01/01/1900	Shape:	C

Street:	S ILLINOIS ST	Flow Control:	Not Controlled
City:	Hobart, IN	Year Renewed:	
Location:	Light Highway	Tape/Media #:	
Purpose:	Maintenance Related	Dia/Height:	8"
Use:	Sanitary	Material:	PVC
Drain Area:	NA	Lining:	Cured in Place
Category:	NA		
Comment:	Flow direction wrong.

Location Details:		Direction of Survey:	Upstream
US MH:	M-807-006	DS MH:	M-807-005
		Total Length Surveyed (ft):	346.5

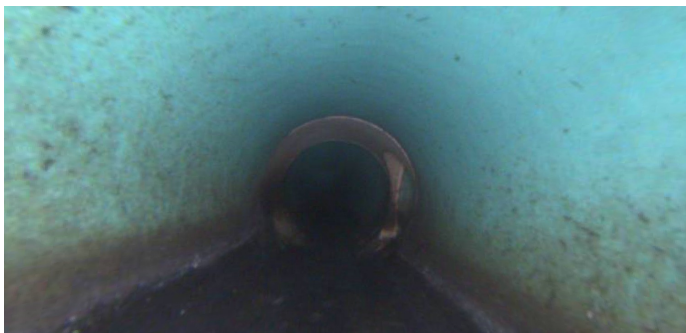
Code: **AMH**
Description: **Manhole**

Distance (ft): **.0**
Structural Grade: **0**
O&M Grade: **0**
Clock Start/From:
Clock To:
1st Value:
2nd Value:
Value Percent:
Continuous Index:
Within 8" of Joint: **NO**
Remarks: **M-807-005**

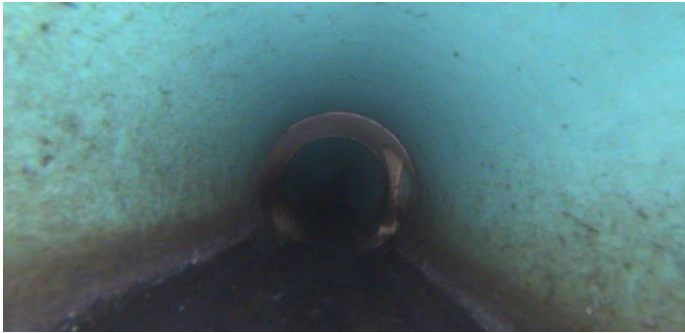
Code:	MWL
Description:	Water Level

Distance (ft):	.0
Structural Grade:	0
O&M Grade:	0
Clock Start/From:	
Clock To:	
1st Value:	
2nd Value:	
Value Percent:	5.000
Continuous Index:	
Within 8" of Joint:	NO
Remarks:

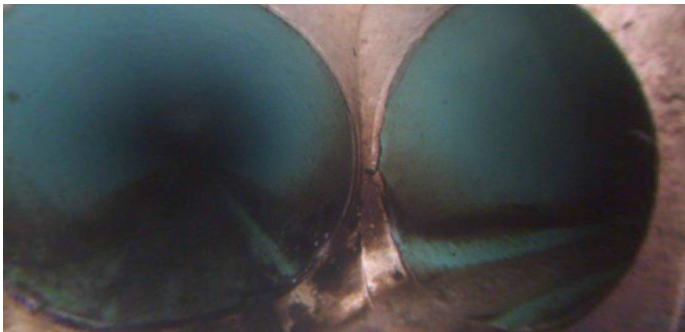
Code:	TF
Description:	Tap Factory

Distance (ft):	2.0
Structural Grade:	0
O&M Grade:	0
Clock Start/From:	3
Clock To:	
1st Value:	4.000
2nd Value:	
Value Percent:	
Continuous Index:	
Within 8" of Joint:	
Remarks:

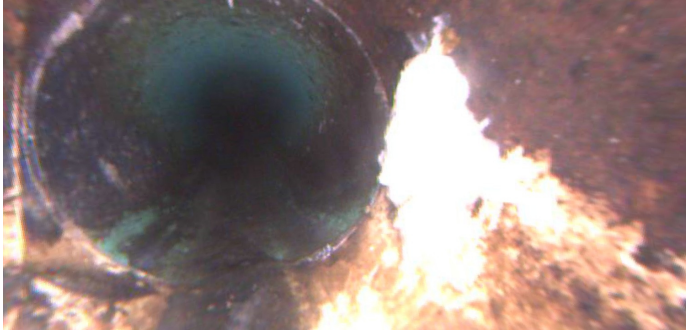
Code: **DAZ**
Description: **Deposits Attached Other**

Distance (ft): **85.7**
Structural Grade: **0**
O&M Grade: **2**
Clock Start/From: **2**
Clock To: **4**
1st Value:
2nd Value:
Value Percent: **5.000**
Continuous Index:
Within 8" of Joint: **NO**
Remarks: **PAPER PRODUCTS**

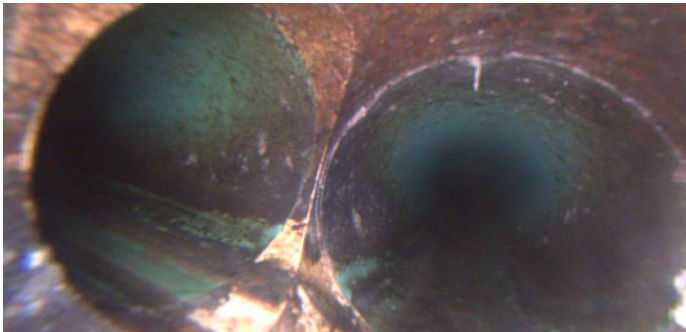
Code: **TF**
Description: **Tap Factory**

Distance (ft): **85.7**
Structural Grade: **0**
O&M Grade: **0**
Clock Start/From: **9**
Clock To:
1st Value: **4.000**
2nd Value:
Value Percent:
Continuous Index:
Within 8" of Joint:
Remarks:

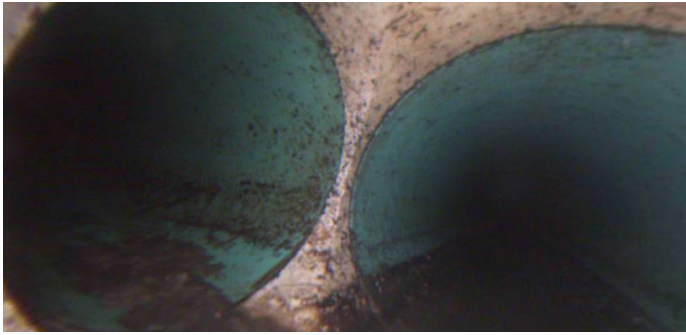
Code: **TF**
Description: **Tap Factory**

Distance (ft): **96.0**
Structural Grade: **0**
O&M Grade: **0**
Clock Start/From: **9**
Clock To:
1st Value: **4.000**
2nd Value:
Value Percent:
Continuous Index:
Within 8" of Joint:
Remarks:

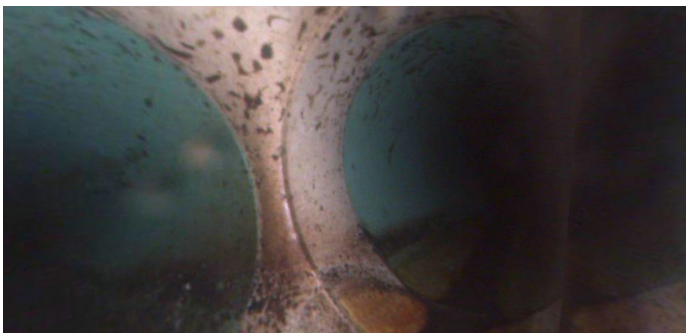
Code: **TFA**
Description: **Tap Factory Active**

Distance (ft): **163.7**
Structural Grade: **0**
O&M Grade: **0**
Clock Start/From: **3**
Clock To:
1st Value: **4.000**
2nd Value:
Value Percent:
Continuous Index:
Within 8" of Joint:
Remarks:

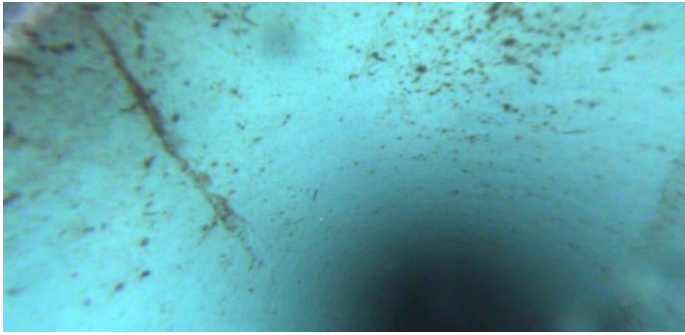
Code: **RFJ**
Description: **Roots Fine Joint**

Distance (ft): **204.8**
Structural Grade: **0**
O&M Grade: **1**
Clock Start/From: **10**
Clock To:
1st Value:
2nd Value:
Value Percent:
Continuous Index:
Within 8" of Joint: **YES**
Remarks:

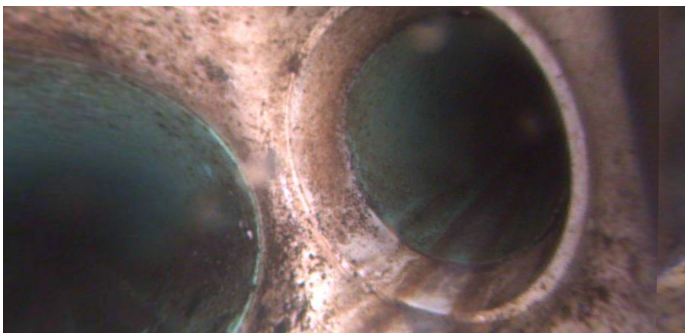
Code: **TF**
Description: **Tap Factory**

Distance (ft): **219.1**
Structural Grade: **0**
O&M Grade: **0**
Clock Start/From: **3**
Clock To:
1st Value: **4.000**
2nd Value:
Value Percent:
Continuous Index:
Within 8" of Joint:
Remarks:

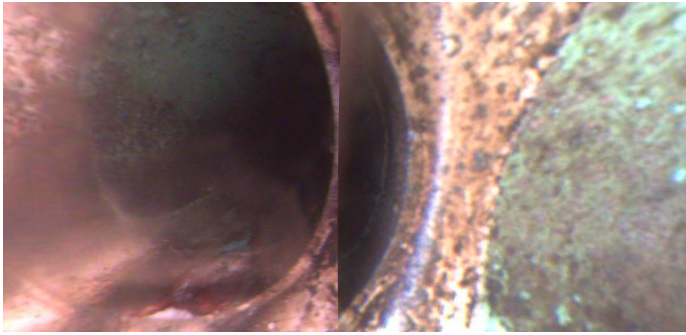
Code: **TFA**
Description: **Tap Factory Active**

Distance (ft): **229.9**
Structural Grade: **0**
O&M Grade: **0**
Clock Start/From: **9**
Clock To:
1st Value: **4.000**
2nd Value:
Value Percent:
Continuous Index:
Within 8" of Joint:
Remarks:

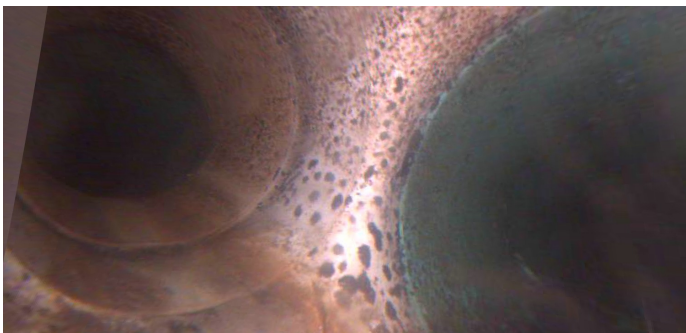
Code: **TFA**
Description: **Tap Factory Active**

Distance (ft): **269.4**
Structural Grade: **0**
O&M Grade: **0**
Clock Start/From: **3**
Clock To:
1st Value: **4.000**
2nd Value:
Value Percent:
Continuous Index:
Within 8" of Joint:
Remarks:

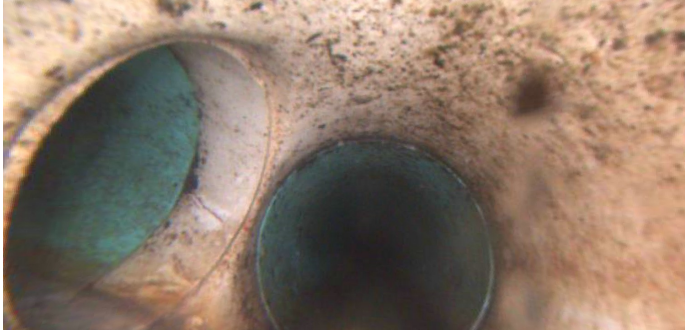
Code: **TF**
Description: **Tap Factory**

Distance (ft): **278.0**
Structural Grade: **0**
O&M Grade: **0**
Clock Start/From: **9**
Clock To:
1st Value: **4.000**
2nd Value:
Value Percent:
Continuous Index:
Within 8" of Joint:
Remarks:

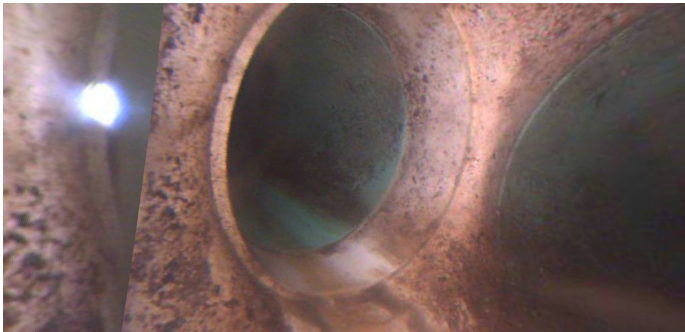
Code: **TFA**
Description: **Tap Factory Active**

Distance (ft): **296.7**
Structural Grade: **0**
O&M Grade: **0**
Clock Start/From: **3**
Clock To:
1st Value: **4.000**
2nd Value:
Value Percent:
Continuous Index:
Within 8" of Joint:
Remarks:

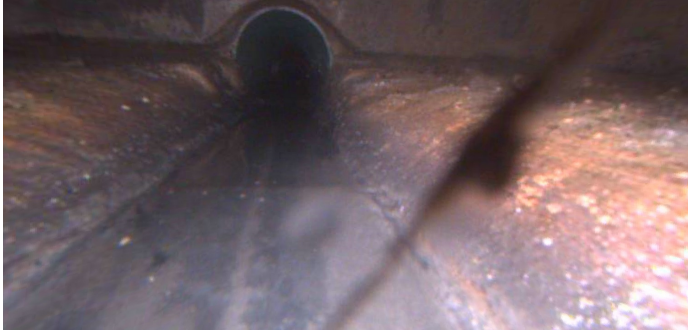
Code:	AMH
Description:	Manhole
Distance (ft):	346.5
Structural Grade:	0
O&M Grade:	0
Clock Start/From:	
Clock To:	
1st Value:	
2nd Value:	
Value Percent:	
Continuous Index:	
Within 8" of Joint:	NO
Remarks:	M-807-006
